DRAFT ADA TRANSITION PLAN UPDATE
NEIGHBORHOOD AREA 9 SONA
SEPTEMBER 20, 2011

CITY OF CITRUS HEIGHTS

The Sunrise Oaks Neighborhood Association (SONA)

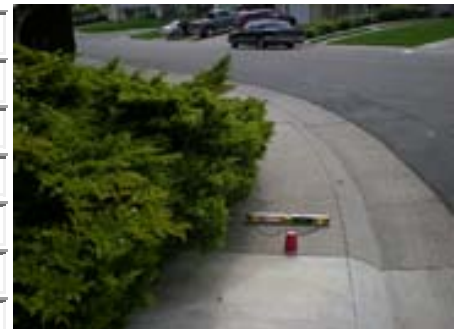
Field Date:	4/15/2011	Report Date:	4/15/2011	Barrier #:	6982B
Location:	Red Pine Ct - North				
X Coordinate:	-121.26535				
Y Coordinate:	38.69139				
Barrier Area:	Sidewalks				
Barrier Type:	Clear Width - Existing ($\leq 31"$ or less)				
Code Ref:	CBC 1133B.7.1

As Built Meas:	1	Quantity:	LF
Description:	Pedestrian route is not min. 48" wide ($\leq 31"$ or less)		
As Built Desc:	24" clear width due to foliage		
Solution:	Trim foliage to provide min. 48" clear width		
Bar. Severity:	1 Necessary	Cost Estimate:	\$125.00
Implementation Priority:	4	Facility Function:	
Implementation Phase:		Implementation Date:	
Official Responsible:

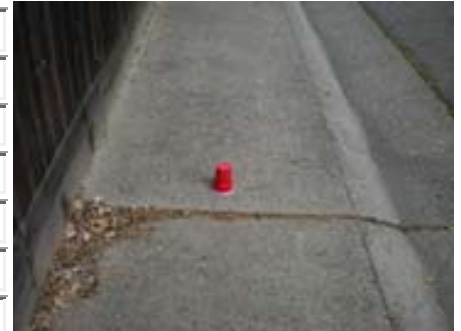
Field Date:	4/15/2011	Report Date:	4/15/2011	Barrier #:	6983A
Location:	Larwin Dr - West				
X Coordinate:	-121.26467				
Y Coordinate:	38.69171				
Barrier Area:	Sidewalks				
Barrier Type:	Abrupt Change in Level - > 1/2"				
Code Ref:	CBC 1133B.7.1 and ADA/ABA 303.3

As Built Meas:	4	Quantity:	LF
Description:	Change in level greater than 1/2"		
As Built Desc:	1/2" lip in sidewalk surface		
Solution:	Grind or repair sidewalk to remove trip hazard		
Bar. Severity:	1 Necessary	Cost Estimate:	\$1,000.00
Implementation Priority:	2	Facility Function:	
Implementation Phase:		Implementation Date:	
Official Responsible:			
Notes:

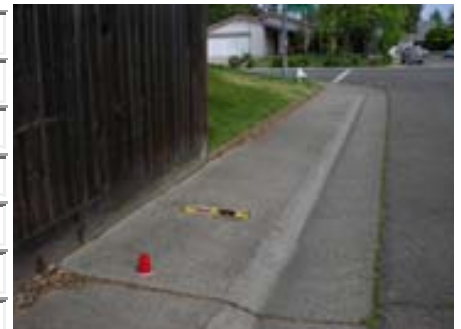
Field Date:	4/15/2011	Report Date:	4/15/2011	Barrier #:	6983B
Location:	Larwin Dr - West				
X Coordinate:	-121.26465				
Y Coordinate:	38.69174				
Barrier Area:	Sidewalks				
Barrier Type:	Cross Slope - Existing (4.1% to 4.9%)				
Code Ref:	CBC 1133B.7.1.3 and ADA/ABA 403.3

As Built Meas:	63	Quantity:	LF
Description:	Cross slope exceeds 2.0% (4.1% to 4.9%)		
As Built Desc:	4.5% cross slope		
Solution:	Demolish existing and construct new route		
Bar. Severity:	2 Recommended	Cost Estimate:	\$7,875.00
Implementation Priority:	2	Facility Function:	
Implementation Phase:		Implementation Date:	
Official Responsible:			
Notes:

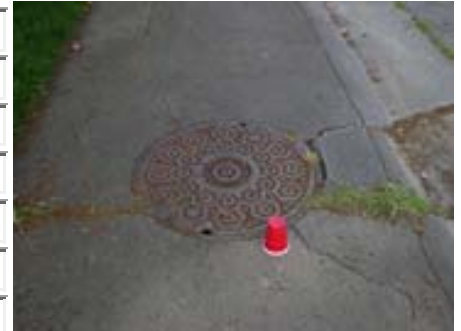
Field Date:	4/15/2011	Report Date:	4/15/2011	Barrier #:	6984
Location:	Woodmore Oaks Dr - South				
X Coordinate:	-121.2685				
Y Coordinate:	38.69193				
Barrier Area:	Sidewalks				
Barrier Type:	Surface Condition - Damaged				
Code Ref:	CBC 1133B.7.1 and ADA/ABA 302.1

As Built Meas:	4	Quantity:	LF
Description:	Surface is not firm and stable (cracked, broken or loose soil, etc.)		
As Built Desc:	Cracked concrete		
Solution:	Repair surface to make firm and stable		
Bar. Severity:	1 Necessary	Cost Estimate:	\$500.00
Implementation Priority:	3	Facility Function:	
Implementation Phase:		Implementation Date:	
Official Responsible:

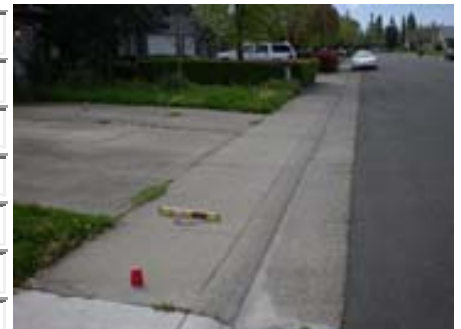
Field Date:	4/15/2011	Report Date:	4/15/2011	Barrier #:	6985A
Location:	Trovita Wy - East				
X Coordinate:	-121.26897				
Y Coordinate:	38.69181				
Barrier Area:	Sidewalks				
Barrier Type:	Cross Slope - Existing (4.1% to 4.9%)				
Code Ref:	CBC 1133B.7.1.3 and ADA/ABA 403.3

As Built Meas:	260	Quantity:	LF
Description:	Cross slope exceeds 2.0% (4.1% to 4.9%)		
As Built Desc:	4.9% cross slope		
Solution:	Demolish existing and construct new route		
Bar. Severity:	2 Recommended	Cost Estimate:	\$32,500.00
Implementation Priority:	4	Facility Function:	
Implementation Phase:		Implementation Date:	
Official Responsible:

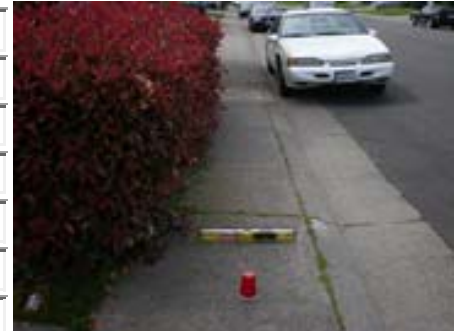
Field Date:	4/15/2011	Report Date:	4/15/2011	Barrier #:	6985B
Location:	Trovita Wy - East				
X Coordinate:	-121.26896				
Y Coordinate:	38.69154				
Barrier Area:	Sidewalks				
Barrier Type:	Clear Width - Existing ($\leq 31"$ or less)				
Code Ref:	CBC 1133B.7.1

As Built Meas:	1	Quantity:	LF
Description:	Pedestrian route is not min. 48" wide ($\leq 31"$ or less)		
As Built Desc:	30" clear width due to foliage		
Solution:	Trim foliage to provide min. 48" clear width		
Bar. Severity:	1 Necessary	Cost Estimate:	\$125.00
Implementation Priority:	4	Facility Function:	
Implementation Phase:		Implementation Date:	
Official Responsible:

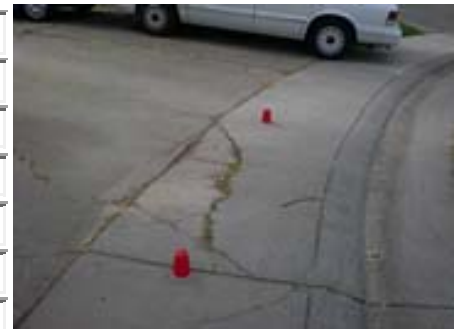
Field Date:	4/15/2011	Report Date:	4/15/2011	Barrier #:	6985C
Location:	Trovita Wy - East				
X Coordinate:	-121.26891				
Y Coordinate:	38.6898				
Barrier Area:	Sidewalks				
Barrier Type:	Surface Condition - Damaged				
Code Ref:	CBC 1133B.7.1 and ADA/ABA 302.1

As Built Meas:	8	Quantity:	LF
Description:	Surface is not firm and stable (cracked, broken or loose soil, etc.)		
As Built Desc:	Cracked concrete		
Solution:	Repair surface to make firm and stable		
Bar. Severity:	1 Necessary	Cost Estimate:	\$1,000.00
Implementation Priority:	4	Facility Function:	
Implementation Phase:		Implementation Date:	
Official Responsible:

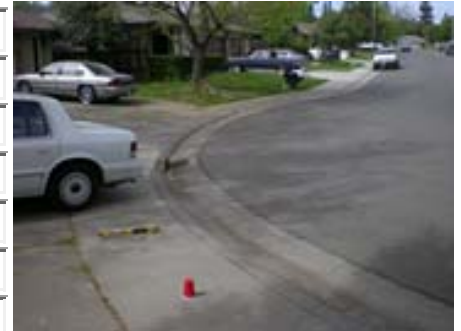
Barrier Type: Cross Slope - Existing (4.1% to 4.9%)

Code Ref: CBC 1133B.7.1.3 and ADA/ABA 403.3

As Built Meas: 575 Quantity: LF

Description: Cross slope exceeds 2.0% (4.1% to 4.9%)

Bar. Severity: 2 Recommended Cost Estimate: \$71,875.00 Status:

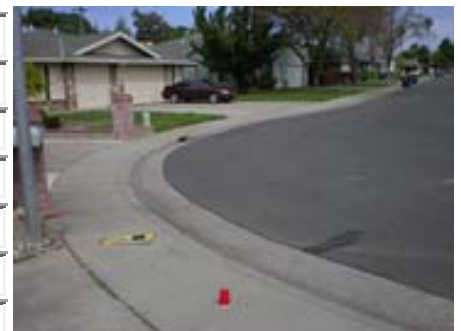
Barrier Type: Cross Slope - Existing (4.1% to 4.9%)

Code Ref: CBC 1133B.7.1.3 and ADA/ABA 403.3

As Built Meas: 534 Quantity: LF

Description: Cross slope exceeds 2.0% (4.1% to 4.9%)

Bar. Severity: 2 Recommended Cost Estimate: \$66,750.00 Status:

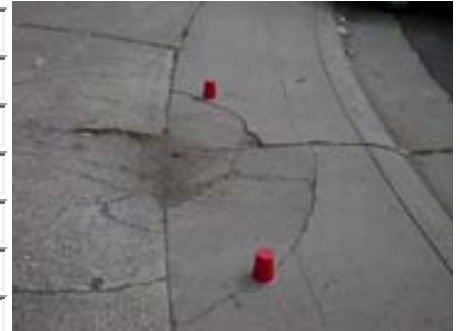
Field Date:	4/15/2011	Report Date:	4/15/2011	Barrier #:	6987B
Location:	Trovita Wy - West				
X Coordinate:	-121.27096				
Y Coordinate:	38.69108				
Barrier Area:	Sidewalks				
Barrier Type:	Surface Condition - Damaged				
Code Ref:	CBC 1133B.7.1 and ADA/ABA 302.1

As Built Meas:	8	Quantity:	LF
Description:	Surface is not firm and stable (cracked, broken or loose soil, etc.)		
As Built Desc:	Cracked concrete		
Solution:	Repair surface to make firm and stable		
Bar. Severity:	1 Necessary	Cost Estimate:	\$1,000.00
Implementation Priority:	4	Facility Function:	
Implementation Phase:		Implementation Date:	
Official Responsible:			
Notes:

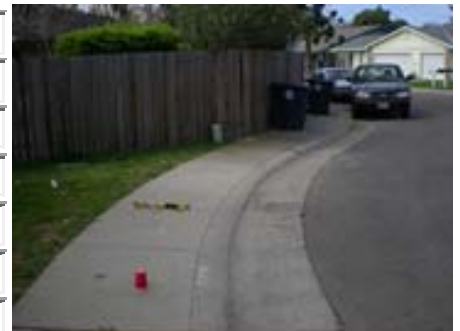
Field Date:	4/15/2011	Report Date:	4/15/2011	Barrier #:	6988
Location:	Trovita Wy - East				
X Coordinate:	-121.27076				
Y Coordinate:	38.69096				
Barrier Area:	Sidewalks				
Barrier Type:	Cross Slope - Existing (2.1% to 3.0%)				
Code Ref:	CBC 1133B.7.1.3 and ADA/ABA 403.3

As Built Meas:	126	Quantity:	LF
Description:	Cross slope exceeds 2.0% (2.1% to 3.0%)		
As Built Desc:	3.0% cross slope		
Solution:	Low severity barrier - no remediation recommended		
Bar. Severity:	4 Low Severity	Cost Estimate:	\$0.00
Implementation Priority:	4	Facility Function:	
Implementation Phase:		Implementation Date:	
Official Responsible:			
Notes:

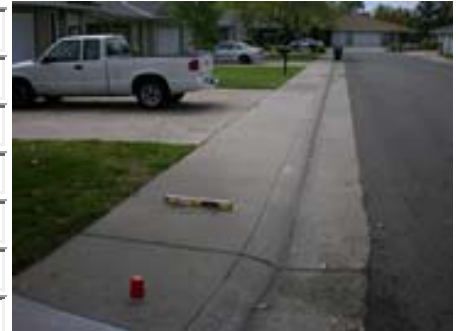
Field Date:	4/15/2011	Report Date:	4/15/2011	Barrier #:	6989
Location:	Trovita Wy - East				
X Coordinate:	-121.27089				
Y Coordinate:	38.69043				
Barrier Area:	Sidewalks				
Barrier Type:	Cross Slope - Existing (4.1% to 4.9%)				
Code Ref:	CBC 1133B.7.1.3 and ADA/ABA 403.3

As Built Meas:	151	Quantity:	LF
Description:	Cross slope exceeds 2.0% (4.1% to 4.9%)		
As Built Desc:	4.5% cross slope		
Solution:	Demolish existing and construct new route		
Bar. Severity:	2 Recommended	Cost Estimate:	\$18,875.00
Implementation Priority:	4	Facility Function:	
Implementation Phase:		Implementation Date:	
Official Responsible:

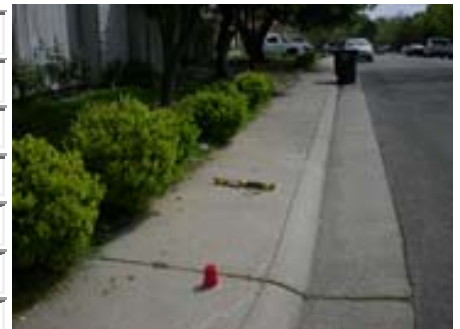
Field Date:	4/15/2011	Report Date:	4/15/2011	Barrier #:	6990
Location:	Trovita Wy - North				
X Coordinate:	-121.27082				
Y Coordinate:	38.68982				
Barrier Area:	Sidewalks				
Barrier Type:	Cross Slope - Existing (5.0% or more)				
Code Ref:	CBC 1133B.7.1.3 and ADA/ABA 403.3

As Built Meas:	507	Quantity:	LF
Description:	Cross slope exceeds 2.0% (5.0% or more)		
As Built Desc:	5.5% cross slope		
Solution:	Demolish existing and construct new route		
Bar. Severity:	1 Necessary	Cost Estimate:	\$63,375.00
Implementation Priority:	4	Facility Function:	
Implementation Phase:		Implementation Date:	
Official Responsible:

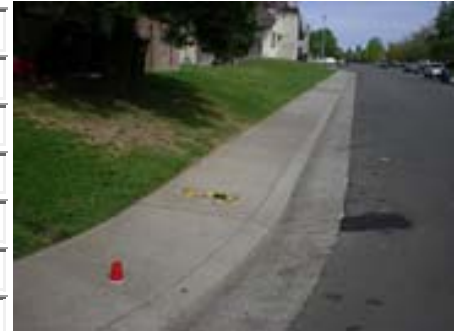
Field Date:	4/15/2011	Report Date:	4/15/2011	Barrier #:	6991
Location:	Trovita Wy - West				
X Coordinate:	-121.26901				
Y Coordinate:	38.68991				
Barrier Area:	Sidewalks				
Barrier Type:	Cross Slope - Existing (4.1% to 4.9%)				
Code Ref:	CBC 1133B.7.1.3 and ADA/ABA 403.3

As Built Meas:	200	Quantity:	LF
Description:	Cross slope exceeds 2.0% (4.1% to 4.9%)		
As Built Desc:	4.7% cross slope		
Solution:	Demolish existing and construct new route		
Bar. Severity:	2 Recommended	Cost Estimate:	\$25,000.00
Status:			
Implementation Priority:	4	Facility Function:	
Implementation Phase:		Implementation Date:	
Official Responsible:

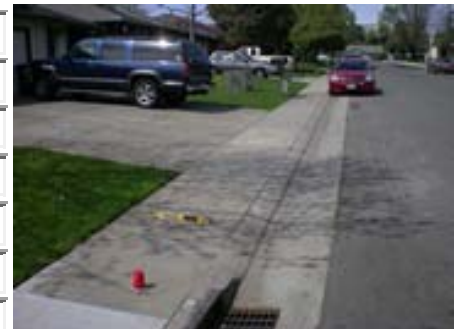
Field Date:	4/15/2011	Report Date:	4/15/2011	Barrier #:	6992
Location:	Tangors Wy - South				
X Coordinate:	-121.26909				
Y Coordinate:	38.6905				
Barrier Area:	Sidewalks				
Barrier Type:	Cross Slope - Existing (4.1% to 4.9%)				
Code Ref:	CBC 1133B.7.1.3 and ADA/ABA 403.3

As Built Meas:	493	Quantity:	LF
Description:	Cross slope exceeds 2.0% (4.1% to 4.9%)		
As Built Desc:	4.5% cross slope		
Solution:	Demolish existing and construct new route		
Bar. Severity:	2 Recommended	Cost Estimate:	\$61,625.00
Status:			
Implementation Priority:	4	Facility Function:	
Implementation Phase:		Implementation Date:	
Official Responsible:

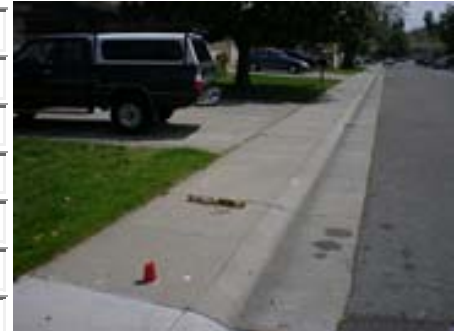
Field Date:	4/15/2011	Report Date:	4/15/2011	Barrier #:	6993A
Location:	Tangors Wy - North				
X Coordinate:	-121.27082				
Y Coordinate:	38.6906				
Barrier Area:	Sidewalks				
Barrier Type:	Cross Slope - Existing (4.1% to 4.9%)				
Code Ref:	CBC 1133B.7.1.3 and ADA/ABA 403.3

As Built Meas:	147	Quantity:	LF
Description:	Cross slope exceeds 2.0% (4.1% to 4.9%)		
As Built Desc:	4.4% cross slope		
Solution:	Demolish existing and construct new route		
Bar. Severity:	2 Recommended	Cost Estimate:	\$18,375.00
Implementation Priority:	4	Facility Function:	
Implementation Phase:		Implementation Date:	
Official Responsible:

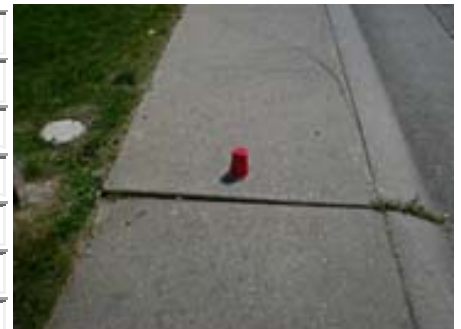
Field Date:	4/15/2011	Report Date:	4/15/2011	Barrier #:	6993B
Location:	Tangors Wy - North				
X Coordinate:	-121.27067				
Y Coordinate:	38.69057				
Barrier Area:	Sidewalks				
Barrier Type:	Abrupt Change in Level - > 1/2"				
Code Ref:	CBC 1133B.7.1 and ADA/ABA 303.3

As Built Meas:	4	Quantity:	LF
Description:	Change in level greater than 1/2"		
As Built Desc:	1/2" lip in sidewalk surface		
Solution:	Grind or repair sidewalk to remove trip hazard		
Bar. Severity:	1 Necessary	Cost Estimate:	\$1,000.00
Implementation Priority:	4	Facility Function:	
Implementation Phase:		Implementation Date:	
Official Responsible:

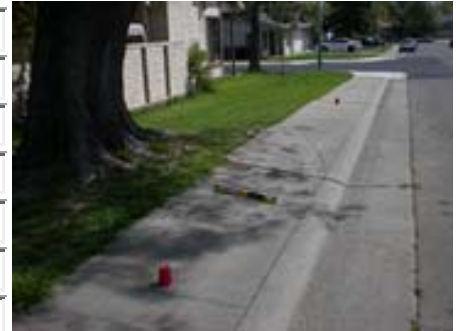
Field Date:	4/15/2011	Report Date:	4/15/2011	Barrier #:	6993C
Location:	Tangors Wy - North				
X Coordinate:	-121.27026				
Y Coordinate:	38.69059				
Barrier Area:	Sidewalks				
Barrier Type:	Cross Slope - Existing (5.0% or more)				
Code Ref:	CBC 1133B.7.1.3 and ADA/ABA 403.3

As Built Meas:	30	Quantity:	LF
Description:	Cross slope exceeds 2.0% (5.0% or more)		
As Built Desc:	12.8% cross slope at tree heaves		
Solution:	Demolish existing and construct new route		
Bar. Severity:	1 Necessary	Cost Estimate:	\$3,750.00
Implementation Priority:	4	Facility Function:	
Implementation Phase:		Implementation Date:	
Official Responsible:

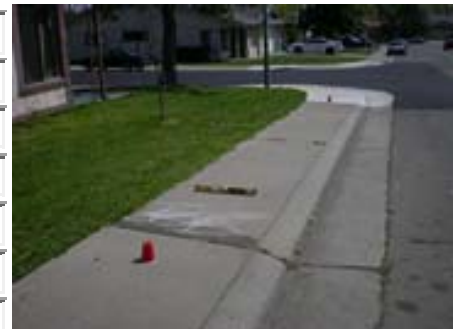
Field Date:	4/15/2011	Report Date:	4/15/2011	Barrier #:	6994
Location:	Tangors Wy - North				
X Coordinate:	-121.27016				
Y Coordinate:	38.69057				
Barrier Area:	Sidewalks				
Barrier Type:	Cross Slope - Existing (4.1% to 4.9%)				
Code Ref:	CBC 1133B.7.1.3 and ADA/ABA 403.3

As Built Meas:	68	Quantity:	LF
Description:	Cross slope exceeds 2.0% (4.1% to 4.9%)		
As Built Desc:	4.5% cross slope		
Solution:	Demolish existing and construct new route		
Bar. Severity:	2 Recommended	Cost Estimate:	\$8,500.00
Implementation Priority:	4	Facility Function:	
Implementation Phase:		Implementation Date:	
Official Responsible:

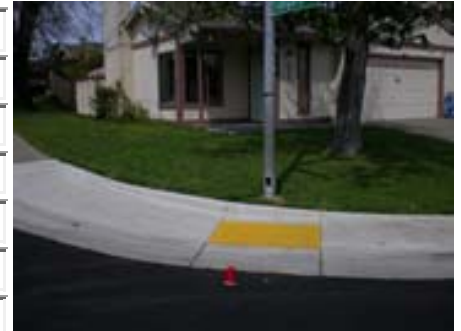
Field Date:	4/15/2011	Report Date:	4/15/2011	Barrier #:	6995A
Location:	Tangors Wy and Tarocco Wy - Corner A				
X Coordinate:	-121.27003				
Y Coordinate:	38.69056				
Barrier Area:	Curb Ramps				
Barrier Type:	12" Grooves - Existing (>5.0%)				
Code Ref:	CBC 1127B.5.6

As Built Meas:	1	Quantity:	EACH
Description:	12" grooves at top of curb ramp are not level (>5.0%)		
As Built Desc:	6.7% at 12" grooves		
Solution:	Demolish existing and construct new curb ramp		
Bar. Severity:	1 Necessary	Cost Estimate:	\$2,500.00
Implementation Priority:	4	Facility Function:	
Implementation Phase:		Implementation Date:	
Official Responsible:			
Notes:	Two - way intersection corners A, B. Corner B compliant

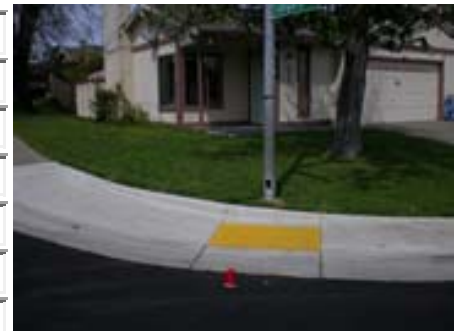
Field Date:	4/15/2011	Report Date:	4/15/2011	Barrier #:	6995B
Location:	Tangors Wy and Tarocco Wy - Corner A				
X Coordinate:	-121.27003				
Y Coordinate:	38.69056				
Barrier Area:	Curb Ramps				
Barrier Type:	Running Slope - Existing (9.0% to 9.4%)				
Code Ref:	CBC 1127B.5.3 and ADA/ABA 406.1

As Built Meas:	1	Quantity:	EACH
Description:	Ramp run cross slope exceeds 2.0% (9.0% to 9.4%)		
As Built Desc:	9.1% running slope		
Solution:	Demolish existing and construct new curb ramp		
Bar. Severity:	2 Recommended	Cost Estimate:	\$0.00
Implementation Priority:	4	Facility Function:	
Implementation Phase:		Implementation Date:	
Official Responsible:			
Notes:	Two - way intersection corners A, B. Corner B compliant

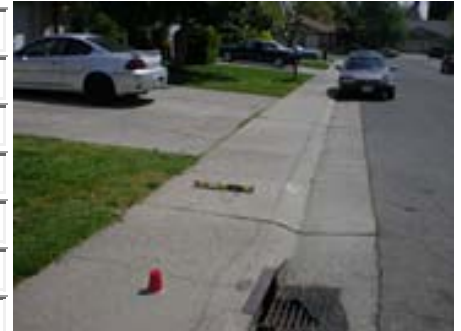
Field Date:	4/15/2011	Report Date:	4/15/2011	Barrier #:	6996
Location:	Tangors Wy - North				
X Coordinate:	-121.2698				
Y Coordinate:	38.69057				
Barrier Area:	Sidewalks				
Barrier Type:	Cross Slope - Existing (5.0% or more)				
Code Ref:	CBC 1133B.7.1.3 and ADA/ABA 403.3

As Built Meas:	190	Quantity:	LF
Description:	Cross slope exceeds 2.0% (5.0% or more)		
As Built Desc:	6.1% cross slope		
Solution:	Demolish existing and construct new route		
Bar. Severity:	1 Necessary	Cost Estimate:	\$23,750.00
Implementation Priority:	4	Facility Function:	
Implementation Phase:		Implementation Date:	
Official Responsible:

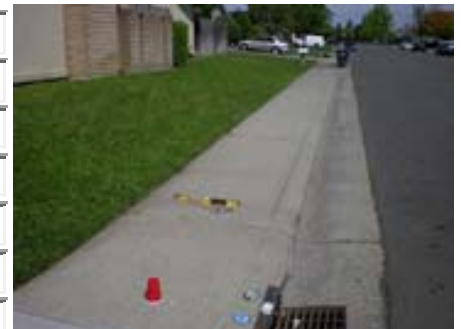
Field Date:	4/15/2011	Report Date:	4/15/2011	Barrier #:	6997
Location:	Trovita Wy - West				
X Coordinate:	-121.26907				
Y Coordinate:	38.69067				
Barrier Area:	Sidewalks				
Barrier Type:	Cross Slope - Existing (5.0% or more)				
Code Ref:	CBC 1133B.7.1.3 and ADA/ABA 403.3

As Built Meas:	440	Quantity:	LF
Description:	Cross slope exceeds 2.0% (5.0% or more)		
As Built Desc:	5.2% cross slope		
Solution:	Demolish existing and construct new route		
Bar. Severity:	1 Necessary	Cost Estimate:	\$55,000.00
Implementation Priority:	4	Facility Function:	
Implementation Phase:		Implementation Date:	
Official Responsible:

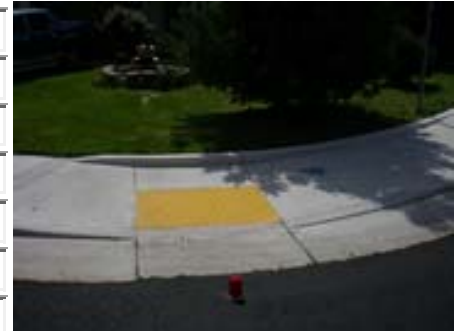
Barrier Type: 12" Grooves - Existing (3.1% to 4.0%)

Code Ref: CBC 1127B.5.6

As Built Meas: 1 Quantity: EACH

Description: 12" grooves at top of curb ramp are not level (3.1% to 4.0%)

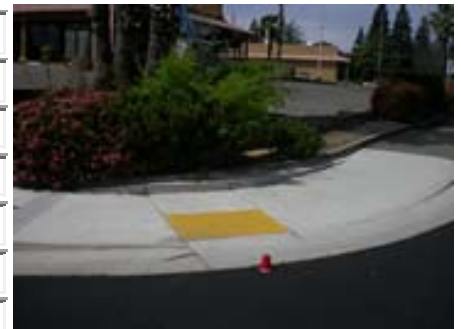
Barrier Type: 12" Grooves - Existing (>5.0%)

Code Ref: CBC 1127B.5.6

As Built Meas: 1 Quantity: EACH

Description: 12" grooves at top of curb ramp are not level (>5.0%)

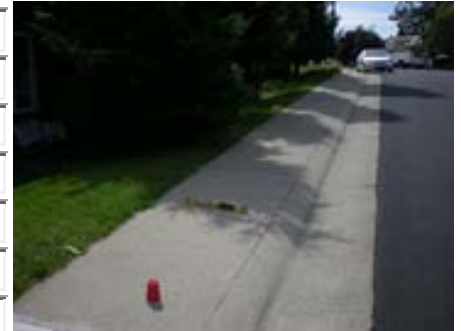
Field Date:	4/15/2011	Report Date:	4/15/2011	Barrier #:	7000
Location:	Tarocco Wy - East				
X Coordinate:	-121.27006				
Y Coordinate:	38.69183				
Barrier Area:	Sidewalks				
Barrier Type:	Cross Slope - Existing (4.1% to 4.9%)				
Code Ref:	CBC 1133B.7.1.3 and ADA/ABA 403.3

As Built Meas:	447	Quantity:	LF
Description:	Cross slope exceeds 2.0% (4.1% to 4.9%)		
As Built Desc:	4.4% cross slope		
Solution:	Demolish existing and construct new route		
Bar. Severity:	2 Recommended	Cost Estimate:	\$55,875.00
Implementation Priority:	4	Facility Function:	
Implementation Phase:		Implementation Date:	
Official Responsible:

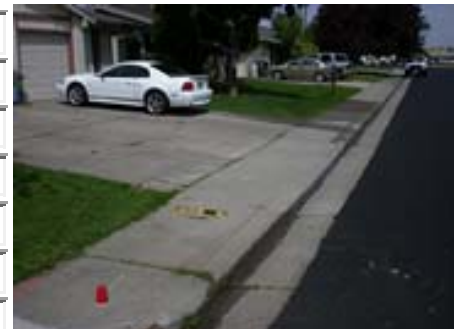
Field Date:	4/15/2011	Report Date:	4/15/2011	Barrier #:	7001
Location:	Tarocco Wy - West				
X Coordinate:	-121.27001				
Y Coordinate:	38.6907				
Barrier Area:	Sidewalks				
Barrier Type:	Cross Slope - Existing (5.0% or more)				
Code Ref:	CBC 1133B.7.1.3 and ADA/ABA 403.3

As Built Meas:	296	Quantity:	LF
Description:	Cross slope exceeds 2.0% (5.0% or more)		
As Built Desc:	5.2% cross slope		
Solution:	Demolish existing and construct new route		
Bar. Severity:	1 Necessary	Cost Estimate:	\$37,000.00
Implementation Priority:	4	Facility Function:	
Implementation Phase:		Implementation Date:	
Official Responsible:

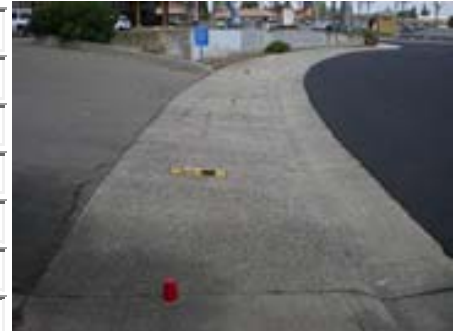
Field Date:	4/15/2011	Report Date:	4/15/2011	Barrier #:	7002
Location:	Tarocco Wy - West				
X Coordinate:	-121.27016				
Y Coordinate:	38.69142				
Barrier Area:	Sidewalks				
Barrier Type:	Driveway - Existing (5.0% or more)				
Code Ref:	CBC 1133B.7.1.3 and ADA/ABA 403.3

As Built Meas:	40	Quantity:	LF
Description:	Driveway cross slope exceeds 2.0% (5.0% or more)		
As Built Desc:	7.9% cross slope at cracked concrete		
Solution:	Provide min. 48" wide level walkway through driveway		
Bar. Severity:	4 Low Severity	Cost Estimate:	\$5,000.00
Implementation Priority:	4	Facility Function:	
Implementation Phase:		Implementation Date:	
Official Responsible:

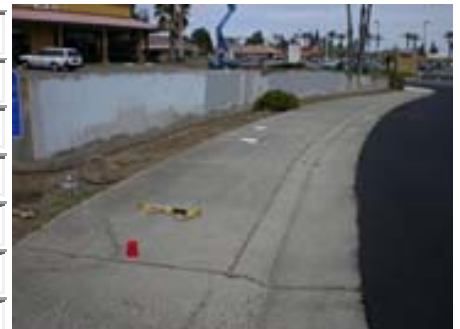
Field Date:	4/15/2011	Report Date:	4/15/2011	Barrier #:	7003
Location:	Tarocco Wy - West				
X Coordinate:	-121.27022				
Y Coordinate:	38.69148				
Barrier Area:	Sidewalks				
Barrier Type:	Cross Slope - Existing (4.1% to 4.9%)				
Code Ref:	CBC 1133B.7.1.3 and ADA/ABA 403.3

As Built Meas:	145	Quantity:	LF
Description:	Cross slope exceeds 2.0% (4.1% to 4.9%)		
As Built Desc:	4.5% cross slope		
Solution:	Demolish existing and construct new route		
Bar. Severity:	2 Recommended	Cost Estimate:	\$18,125.00
Implementation Priority:	4	Facility Function:	
Implementation Phase:		Implementation Date:	
Official Responsible:

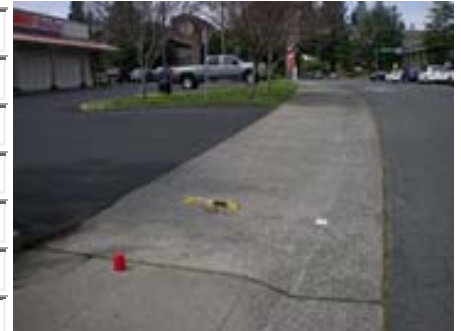
Barrier Type: Driveway - Existing (5.0% or more)

As Built Meas: 40 Quantity: LF

Description: Driveway cross slope exceeds 2.0% (5.0% or more)

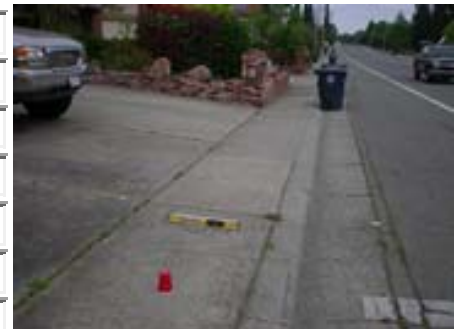
Barrier Type: Cross Slope - Existing (4.1% to 4.9%)

As Built Meas: 584 Quantity: LF

Description: Cross slope exceeds 2.0% (4.1% to 4.9%)

Bar. Severity: 2 Recommended Cost Estimate: \$73,000.00 Status:

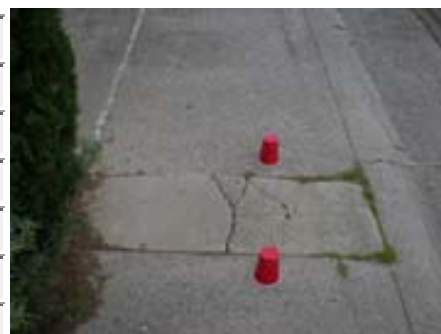
Field Date:	4/18/2011	Report Date:	4/18/2011	Barrier #:	7006
Location:	Kenneth Ave - West				
X Coordinate:	-121.24446				
Y Coordinate:	38.69466				
Barrier Area:	Sidewalks				
Barrier Type:	Surface Condition - Damaged				
Code Ref:	CBC 1133B.7.1 and ADA/ABA 302.1

As Built Meas:	4	Quantity:	LF
Description:	Surface is not firm and stable (cracked, broken or loose soil, etc.)		
As Built Desc:	Cracked concrete		
Solution:	Repair surface to make firm and stable		
Bar. Severity:	1 Necessary	Cost Estimate:	\$500.00
Implementation Priority:	4	Facility Function:	
Implementation Phase:		Implementation Date:	
Official Responsible:			
Notes:

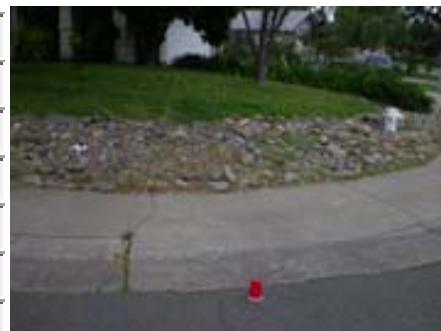
Field Date:	4/18/2011	Report Date:	4/18/2011	Barrier #:	7007
Location:	Kenneth Ave and Mansfield Dr - Corner A				
X Coordinate:	-121.24451				
Y Coordinate:	38.69502				
Barrier Area:	Curb Ramps				
Barrier Type:	No Curb Ramp - Depressed Existing Curb				
Code Ref:	CBC 1127B.5.1 and ADA/ABA 402.2

As Built Meas:	1	Quantity:	EACH
Description:	No compliant curb cut at corner (intersection)		
As Built Desc:	14.2% running slope at depressed area		
Solution:	Demolish existing and construct curb cut		
Bar. Severity:	1 Necessary	Cost Estimate:	\$2,500.00
Implementation Priority:	4	Facility Function:	
Implementation Phase:		Implementation Date:	
Official Responsible:			
Notes:	Two - way intersection corners A, D

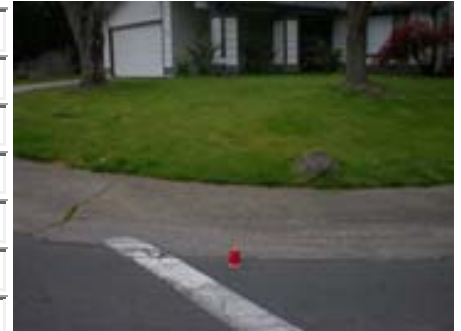
Barrier Type: No Curb Ramp - Depressed Existing Curb

As Built Meas: 1 Quantity: EACH

Description: No compliant curb cut at corner (intersection)

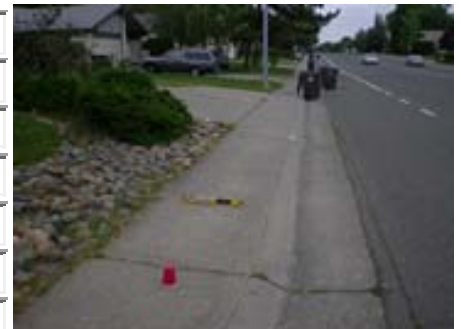
Barrier Type: Cross Slope - Existing (5.0% or more)

As Built Meas: 610 Quantity: LF

Description: Cross slope exceeds 2.0% (5.0% or more)

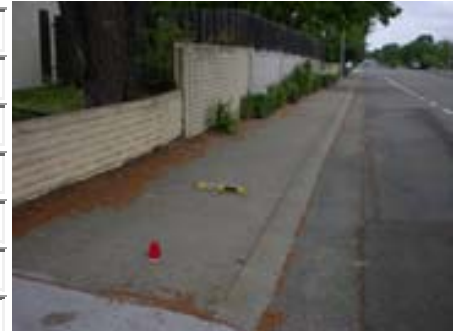
Field Date:	4/18/2011	Report Date:	4/18/2011	Barrier #:	7010
Location:	Kenneth Ave - West				
X Coordinate:	-121.24447				
Y Coordinate:	38.69696				
Barrier Area:	Sidewalks				
Barrier Type:	Cross Slope - Existing (3.1% to 4.0%)				
Code Ref:	CBC 1133B.7.1.3 and ADA/ABA 403.3

As Built Meas:	249	Quantity:	LF
Description:	Cross slope exceeds 2.0% (3.1% to 4.0%)		
As Built Desc:	4.0% cross slope		
Solution:	Demolish existing and construct new route		
Bar. Severity:	3 Hindrance	Cost Estimate:	\$31,125.00
Implementation Priority:	4	Facility Function:	
Implementation Phase:		Implementation Date:	
Official Responsible:

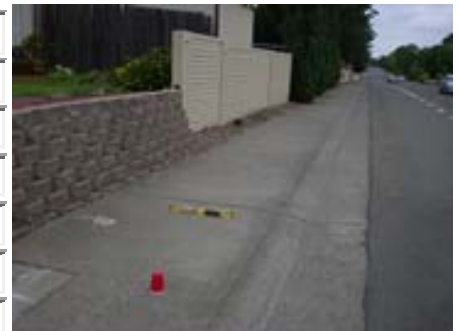
Field Date:	4/18/2011	Report Date:	4/18/2011	Barrier #:	7011
Location:	Kenneth Ave - West				
X Coordinate:	-121.24445				
Y Coordinate:	38.69788				
Barrier Area:	Sidewalks				
Barrier Type:	Cross Slope - Existing (5.0% or more)				
Code Ref:	CBC 1133B.7.1.3 and ADA/ABA 403.3

As Built Meas:	854	Quantity:	LF
Description:	Cross slope exceeds 2.0% (5.0% or more)		
As Built Desc:	5.6% cross slope		
Solution:	Demolish existing and construct new route		
Bar. Severity:	1 Necessary	Cost Estimate:	\$106,750.00
Implementation Priority:	4	Facility Function:	
Implementation Phase:		Implementation Date:	
Official Responsible:

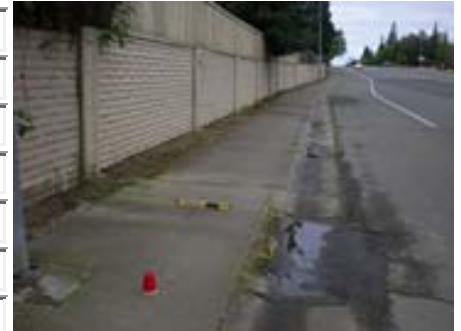
Field Date:	4/18/2011	Report Date:	4/18/2011	Barrier #:	7012A
Location:	Oak Ave - South				
X Coordinate:	-121.24481				
Y Coordinate:	38.70033				
Barrier Area:	Sidewalks				
Barrier Type:	Cross Slope - Existing (3.1% to 4.0%)				
Code Ref:	CBC 1133B.7.1.3 and ADA/ABA 403.3

As Built Meas:	1020	Quantity:	LF
Description:	Cross slope exceeds 2.0% (3.1% to 4.0%)		
As Built Desc:	4.0% cross slope		
Solution:	Demolish existing and construct new route		
Bar. Severity:	3 Hindrance	Cost Estimate:	\$127,500.00
Implementation Priority:	1	Facility Function:	
Implementation Phase:		Implementation Date:	
Official Responsible:			
Notes:

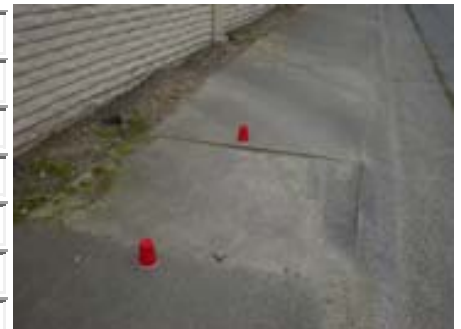
Field Date:	4/18/2011	Report Date:	4/18/2011	Barrier #:	7012B
Location:	Oak Ave - South				
X Coordinate:	-121.24615				
Y Coordinate:	38.70035				
Barrier Area:	Sidewalks				
Barrier Type:	Abrupt Change in Level - > 1/2"				
Code Ref:	CBC 1133B.7.1 and ADA/ABA 303.3

As Built Meas:	4	Quantity:	LF
Description:	Change in level greater than 1/2"		
As Built Desc:	1/2" lip in sidewalk surface		
Solution:	Grind or repair sidewalk to remove trip hazard		
Bar. Severity:	1 Necessary	Cost Estimate:	\$1,000.00
Implementation Priority:	1	Facility Function:	
Implementation Phase:		Implementation Date:	
Official Responsible:			
Notes:

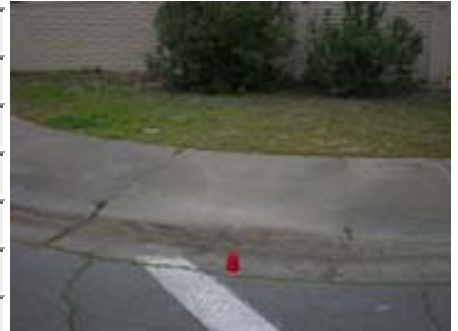
Field Date:	4/18/2011	Report Date:	4/18/2011	Barrier #:	7013
Location:	Oak Ave and Menke Wy - Corner C				
X Coordinate:	-121.2485				
Y Coordinate:	38.70036				
Barrier Area:	Curb Ramps				
Barrier Type:	No Curb Ramp - Depressed Existing Curb				
Code Ref:	CBC 1127B.5.1 and ADA/ABA 402.2

As Built Meas:	1	Quantity:	EACH
Description:	No compliant curb cut at corner (intersection)		
As Built Desc:	6.4% running slope at depressed area		
Solution:	Demolish existing and construct curb cut		
Bar. Severity:	1 Necessary	Cost Estimate:	\$2,500.00
Implementation Priority:	1	Facility Function:	
Implementation Phase:		Implementation Date:	
Official Responsible:			
Notes:	Two - way intersection corners C,D

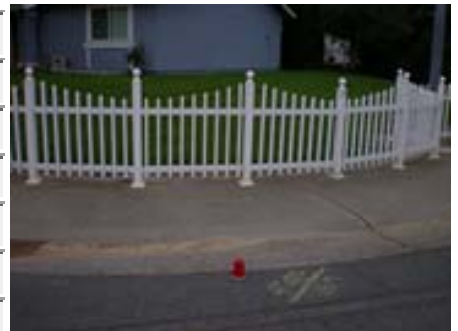
Field Date:	4/18/2011	Report Date:	4/18/2011	Barrier #:	7014
Location:	Oak Ave and Menke Wy - Corner D				
X Coordinate:	-121.24868				
Y Coordinate:	38.70036				
Barrier Area:	Curb Ramps				
Barrier Type:	No Curb Ramp - Depressed Existing Curb				
Code Ref:	CBC 1127B.5.1 and ADA/ABA 402.2

As Built Meas:	1	Quantity:	EACH
Description:	No compliant curb cut at corner (intersection)		
As Built Desc:	8.6% running slope at depressed area		
Solution:	Demolish existing and construct curb cut		
Bar. Severity:	1 Necessary	Cost Estimate:	\$2,500.00
Implementation Priority:	1	Facility Function:	
Implementation Phase:		Implementation Date:	
Official Responsible:			
Notes:	Two - way intersection corners C,D

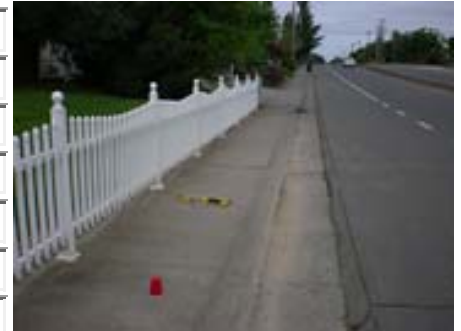
Field Date:	4/18/2011	Report Date:	4/18/2011	Barrier #:	7015
Location:	Oak Ave - South				
X Coordinate:	-121.24876				
Y Coordinate:	38.70036				
Barrier Area:	Sidewalks				
Barrier Type:	Cross Slope - Existing (4.1% to 4.9%)				
Code Ref:	CBC 1133B.7.1.3 and ADA/ABA 403.3

As Built Meas:	763	Quantity:	LF
Description:	Cross slope exceeds 2.0% (4.1% to 4.9%)		
As Built Desc:	4.7% cross slope		
Solution:	Demolish existing and construct new route		
Bar. Severity:	2 Recommended	Cost Estimate:	\$95,375.00
Implementation Priority:	1	Facility Function:	
Implementation Phase:		Implementation Date:	
Official Responsible:

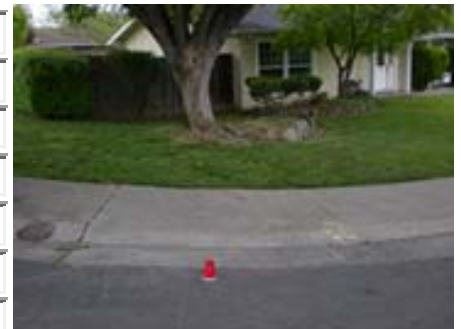
Field Date:	4/18/2011	Report Date:	4/18/2011	Barrier #:	7016
Location:	Oak Ave and Old Ranch Rd - Corner C				
X Coordinate:	-121.25145				
Y Coordinate:	38.70034				
Barrier Area:	Curb Ramps				
Barrier Type:	No Curb Ramp - Depressed Existing Curb				
Code Ref:	CBC 1127B.5.1 and ADA/ABA 402.2

As Built Meas:	1	Quantity:	EACH
Description:	No compliant curb cut at corner (intersection)		
As Built Desc:	12.4% running slope at depressed area		
Solution:	Demolish existing and construct curb cut		
Bar. Severity:	1 Necessary	Cost Estimate:	\$2,500.00
Implementation Priority:	1	Facility Function:	
Implementation Phase:		Implementation Date:	
Official Responsible:

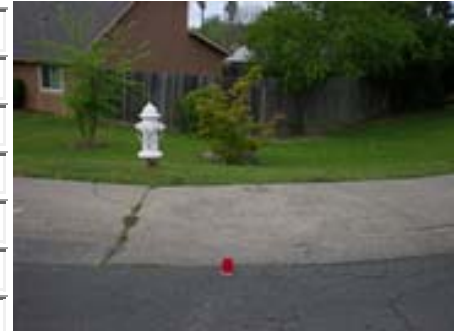
Barrier Type: No Curb Ramp - Depressed Existing Curb

As Built Meas: 1 Quantity: EACH

Description: No compliant curb cut at corner (intersection)

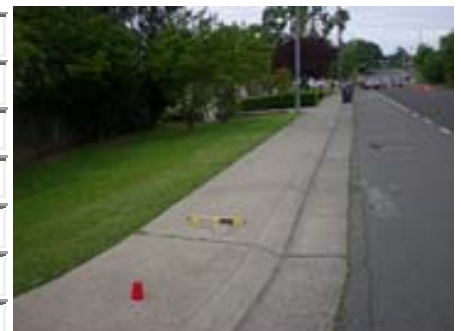
Barrier Type: Cross Slope - Existing (5.0% or more)

As Built Meas: 518 Quantity: LF

Description: Cross slope exceeds 2.0% (5.0% or more)

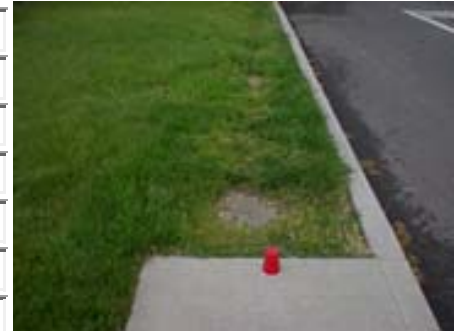
Field Date:	4/18/2011	Report Date:	4/18/2011	Barrier #:	7019
Location:	Oak Ave - South				
X Coordinate:	-121.25445				
Y Coordinate:	38.70038				
Barrier Area:	Sidewalks				
Barrier Type:	No Sidewalk - No Barricade				
Code Ref:	MUTCD Section 6D.01

As Built Meas:	1	Quantity:	JOB
Description:	No barricade provided where sidewalk ends in hazardous location		
As Built Desc:	No barricade or other warning provided for the visually impaired at end of sidewalk		
Solution:	Provide barricade with cane detectable warning at end of sidewalk		
Bar. Severity:	1 Necessary	Cost Estimate:	\$1,350.00
Implementation Priority:	1	Facility Function:	
Implementation Phase:		Implementation Date:	
Official Responsible:

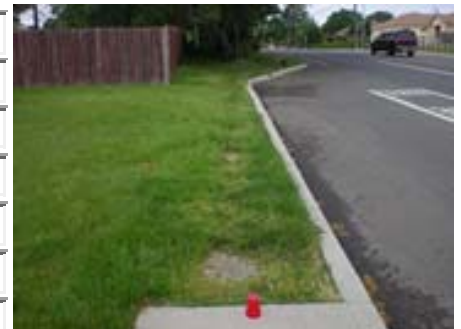
Field Date:	4/18/2011	Report Date:	4/18/2011	Barrier #:	7020
Location:	Oak Ave - South				
X Coordinate:	-121.25446				
Y Coordinate:	38.70037				
Barrier Area:	Sidewalks				
Barrier Type:	No sidewalk				
Code Ref:	CBC 1127B.1 and ADA/ABA 206.2.1

As Built Meas:	80	Quantity:	LF
Description:	No pedestrian route provided		
As Built Desc:	No sidewalk provided		
Solution:	Construct new firm and stable pedestrian route		
Bar. Severity:	1 Necessary	Cost Estimate:	\$8,000.00
Implementation Priority:	1	Facility Function:	
Implementation Phase:		Implementation Date:	
Official Responsible:

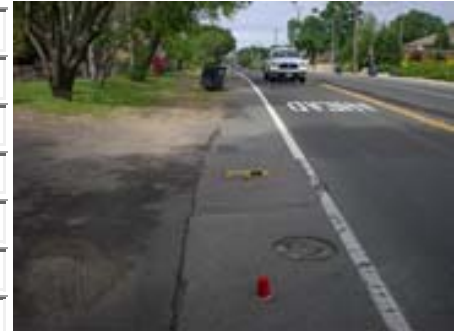
Field Date:	4/18/2011	Report Date:	4/18/2011	Barrier #:	7021
Location:	Oak Ave - South				
X Coordinate:	-121.25507				
Y Coordinate:	38.70046				
Barrier Area:	Sidewalks				
Barrier Type:	Shoulder Cross Slope - Existing (3.1% to 4.0%)				
Code Ref:	CBC 1133B.7.1.3 and ADA/ABA 403.3

As Built Meas:	116	Quantity:	LF
Description:	Cross slope exceeds 2.0% (3.1% to 4.0%)		
As Built Desc:	3.4% cross slope		
Solution:	Demolish existing and construct new pedestrian route		
Bar. Severity:	3 Hindrance	Cost Estimate:	\$14,500.00
Implementation Priority:	1	Facility Function:	
Implementation Phase:		Implementation Date:	
Official Responsible:

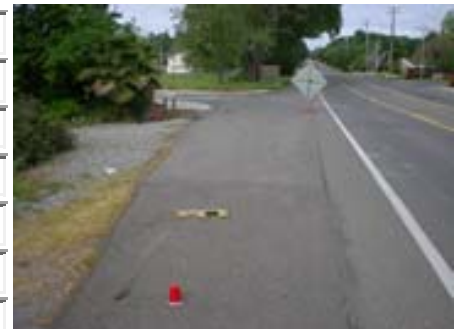
Field Date:	4/18/2011	Report Date:	4/18/2011	Barrier #:	7022
Location:	Oak Ave - South				
X Coordinate:	-121.25655				
Y Coordinate:	38.70044				
Barrier Area:	Sidewalks				
Barrier Type:	Shoulder Cross Slope - Existing (3.1% to 4.0%)				
Code Ref:	CBC 1133B.7.1.3 and ADA/ABA 403.3

As Built Meas:	42	Quantity:	LF
Description:	Cross slope exceeds 2.0% (3.1% to 4.0%)		
As Built Desc:	3.5% cross slope		
Solution:	Demolish existing and construct new pedestrian route		
Bar. Severity:	3 Hindrance	Cost Estimate:	\$5,250.00
Implementation Priority:	1	Facility Function:	
Implementation Phase:		Implementation Date:	
Official Responsible:

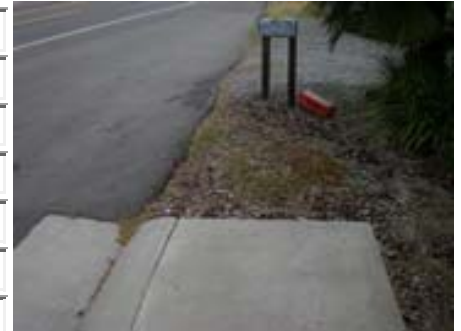
Field Date:	4/18/2011	Report Date:	4/18/2011	Barrier #:	7023
Location:	Oak Ave - South				
X Coordinate:	-121.25679				
Y Coordinate:	38.70042				
Barrier Area:	Sidewalks				
Barrier Type:	No Sidewalk - No Barricade				
Code Ref:	MUTCD Section 6D.01

As Built Meas:	1	Quantity:	JOB
Description:	No barricade provided where sidewalk ends in hazardous location		
As Built Desc:	No barricade or other warning provided for the visually impaired at end of sidewalk		
Solution:	Provide barricade with cane detectable warning at end of sidewalk		
Bar. Severity:	1 Necessary	Cost Estimate:	\$1,350.00
Implementation Priority:	1	Facility Function:	
Implementation Phase:		Implementation Date:	
Official Responsible:			
Notes:

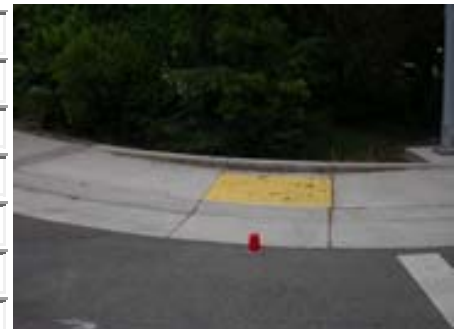
Field Date:	4/18/2011	Report Date:	4/18/2011	Barrier #:	7024
Location:	Oak Ave and Streng Ave - Corner C				
X Coordinate:	-121.25688				
Y Coordinate:	38.70042				
Barrier Area:	Curb Ramps				
Barrier Type:	12" Grooves - Existing (>5.0%)				
Code Ref:	CBC 1127B.5.6

As Built Meas:	1	Quantity:	EACH
Description:	12" grooves at top of curb ramp are not level (>5.0%)		
As Built Desc:	5.6% at 12" grooves		
Solution:	Demolish existing and construct new curb ramp		
Bar. Severity:	1 Necessary	Cost Estimate:	\$2,500.00
Implementation Priority:	1	Facility Function:	
Implementation Phase:		Implementation Date:	
Official Responsible:			
Notes:	Two - way intersection corners C, D. Corner D compliant

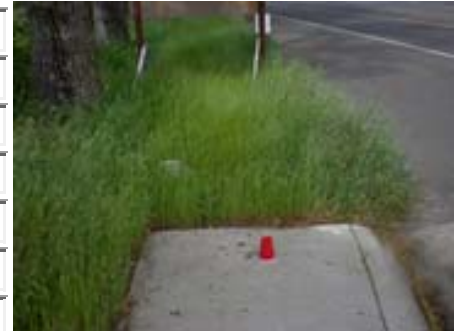
Field Date:	4/18/2011	Report Date:	4/18/2011	Barrier #:	7025
Location:	Oak Ave - South				
X Coordinate:	-121.25711				
Y Coordinate:	38.70043				
Barrier Area:	Sidewalks				
Barrier Type:	No Sidewalk - No Barricade				
Code Ref:	MUTCD Section 6D.01

As Built Meas:	1	Quantity:	JOB
Description:	No barricade provided where sidewalk ends in hazardous location		
As Built Desc:	No barricade or other warning provided for the visually impaired at end of sidewalk		
Solution:	Provide barricade with cane detectable warning at end of sidewalk		
Bar. Severity:	1 Necessary	Cost Estimate:	\$1,350.00
Implementation Priority:	1	Facility Function:	
Implementation Phase:		Implementation Date:	
Official Responsible:

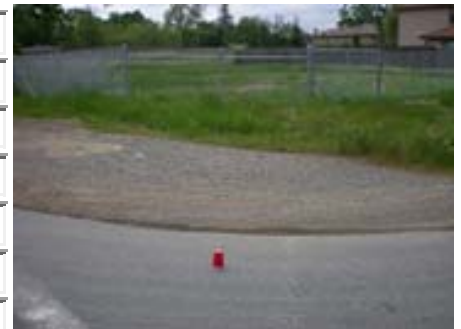
Field Date:	4/18/2011	Report Date:	4/18/2011	Barrier #:	7026
Location:	Oak Ave and Cross Dr - Corner C				
X Coordinate:	-121.25798				
Y Coordinate:	38.70045				
Barrier Area:	Blended Transitions				
Barrier Type:	Detectable Warnings - Truncated Domes				
Code Ref:	CBC 1127B.5.3

As Built Meas:	1	Quantity:	EACH
Description:	No truncated domes provided at transition into roadway		
As Built Desc:	No required detectable warning provided		
Solution:	Provide compliant truncated domes		
Bar. Severity:	2 Recommended	Cost Estimate:	\$1,400.00
Implementation Priority:	1	Facility Function:	
Implementation Phase:		Implementation Date:	
Official Responsible:

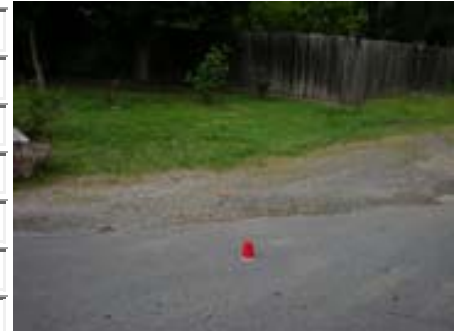
Field Date:	4/18/2011	Report Date:	4/18/2011	Barrier #:	7027
Location:	Oak Ave and Cross Dr - Corner D				
X Coordinate:	-121.25812				
Y Coordinate:	38.70045				
Barrier Area:	Blended Transitions				
Barrier Type:	Detectable Warnings - Truncated Domes				
Code Ref:	CBC 1127B.5.3

As Built Meas:	1	Quantity:	EACH
Description:	No truncated domes provided at transition into roadway		
As Built Desc:	No required detectable warning provided		
Solution:	Provide compliant truncated domes		
Bar. Severity:	2 Recommended	Cost Estimate:	\$1,400.00
Implementation Priority:	1	Facility Function:	
Implementation Phase:		Implementation Date:	
Official Responsible:			
Notes:	Two - way intersection corners C,D

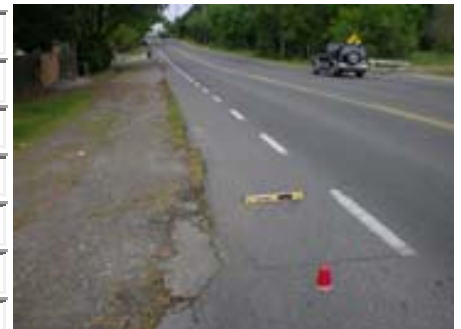
Field Date:	4/18/2011	Report Date:	4/18/2011	Barrier #:	7028
Location:	Oak Ave - South				
X Coordinate:	-121.25816				
Y Coordinate:	38.70046				
Barrier Area:	Sidewalks				
Barrier Type:	Shoulder Cross Slope - Existing (5.0% or more)				
Code Ref:	CBC 1133B.7.1.3 and ADA/ABA 403.3

As Built Meas:	386	Quantity:	LF
Description:	Cross slope exceeds 2.0% (5.0% or more)		
As Built Desc:	5.5% cross slope		
Solution:	Demolish existing and construct new pedestrian route		
Bar. Severity:	1 Necessary	Cost Estimate:	\$48,250.00
Implementation Priority:	1	Facility Function:	
Implementation Phase:		Implementation Date:	
Official Responsible:			
Notes:

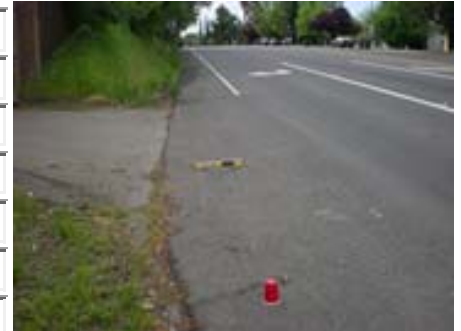
Field Date:	4/18/2011	Report Date:	4/18/2011	Barrier #:	7029
Location:	Fair Oaks Blvd - East				
X Coordinate:	-121.26234				
Y Coordinate:	38.70023				
Barrier Area:	Sidewalks				
Barrier Type:	Shoulder Cross Slope - Existing (4.1% to 4.9%)				
Code Ref:	CBC 1133B.7.1.3 and ADA/ABA 403.3

As Built Meas:	333	Quantity:	LF
Description:	Cross slope exceeds 2.0% (4.1% to 4.9%)		
As Built Desc:	4.5% cross slope		
Solution:	Demolish existing and construct new pedestrian route		
Bar. Severity:	2 Recommended	Cost Estimate:	\$41,625.00
Implementation Priority:	1	Facility Function:	
Implementation Phase:		Implementation Date:	
Official Responsible:

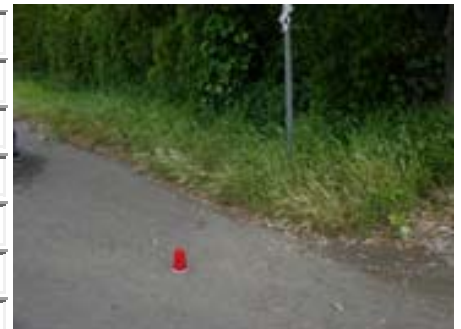
Field Date:	4/18/2011	Report Date:	4/18/2011	Barrier #:	7030
Location:	Fair Oaks Blvd and Pleasant View Dr - Corner B				
X Coordinate:	-121.26238				
Y Coordinate:	38.69929				
Barrier Area:	Blended Transitions				
Barrier Type:	Detectable Warnings - Truncated Domes				
Code Ref:	CBC 1127B.5.3

As Built Meas:	1	Quantity:	EACH
Description:	No truncated domes provided at transition into roadway		
As Built Desc:	No required detectable warning provided		
Solution:	Provide compliant truncated domes		
Bar. Severity:	2 Recommended	Cost Estimate:	\$1,400.00
Implementation Priority:	1	Facility Function:	
Implementation Phase:		Implementation Date:	
Official Responsible:

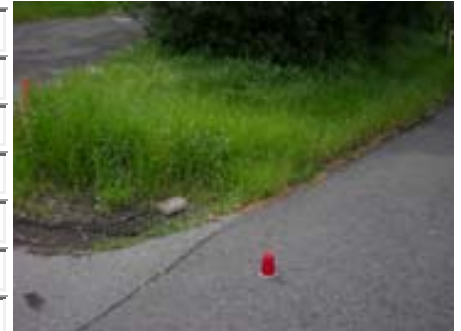
Field Date:	4/18/2011	Report Date:	4/18/2011	Barrier #:	7031
Location:	Fair Oaks Blvd and Pleasant View Dr - Corner C				
X Coordinate:	-121.2624				
Y Coordinate:	38.69916				
Barrier Area:	Blended Transitions				
Barrier Type:	Detectable Warnings - Truncated Domes				
Code Ref:	CBC 1127B.5.3

As Built Meas:	1	Quantity:	EACH
Description:	No truncated domes provided at transition into roadway		
As Built Desc:	No required detectable warning provided		
Solution:	Provide compliant truncated domes		
Bar. Severity:	2 Recommended	Cost Estimate:	\$1,400.00
Implementation Priority:	1	Facility Function:	
Implementation Phase:		Implementation Date:	
Official Responsible:			
Notes:	Two - way intersection corners B,C

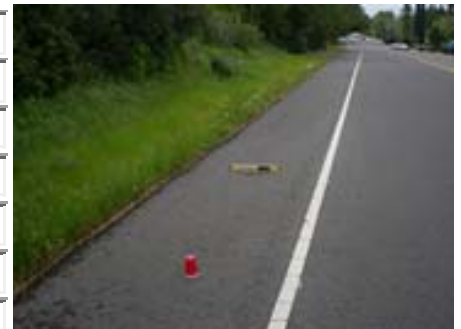
Field Date:	4/18/2011	Report Date:	4/18/2011	Barrier #:	7032
Location:	Fair Oaks Blvd - East				
X Coordinate:	-121.26238				
Y Coordinate:	38.69896				
Barrier Area:	Sidewalks				
Barrier Type:	Shoulder Cross Slope - Existing (4.1% to 4.9%)				
Code Ref:	CBC 1133B.7.1.3 and ADA/ABA 403.3

As Built Meas:	245	Quantity:	LF
Description:	Cross slope exceeds 2.0% (4.1% to 4.9%)		
As Built Desc:	4.2% cross slope		
Solution:	Demolish existing and construct new pedestrian route		
Bar. Severity:	2 Recommended	Cost Estimate:	\$30,625.00
Implementation Priority:	1	Facility Function:	
Implementation Phase:		Implementation Date:	
Official Responsible:			
Notes:

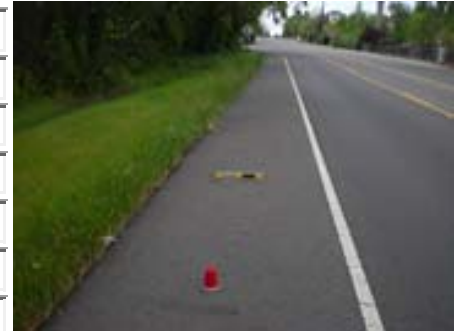
Field Date:	4/18/2011	Report Date:	4/18/2011	Barrier #:	7033
Location:	Fair Oaks Blvd - East				
X Coordinate:	-121.26245				
Y Coordinate:	38.69724				
Barrier Area:	Sidewalks				
Barrier Type:	Shoulder Cross Slope - Existing (3.1% to 4.0%)				
Code Ref:	CBC 1133B.7.1.3 and ADA/ABA 403.3

As Built Meas:	183	Quantity:	LF
Description:	Cross slope exceeds 2.0% (3.1% to 4.0%)		
As Built Desc:	3.4% cross slope		
Solution:	Demolish existing and construct new pedestrian route		
Bar. Severity:	3 Hindrance	Cost Estimate:	\$22,875.00
Implementation Priority:	1	Facility Function:	
Implementation Phase:		Implementation Date:	
Official Responsible:

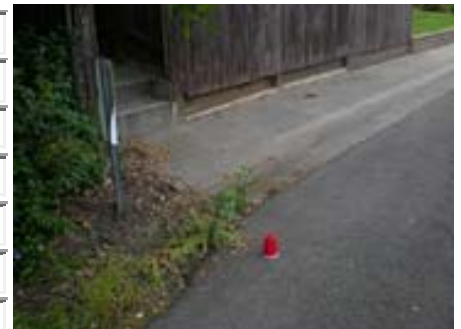
Field Date:	4/18/2011	Report Date:	4/18/2011	Barrier #:	7034
Location:	Fair Oaks Blvd - East				
X Coordinate:	-121.26238				
Y Coordinate:	38.69663				
Barrier Area:	Sidewalks				
Barrier Type:	No Sidewalk - Transition to Shoulder				
Code Ref:	CBC 1121B.2 and ADA/ABA 206.2.1

As Built Meas:	1	Quantity:	JOB
Description:	Sidewalk ends and no ramp to pedestrian shoulder is provided		
As Built Desc:	No ramp to shoulder to enable pedestrian travel onto existing shoulder		
Solution:	Provide transition ramp to paved shoulder where no opposite sidewalk exists		
Bar. Severity:	1 Necessary	Cost Estimate:	\$2,500.00
Implementation Priority:	1	Facility Function:	
Implementation Phase:		Implementation Date:	
Official Responsible:

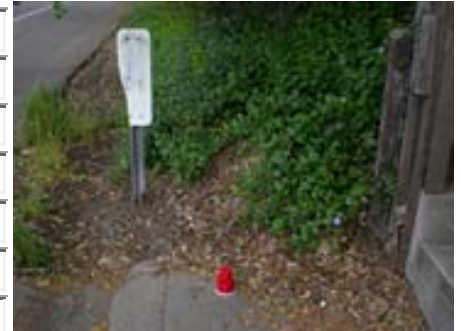
Field Date:	4/18/2011	Report Date:	4/18/2011	Barrier #:	7035
Location:	Fair Oaks Blvd - East				
X Coordinate:	-121.26239				
Y Coordinate:	38.69661				
Barrier Area:	Sidewalks				
Barrier Type:	No Sidewalk - No Barricade				
Code Ref:	MUTCD Section 6D.01

As Built Meas:	1	Quantity:	JOB
Description:	No barricade provided where sidewalk ends in hazardous location		
As Built Desc:	No barricade or other warning provided for the visually impaired at end of sidewalk		
Solution:	Provide barricade with cane detectable warning at end of sidewalk		
Bar. Severity:	1 Necessary	Cost Estimate:	\$1,350.00
Implementation Priority:	1	Facility Function:	
Implementation Phase:		Implementation Date:	
Official Responsible:

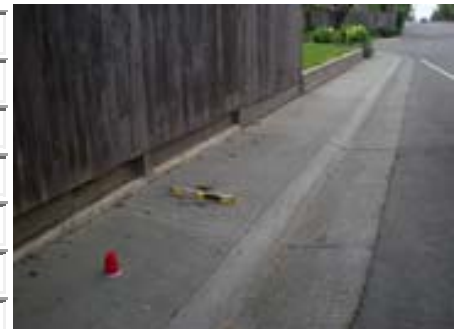
Field Date:	4/18/2011	Report Date:	4/18/2011	Barrier #:	7036
Location:	Fair Oaks Blvd - East				
X Coordinate:	-121.26238				
Y Coordinate:	38.69661				
Barrier Area:	Sidewalks				
Barrier Type:	Cross Slope - Existing (5.0% or more)				
Code Ref:	CBC 1133B.7.1.3 and ADA/ABA 403.3

As Built Meas:	80	Quantity:	LF
Description:	Cross slope exceeds 2.0% (5.0% or more)		
As Built Desc:	6.0% cross slope		
Solution:	Demolish existing and construct new route		
Bar. Severity:	1 Necessary	Cost Estimate:	\$10,000.00
Implementation Priority:	1	Facility Function:	
Implementation Phase:		Implementation Date:	
Official Responsible:

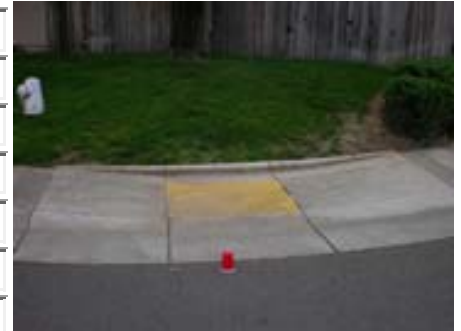
Barrier Type: 12" Grooves - Existing (2.1% to 3.0%)

Code Ref: CBC 1127B.5.6

Description: 12" grooves at top of curb ramp are not level (2.1% to 3.0%)

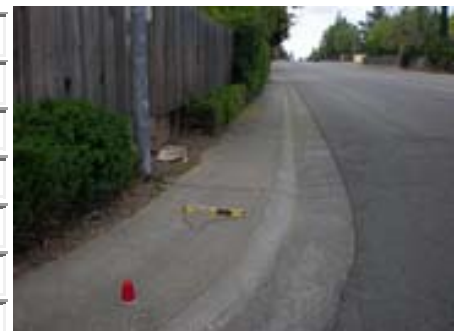
Barrier Type: Cross Slope - Existing (4.1% to 4.9%)

Code Ref: CBC 1133B.7.1.3 and ADA/ABA 403.3

Description: Cross slope exceeds 2.0% (4.1% to 4.9%)

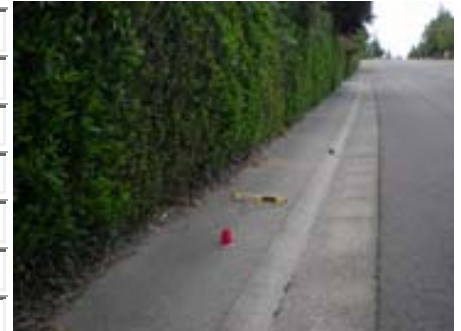
Field Date:	4/18/2011	Report Date:	4/18/2011	Barrier #:	7038B
Location:	Fair Oaks Blvd - East				
X Coordinate:	-121.26236				
Y Coordinate:	38.69601				
Barrier Area:	Sidewalks				
Barrier Type:	Clear Width - Existing (32" to 35")				
Code Ref:	CBC 1133B.7.1

As Built Meas:	1	Quantity:	LF
Description:	Pedestrian route is not min. 48" wide (32" to 35")		
As Built Desc:	32" clear width due to foliage		
Solution:	Trim foliage to provide min. 48" clear width		
Bar. Severity:	1 Necessary	Cost Estimate:	\$125.00
Implementation Priority:	1	Facility Function:	
Implementation Phase:		Implementation Date:	
Official Responsible:

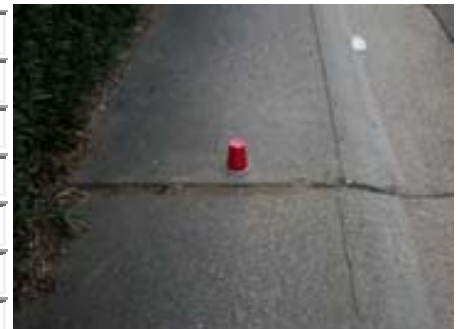
Field Date:	4/18/2011	Report Date:	4/18/2011	Barrier #:	7038C
Location:	Fair Oaks Blvd - East				
X Coordinate:	-121.26228				
Y Coordinate:	38.69515				
Barrier Area:	Sidewalks				
Barrier Type:	Abrupt Change in Level - > 1/2"				
Code Ref:	CBC 1133B.7.1 and ADA/ABA 303.3

As Built Meas:	4	Quantity:	LF
Description:	Change in level greater than 1/2"		
As Built Desc:	1/2" lip in sidewalk surface		
Solution:	Grind or repair sidewalk to remove trip hazard		
Bar. Severity:	1 Necessary	Cost Estimate:	\$1,000.00
Implementation Priority:	1	Facility Function:	
Implementation Phase:		Implementation Date:	
Official Responsible:

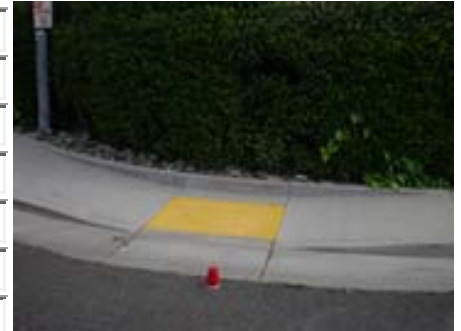
Field Date:	4/18/2011	Report Date:	4/18/2011	Barrier #:	7039
Location:	Fair Oaks Blvd and Dart Wy - Corner B				
X Coordinate:	-121.26221				
Y Coordinate:	38.69365				
Barrier Area:	Curb Ramps				
Barrier Type:	12" Grooves - Existing (>5.0%)				
Code Ref:	CBC 1127B.5.6

As Built Meas:	1	Quantity:	EACH
Description:	12" grooves at top of curb ramp are not level (>5.0%)		
As Built Desc:	5.4% at 12" grooves		
Solution:	Demolish existing and construct new curb ramp		
Bar. Severity:	1 Necessary	Cost Estimate:	\$2,500.00
Implementation Priority:	1	Facility Function:	
Implementation Phase:		Implementation Date:	
Official Responsible:			
Notes:	Two - way intersection corners B,C. Corner C compliant

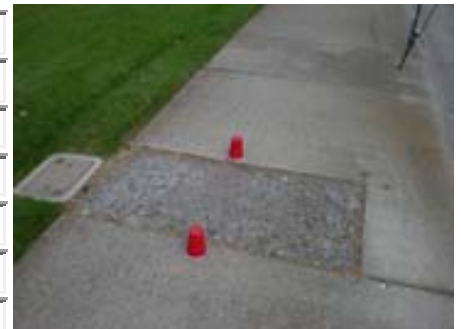
Field Date:	4/18/2011	Report Date:	4/18/2011	Barrier #:	7040
Location:	Fair Oaks Blvd - West				
X Coordinate:	-121.26222				
Y Coordinate:	38.69363				
Barrier Area:	Sidewalks				
Barrier Type:	Surface Condition - Damaged				
Code Ref:	CBC 1133B.7.1 and ADA/ABA 302.1

As Built Meas:	4	Quantity:	LF
Description:	Surface is not firm and stable (cracked, broken or loose soil, etc.)		
As Built Desc:	Cracked concrete		
Solution:	Repair surface to make firm and stable		
Bar. Severity:	1 Necessary	Cost Estimate:	\$500.00
Implementation Priority:	1	Facility Function:	
Implementation Phase:		Implementation Date:	
Official Responsible:			
Notes:

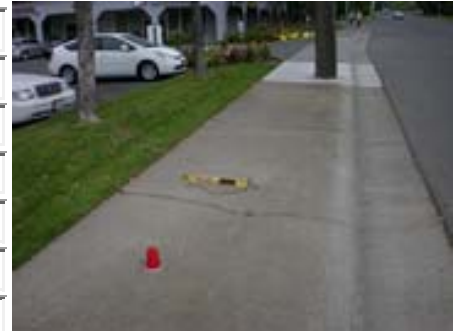
Field Date:	4/18/2011	Report Date:	4/18/2011	Barrier #:	7041
Location:	Fair Oaks Blvd - West				
X Coordinate:	-121.2624				
Y Coordinate:	38.67888				
Barrier Area:	Sidewalks				
Barrier Type:	Cross Slope - Existing (3.1% to 4.0%)				
Code Ref:	CBC 1133B.7.1.3 and ADA/ABA 403.3

As Built Meas:	41	Quantity:	LF
Description:	Cross slope exceeds 2.0% (3.1% to 4.0%)		
As Built Desc:	3.3% cross slope		
Solution:	Demolish existing and construct new route		
Bar. Severity:	3 Hindrance	Cost Estimate:	\$5,125.00
Implementation Priority:	1	Facility Function:	
Implementation Phase:		Implementation Date:	
Official Responsible:
