DRAFT ADA TRANSITION PLAN UPDATE
NEIGHBORHOOD AREA 9 SONA
SEPTEMBER 20, 2011

CITY OF CITRUS HEIGHTS

The Sunrise Oaks Neighborhood Association (SONA)

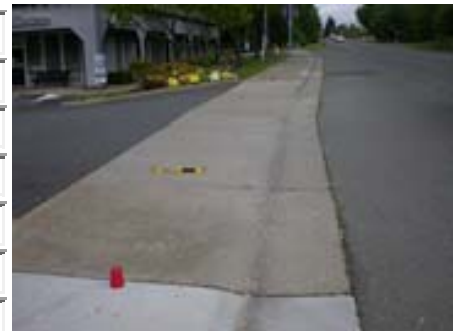
Field Date:	4/18/2011	Report Date:	4/18/2011	Barrier #:	7042
Location:	Fair Oaks Blvd - West				
X Coordinate:	-121.26243				
Y Coordinate:	38.6791				
Barrier Area:	Sidewalks				
Barrier Type:	Driveway - Existing (2.1% to 3.0%)				
Code Ref:	CBC 1133B.7.1.3 and ADA/ABA 403.3

As Built Meas:	50	Quantity:	LF
Description:	Driveway cross slope exceeds 2.0% (2.1% to 3.0%)		
As Built Desc:	3.0% cross slope		
Solution:	Provide min. 48" wide level walkway through driveway		
Bar. Severity:	1 Necessary	Cost Estimate:	\$6,250.00
Implementation Priority:	1	Facility Function:	
Implementation Phase:		Implementation Date:	
Official Responsible:

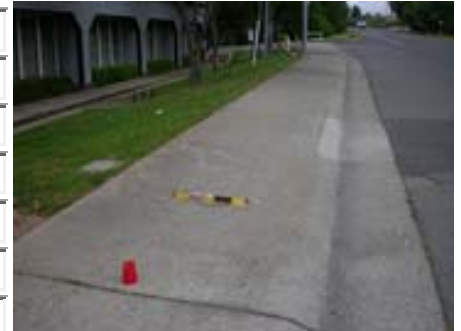
Field Date:	4/18/2011	Report Date:	4/18/2011	Barrier #:	7043
Location:	Fair Oaks Blvd - West				
X Coordinate:	-121.26242				
Y Coordinate:	38.67924				
Barrier Area:	Sidewalks				
Barrier Type:	Cross Slope - Existing (3.1% to 4.0%)				
Code Ref:	CBC 1133B.7.1.3 and ADA/ABA 403.3

As Built Meas:	98	Quantity:	LF
Description:	Cross slope exceeds 2.0% (3.1% to 4.0%)		
As Built Desc:	3.5% cross slope		
Solution:	Demolish existing and construct new route		
Bar. Severity:	3 Hindrance	Cost Estimate:	\$12,250.00
Implementation Priority:	1	Facility Function:	
Implementation Phase:		Implementation Date:	
Official Responsible:

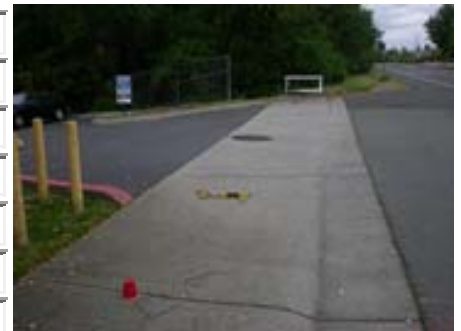
Field Date:	4/18/2011	Report Date:	4/18/2011	Barrier #:	7044
Location:	Fair Oaks Blvd - West				
X Coordinate:	-121.26244				
Y Coordinate:	38.67938				
Barrier Area:	Sidewalks				
Barrier Type:	Driveway - Existing (5.0% or more)				
Code Ref:	CBC 1133B.7.1.3 and ADA/ABA 403.3

As Built Meas:	50	Quantity:	LF
Description:	Driveway cross slope exceeds 2.0% (5.0% or more)		
As Built Desc:	5.2% cross slope		
Solution:	Provide min. 48" wide level walkway through driveway		
Bar. Severity:	4 Low Severity	Cost Estimate:	\$6,250.00
Implementation Priority:	1	Facility Function:	
Implementation Phase:		Implementation Date:	
Official Responsible:

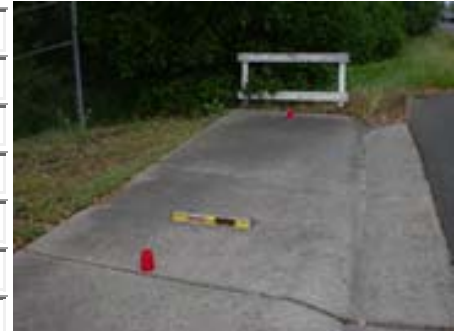
Field Date:	4/18/2011	Report Date:	4/18/2011	Barrier #:	7045
Location:	Fair Oaks Blvd - West				
X Coordinate:	-121.26243				
Y Coordinate:	38.67969				
Barrier Area:	Sidewalks				
Barrier Type:	Cross Slope - Existing (3.1% to 4.0%)				
Code Ref:	CBC 1133B.7.1.3 and ADA/ABA 403.3

As Built Meas:	18	Quantity:	LF
Description:	Cross slope exceeds 2.0% (3.1% to 4.0%)		
As Built Desc:	3.5% cross slope		
Solution:	Demolish existing and construct new route		
Bar. Severity:	3 Hindrance	Cost Estimate:	\$2,250.00
Implementation Priority:	1	Facility Function:	
Implementation Phase:		Implementation Date:	
Official Responsible:

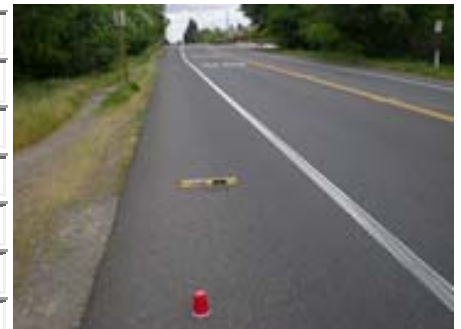
Field Date:	4/18/2011	Report Date:	4/18/2011	Barrier #:	7046
Location:	Fair Oaks Blvd - West				
X Coordinate:	-121.26244				
Y Coordinate:	38.67983				
Barrier Area:	Sidewalks				
Barrier Type:	Shoulder Cross Slope - Existing (3.1% to 4.0%)				
Code Ref:	CBC 1133B.7.1.3 and ADA/ABA 403.3

As Built Meas:	460	Quantity:	LF
Description:	Cross slope exceeds 2.0% (3.1% to 4.0%)		
As Built Desc:	3.6% cross slope		
Solution:	Demolish existing and construct new pedestrian route		
Bar. Severity:	3 Hindrance	Cost Estimate:	\$57,500.00
Implementation Priority:	1	Facility Function:	
Implementation Phase:		Implementation Date:	
Official Responsible:

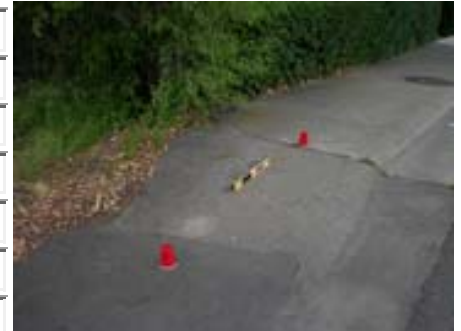
Field Date:	4/18/2011	Report Date:	4/18/2011	Barrier #:	7047
Location:	Fair Oaks Blvd - West				
X Coordinate:	-121.26236				
Y Coordinate:	38.67989				
Barrier Area:	Sidewalks				
Barrier Type:	Running Slope (Existing)				
Code Ref:	CBC 1133B.7.3 and ADA/ABA 403.3

As Built Meas:	8	Quantity:	LF
Description:	Running slope exceeds 5.0%		
As Built Desc:	6.9% running slope		
Solution:	No remediation where sidewalk sloped as roadway		
Bar. Severity:	5 Technically Infeasible	Cost Estimate:	\$0.00
Status:			
Implementation Priority:	1	Facility Function:	
Implementation Phase:		Implementation Date:	
Official Responsible:			
Notes:

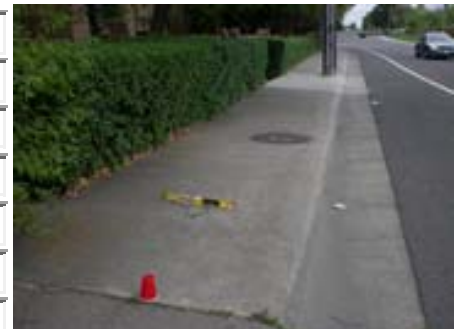
Field Date:	4/18/2011	Report Date:	4/18/2011	Barrier #:	7048
Location:	Fair Oaks Blvd - West				
X Coordinate:	-121.26246				
Y Coordinate:	38.68116				
Barrier Area:	Sidewalks				
Barrier Type:	Cross Slope - Existing (3.1% to 4.0%)				
Code Ref:	CBC 1133B.7.1.3 and ADA/ABA 403.3

As Built Meas:	145	Quantity:	LF
Description:	Cross slope exceeds 2.0% (3.1% to 4.0%)		
As Built Desc:	3.2% cross slope		
Solution:	Demolish existing and construct new route		
Bar. Severity:	3 Hindrance	Cost Estimate:	\$18,125.00
Status:			
Implementation Priority:	1	Facility Function:	
Implementation Phase:		Implementation Date:	
Official Responsible:			
Notes:

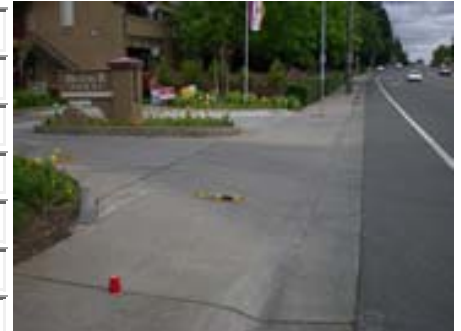
Field Date:	4/18/2011	Report Date:	4/18/2011	Barrier #:	7049
Location:	Fair Oaks Blvd - West				
X Coordinate:	-121.26251				
Y Coordinate:	38.68116				
Barrier Area:	Sidewalks				
Barrier Type:	Driveway - Existing (5.0% or more)				
Code Ref:	CBC 1133B.7.1.3 and ADA/ABA 403.3

As Built Meas:	61	Quantity:	LF
Description:	Driveway cross slope exceeds 2.0% (5.0% or more)		
As Built Desc:	5.0% cross slope		
Solution:	Provide min. 48" wide level walkway through driveway		
Bar. Severity:	4 Low Severity	Cost Estimate:	\$7,625.00
Implementation Priority:	1	Facility Function:	
Implementation Phase:		Implementation Date:	
Official Responsible:

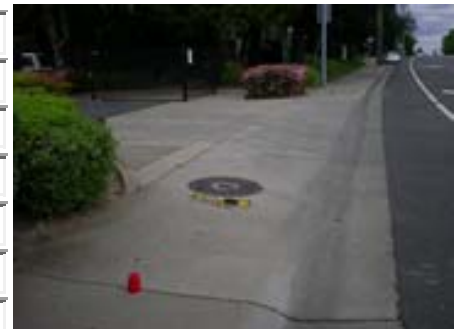
Field Date:	4/18/2011	Report Date:	4/18/2011	Barrier #:	7050
Location:	Fair Oaks Blvd - West				
X Coordinate:	-121.2625				
Y Coordinate:	38.68195				
Barrier Area:	Sidewalks				
Barrier Type:	Driveway - Existing (5.0% or more)				
Code Ref:	CBC 1133B.7.1.3 and ADA/ABA 403.3

As Built Meas:	51	Quantity:	LF
Description:	Driveway cross slope exceeds 2.0% (5.0% or more)		
As Built Desc:	6.5% cross slope		
Solution:	Provide min. 48" wide level walkway through driveway		
Bar. Severity:	4 Low Severity	Cost Estimate:	\$6,375.00
Implementation Priority:	1	Facility Function:	
Implementation Phase:		Implementation Date:	
Official Responsible:

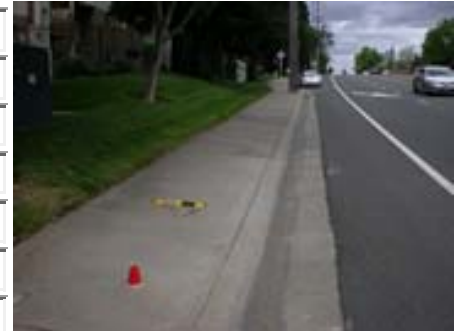
Field Date:	4/18/2011	Report Date:	4/18/2011	Barrier #:	7051
Location:	Fair Oaks Blvd - West				
X Coordinate:	-121.26261				
Y Coordinate:	38.68256				
Barrier Area:	Sidewalks				
Barrier Type:	Cross Slope - Existing (3.1% to 4.0%)				
Code Ref:	CBC 1133B.7.1.3 and ADA/ABA 403.3

As Built Meas:	460	Quantity:	LF
Description:	Cross slope exceeds 2.0% (3.1% to 4.0%)		
As Built Desc:	3.7% cross slope		
Solution:	Demolish existing and construct new route		
Bar. Severity:	3 Hindrance	Cost Estimate:	\$57,500.00
Implementation Priority:	1	Facility Function:	
Implementation Phase:		Implementation Date:	
Official Responsible:

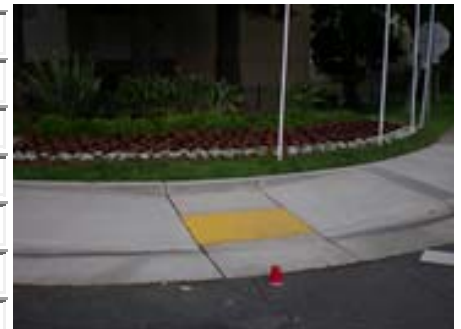
Field Date:	4/18/2011	Report Date:	4/18/2011	Barrier #:	7052
Location:	Fair Oaks Blvd and Oak Creek Apts - Corner A				
X Coordinate:	-121.2626				
Y Coordinate:	38.68272				
Barrier Area:	Curb Ramps				
Barrier Type:	12" Grooves - Existing (3.1% to 4.0%)				
Code Ref:	CBC 1127B.5.6

As Built Meas:	1	Quantity:	EACH
Description:	12" grooves at top of curb ramp are not level (3.1% to 4.0%)		
As Built Desc:	3.1% at 12" grooves		
Solution:	Demolish existing and construct new curb ramp		
Bar. Severity:	3 Hindrance	Cost Estimate:	\$2,500.00
Implementation Priority:	1	Facility Function:	
Implementation Phase:		Implementation Date:	
Official Responsible:

Notes:	Two - way intersection corners A,D. Corner D compliant
--------	--

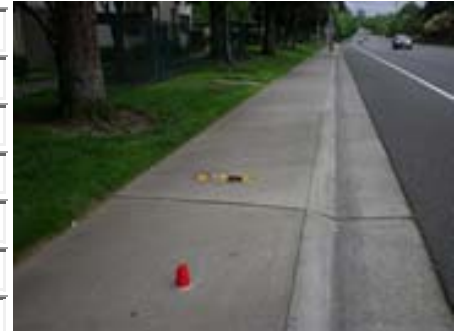
Field Date:	4/18/2011	Report Date:	4/18/2011	Barrier #:	7053
Location:	Fair Oaks Blvd - West				
X Coordinate:	-121.26257				
Y Coordinate:	38.68423				
Barrier Area:	Sidewalks				
Barrier Type:	Cross Slope - Existing (3.1% to 4.0%)				
Code Ref:	CBC 1133B.7.1.3 and ADA/ABA 403.3

As Built Meas:	375	Quantity:	LF
Description:	Cross slope exceeds 2.0% (3.1% to 4.0%)		
As Built Desc:	3.4% cross slope		
Solution:	Demolish existing and construct new route		
Bar. Severity:	3 Hindrance	Cost Estimate:	\$46,875.00
Implementation Priority:	1	Facility Function:	
Implementation Phase:		Implementation Date:	
Official Responsible:

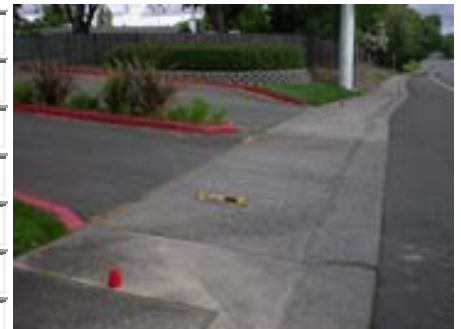
Field Date:	4/18/2011	Report Date:	4/18/2011	Barrier #:	7054
Location:	Fair Oaks Blvd - West				
X Coordinate:	-121.26261				
Y Coordinate:	38.68463				
Barrier Area:	Sidewalks				
Barrier Type:	Driveway - Existing (4.1% to 4.9%)				
Code Ref:	CBC 1133B.7.1.3 and ADA/ABA 403.3

As Built Meas:	50	Quantity:	LF
Description:	Driveway cross slope exceeds 2.0% (4.1% to 4.9%)		
As Built Desc:	4.6% cross slope		
Solution:	Provide min. 48" wide level walkway through driveway		
Bar. Severity:	3 Hindrance	Cost Estimate:	\$6,250.00
Implementation Priority:	1	Facility Function:	
Implementation Phase:		Implementation Date:	
Official Responsible:

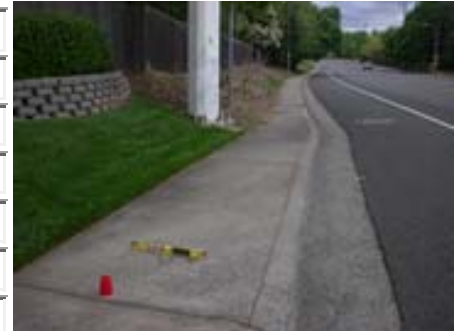
Field Date:	4/18/2011	Report Date:	4/18/2011	Barrier #:	7055
Location:	Fair Oaks Blvd - West				
X Coordinate:	-121.2626				
Y Coordinate:	38.68567				
Barrier Area:	Sidewalks				
Barrier Type:	Cross Slope - Existing (4.1% to 4.9%)				
Code Ref:	CBC 1133B.7.1.3 and ADA/ABA 403.3

As Built Meas:	202	Quantity:	LF
Description:	Cross slope exceeds 2.0% (4.1% to 4.9%)		
As Built Desc:	4.4% cross slope		
Solution:	Demolish existing and construct new route		
Bar. Severity:	2 Recommended	Cost Estimate:	\$25,250.00
Implementation Priority:	1	Facility Function:	
Implementation Phase:		Implementation Date:	
Official Responsible:			
Notes:

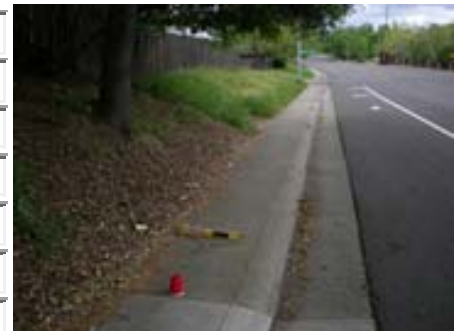
Field Date:	4/18/2011	Report Date:	4/18/2011	Barrier #:	7056
Location:	Fair Oaks Blvd - West				
X Coordinate:	-121.26255				
Y Coordinate:	38.68641				
Barrier Area:	Sidewalks				
Barrier Type:	Cross Slope - Existing (3.1% to 4.0%)				
Code Ref:	CBC 1133B.7.1.3 and ADA/ABA 403.3

As Built Meas:	132	Quantity:	LF
Description:	Cross slope exceeds 2.0% (3.1% to 4.0%)		
As Built Desc:	3.8% cross slope		
Solution:	Demolish existing and construct new route		
Bar. Severity:	3 Hindrance	Cost Estimate:	\$16,500.00
Implementation Priority:	1	Facility Function:	
Implementation Phase:		Implementation Date:	
Official Responsible:			
Notes:

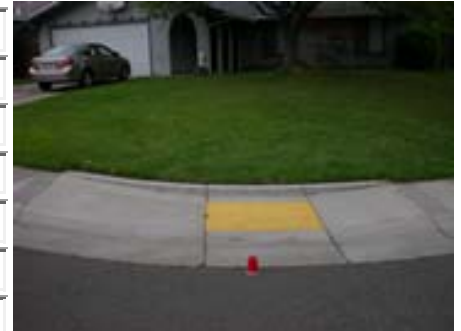
Barrier Type: 12" Grooves - Existing (3.1% to 4.0%)

Description: 12" grooves at top of curb ramp are not level (3.1% to 4.0%)

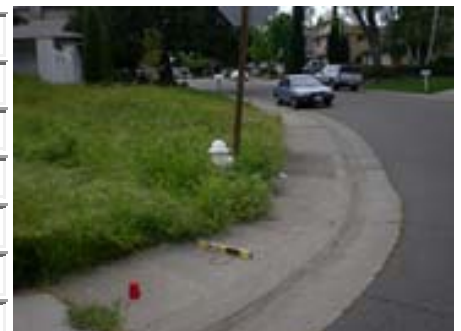
Barrier Type: Cross Slope - Existing (5.0% or more)

Description: Cross slope exceeds 2.0% (5.0% or more)

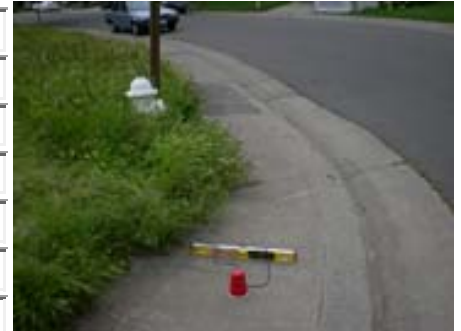
Field Date:	4/18/2011	Report Date:	4/18/2011	Barrier #:	7058B
Location:	Linden Lime Ct - South				
X Coordinate:	-121.26287				
Y Coordinate:	38.6868				
Barrier Area:	Sidewalks				
Barrier Type:	Clear Width - Existing ($\leq 31"$ or less)				
Code Ref:	CBC 1133B.7.1

As Built Meas:	1	Quantity:	LF
Description:	Pedestrian route is not min. 48" wide ($\leq 31"$ or less)		
As Built Desc:	24" clear width due to foliage		
Solution:	Trim foliage to provide min. 48" clear width		
Bar. Severity:	1 Necessary	Cost Estimate:	\$125.00
Implementation Priority:	2	Facility Function:	
Implementation Phase:		Implementation Date:	
Official Responsible:

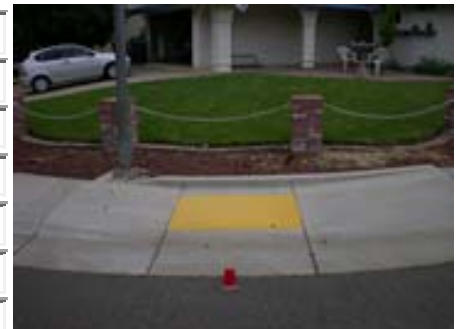
Field Date:	4/18/2011	Report Date:	4/18/2011	Barrier #:	7059
Location:	Linden Lime Ct and Linden Lime Ct - Corner C				
X Coordinate:	-121.26318				
Y Coordinate:	38.6866				
Barrier Area:	Curb Ramps				
Barrier Type:	12" Grooves - Existing (4.1% to 4.9%)				
Code Ref:	CBC 1127B.5.6

As Built Meas:	1	Quantity:	EACH
Description:	12" grooves at top of curb ramp are not level (4.1% to 4.9%)		
As Built Desc:	4.7% at 12" grooves		
Solution:	Demolish existing and construct new curb ramp		
Bar. Severity:	2 Recommended	Cost Estimate:	\$2,500.00
Implementation Priority:	2	Facility Function:	
Implementation Phase:		Implementation Date:	
Official Responsible:

Notes:	Two - way intersection corners C,D
--------	------------------------------------

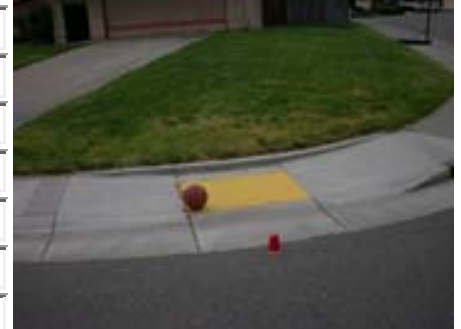
Barrier Type: Cross Slope - Existing (2.1% to 3.0%)

Description: Ramp run cross slope exceeds 2.0% (2.1% to 3.0%)

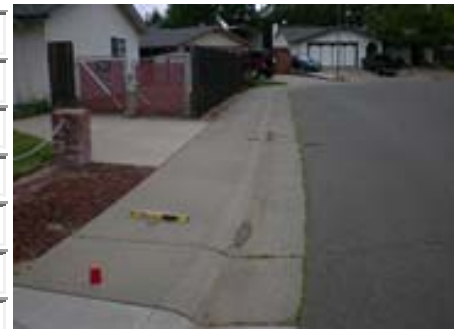
Barrier Type: Cross Slope - Existing (3.1% to 4.0%)

Description: Cross slope exceeds 2.0% (3.1% to 4.0%)

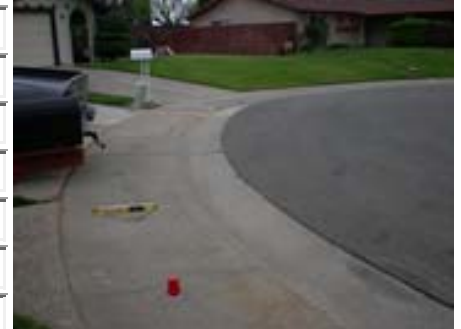
Field Date:	4/18/2011	Report Date:	4/18/2011	Barrier #:	7062
Location:	Linden Lime Ct - West				
X Coordinate:	-121.26313				
Y Coordinate:	38.6862				
Barrier Area:	Sidewalks				
Barrier Type:	Cross Slope - Existing (3.1% to 4.0%)				
Code Ref:	CBC 1133B.7.1.3 and ADA/ABA 403.3

As Built Meas:	145	Quantity:	LF
Description:	Cross slope exceeds 2.0% (3.1% to 4.0%)		
As Built Desc:	3.8% cross slope		
Solution:	Demolish existing and construct new route		
Bar. Severity:	3 Hindrance	Cost Estimate:	\$18,125.00
Implementation Priority:	2	Facility Function:	
Implementation Phase:		Implementation Date:	
Official Responsible:

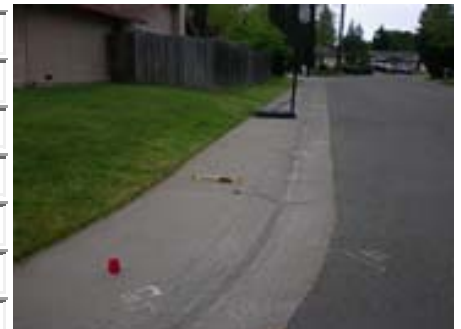
Field Date:	4/18/2011	Report Date:	4/18/2011	Barrier #:	7063A
Location:	Linden Lime Ct - South				
X Coordinate:	-121.26318				
Y Coordinate:	38.6862				
Barrier Area:	Sidewalks				
Barrier Type:	Cross Slope - Existing (4.1% to 4.9%)				
Code Ref:	CBC 1133B.7.1.3 and ADA/ABA 403.3

As Built Meas:	315	Quantity:	LF
Description:	Cross slope exceeds 2.0% (4.1% to 4.9%)		
As Built Desc:	4.7% cross slope		
Solution:	Demolish existing and construct new route		
Bar. Severity:	2 Recommended	Cost Estimate:	\$39,375.00
Implementation Priority:	2	Facility Function:	
Implementation Phase:		Implementation Date:	
Official Responsible:

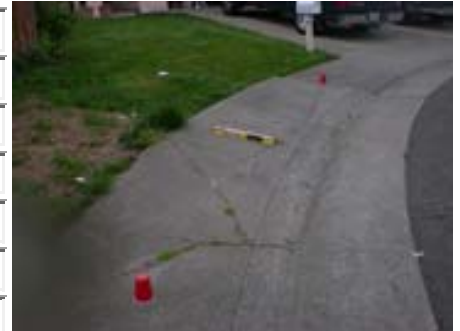
Field Date:	4/18/2011	Report Date:	4/18/2011	Barrier #:	7063B
Location:	Linden Lime Ct - South				
X Coordinate:	-121.26338				
Y Coordinate:	38.68653				
Barrier Area:	Sidewalks				
Barrier Type:	Cross Slope - Existing (5.0% or more)				
Code Ref:	CBC 1133B.7.1.3 and ADA/ABA 403.3

As Built Meas:	8	Quantity:	LF
Description:	Cross slope exceeds 2.0% (5.0% or more)		
As Built Desc:	11.2% cross slope		
Solution:	Demolish existing and construct new route		
Bar. Severity:	1 Necessary	Cost Estimate:	\$1,000.00
Implementation Priority:	2	Facility Function:	
Implementation Phase:		Implementation Date:	
Official Responsible:

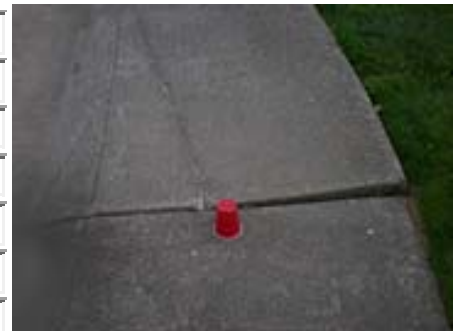
Field Date:	4/18/2011	Report Date:	4/18/2011	Barrier #:	7063C
Location:	Linden Lime Ct - South				
X Coordinate:	-121.26442				
Y Coordinate:	38.68617				
Barrier Area:	Sidewalks				
Barrier Type:	Abrupt Change in Level - > 1/2"				
Code Ref:	CBC 1133B.7.1 and ADA/ABA 303.3

As Built Meas:	8	Quantity:	LF
Description:	Change in level greater than 1/2"		
As Built Desc:	1" lip in sidewalk surface		
Solution:	Grind or repair sidewalk to remove trip hazard		
Bar. Severity:	1 Necessary	Cost Estimate:	\$2,000.00
Implementation Priority:	2	Facility Function:	
Implementation Phase:		Implementation Date:	
Official Responsible:

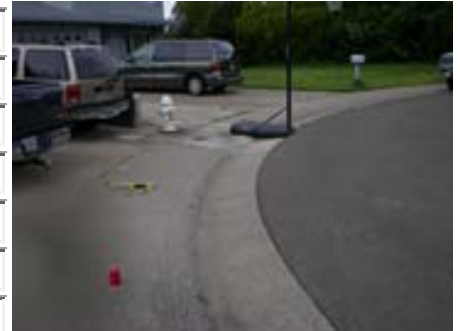
Field Date:	4/18/2011	Report Date:	4/18/2011	Barrier #:	7064A
Location:	Linden Lime Ct - South				
X Coordinate:	-121.26456				
Y Coordinate:	38.68623				
Barrier Area:	Sidewalks				
Barrier Type:	Cross Slope - Existing (5.0% or more)				
Code Ref:	CBC 1133B.7.1.3 and ADA/ABA 403.3

As Built Meas:	71	Quantity:	LF
Description:	Cross slope exceeds 2.0% (5.0% or more)		
As Built Desc:	8.0% cross slope		
Solution:	Demolish existing and construct new route		
Bar. Severity:	1 Necessary	Cost Estimate:	\$8,875.00
Implementation Priority:	2	Facility Function:	
Implementation Phase:		Implementation Date:	
Official Responsible:

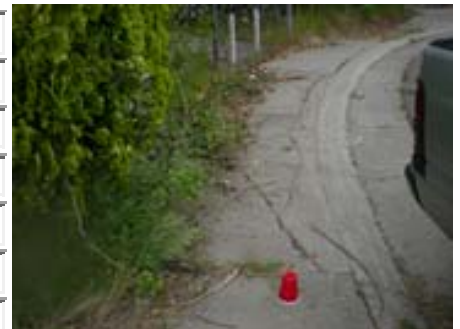
Field Date:	4/18/2011	Report Date:	4/18/2011	Barrier #:	7064B
Location:	Linden Lime Ct - South				
X Coordinate:	-121.2645				
Y Coordinate:	38.6862				
Barrier Area:	Sidewalks				
Barrier Type:	Surface Condition - Damaged				
Code Ref:	CBC 1133B.7.1 and ADA/ABA 302.1

As Built Meas:	8	Quantity:	LF
Description:	Surface is not firm and stable (cracked, broken or loose soil, etc.)		
As Built Desc:	Cracked concrete		
Solution:	Repair surface to make firm and stable		
Bar. Severity:	1 Necessary	Cost Estimate:	\$1,000.00
Implementation Priority:	2	Facility Function:	
Implementation Phase:		Implementation Date:	
Official Responsible:

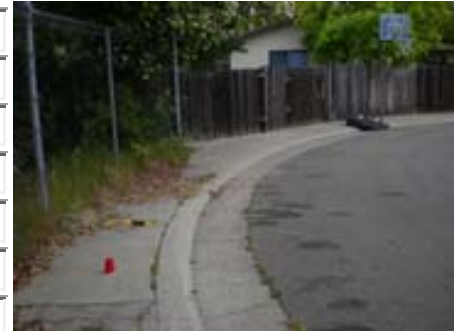
Field Date:	4/18/2011	Report Date:	4/18/2011	Barrier #:	7065
Location:	Linden Lime Ct - North				
X Coordinate:	-121.26404				
Y Coordinate:	38.68631				
Barrier Area:	Sidewalks				
Barrier Type:	Cross Slope - Existing (5.0% or more)				
Code Ref:	CBC 1133B.7.1.3 and ADA/ABA 403.3

As Built Meas:	638	Quantity:	LF
Description:	Cross slope exceeds 2.0% (5.0% or more)		
As Built Desc:	5.5% cross slope		
Solution:	Demolish existing and construct new route		
Bar. Severity:	1 Necessary	Cost Estimate:	\$79,750.00
Implementation Priority:	2	Facility Function:	
Implementation Phase:		Implementation Date:	
Official Responsible:

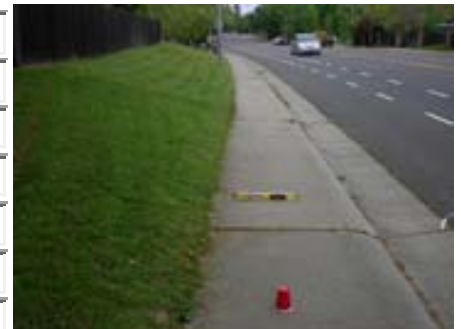
Field Date:	4/19/2011	Report Date:	4/19/2011	Barrier #:	7066A
Location:	Fair Oaks Blvd - West				
X Coordinate:	-121.26241				
Y Coordinate:	38.68709				
Barrier Area:	Sidewalks				
Barrier Type:	Cross Slope - Existing (4.1% to 4.9%)				
Code Ref:	CBC 1133B.7.1.3 and ADA/ABA 403.3

As Built Meas:	208	Quantity:	LF
Description:	Cross slope exceeds 2.0% (4.1% to 4.9%)		
As Built Desc:	4.8% cross slope		
Solution:	Demolish existing and construct new route		
Bar. Severity:	2 Recommended	Cost Estimate:	\$26,000.00
Implementation Priority:	1	Facility Function:	
Implementation Phase:		Implementation Date:	
Official Responsible:

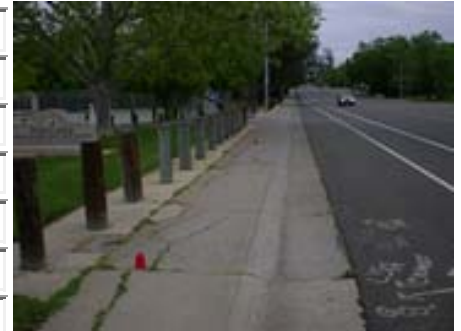
Field Date:	4/19/2011	Report Date:	4/19/2011	Barrier #:	7066B
Location:	Fair Oaks Blvd - West				
X Coordinate:	-121.26246				
Y Coordinate:	38.68764				
Barrier Area:	Sidewalks				
Barrier Type:	Surface Condition - Damaged				
Code Ref:	CBC 1133B.7.1 and ADA/ABA 302.1

As Built Meas:	85	Quantity:	LF
Description:	Surface is not firm and stable (cracked, broken or loose soil, etc.)		
As Built Desc:	Cracked concrete		
Solution:	Repair surface to make firm and stable		
Bar. Severity:	1 Necessary	Cost Estimate:	\$10,625.00
Implementation Priority:	1	Facility Function:	
Implementation Phase:		Implementation Date:	
Official Responsible:

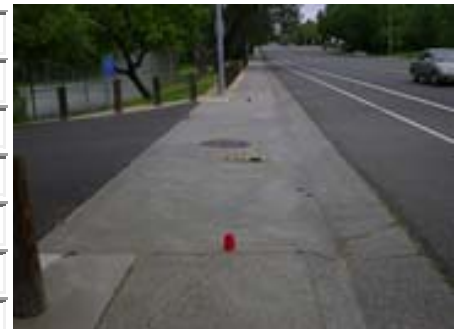
Field Date:	4/19/2011	Report Date:	4/19/2011	Barrier #:	7067
Location:	Fair Oaks Blvd - West				
X Coordinate:	-121.26248				
Y Coordinate:	38.68787				
Barrier Area:	Sidewalks				
Barrier Type:	Driveway - Existing (5.0% or more)				
Code Ref:	CBC 1133B.7.1.3 and ADA/ABA 403.3

As Built Meas:	40	Quantity:	LF
Description:	Driveway cross slope exceeds 2.0% (5.0% or more)		
As Built Desc:	5.4% cross slope 10.5% running slope		
Solution:	Provide min. 48" wide level walkway through driveway		
Bar. Severity:	1 Necessary	Cost Estimate:	\$5,000.00
Implementation Priority:	1	Facility Function:	
Implementation Phase:		Implementation Date:	
Official Responsible:

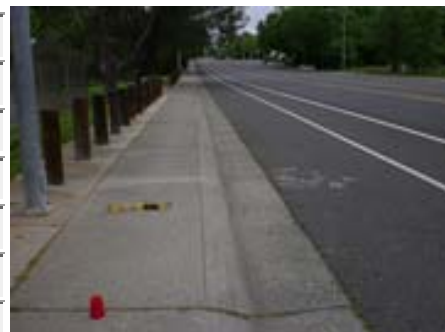
Field Date:	4/19/2011	Report Date:	4/19/2011	Barrier #:	7068
Location:	Fair Oaks Blvd - West				
X Coordinate:	-121.26247				
Y Coordinate:	38.68785				
Barrier Area:	Sidewalks				
Barrier Type:	Cross Slope - Existing (4.1% to 4.9%)				
Code Ref:	CBC 1133B.7.1.3 and ADA/ABA 403.3

As Built Meas:	73	Quantity:	LF
Description:	Cross slope exceeds 2.0% (4.1% to 4.9%)		
As Built Desc:	4.1% cross slope		
Solution:	Demolish existing and construct new route		
Bar. Severity:	2 Recommended	Cost Estimate:	\$9,125.00
Implementation Priority:	1	Facility Function:	
Implementation Phase:		Implementation Date:	
Official Responsible:			
Notes:

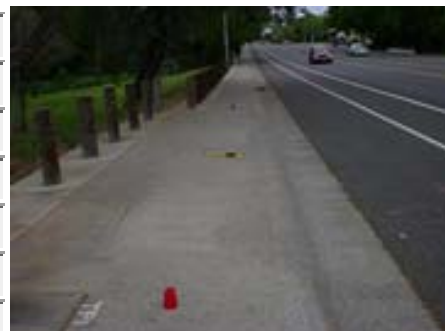
Field Date:	4/19/2011	Report Date:	4/19/2011	Barrier #:	7069
Location:	Fair Oaks Blvd - West				
X Coordinate:	-121.26249				
Y Coordinate:	38.68805				
Barrier Area:	Sidewalks				
Barrier Type:	Driveway - Existing (5.0% or more)				
Code Ref:	CBC 1133B.7.1.3 and ADA/ABA 403.3

As Built Meas:	40	Quantity:	LF
Description:	Driveway cross slope exceeds 2.0% (5.0% or more)		
As Built Desc:	11.4% running slope		
Solution:	Provide min. 48" wide level walkway through driveway		
Bar. Severity:	4 Low Severity	Cost Estimate:	\$5,000.00
Implementation Priority:	1	Facility Function:	
Implementation Phase:		Implementation Date:	
Official Responsible:			
Notes:

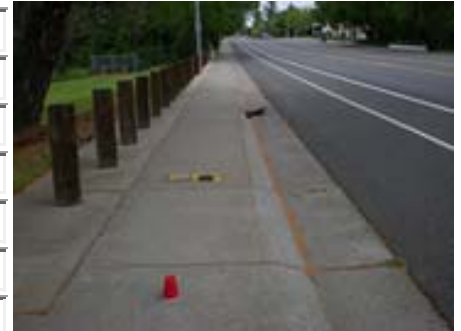
Field Date:	4/19/2011	Report Date:	4/19/2011	Barrier #:	7070
Location:	Fair Oaks Blvd - West				
X Coordinate:	-121.26248				
Y Coordinate:	38.68812				
Barrier Area:	Sidewalks				
Barrier Type:	Cross Slope - Existing (4.1% to 4.9%)				
Code Ref:	CBC 1133B.7.1.3 and ADA/ABA 403.3

As Built Meas:	148	Quantity:	LF
Description:	Cross slope exceeds 2.0% (4.1% to 4.9%)		
As Built Desc:	4.8% cross slope		
Solution:	Demolish existing and construct new route		
Bar. Severity:	2 Recommended	Cost Estimate:	\$18,500.00
Implementation Priority:	1	Facility Function:	
Implementation Phase:		Implementation Date:	
Official Responsible:			
Notes:

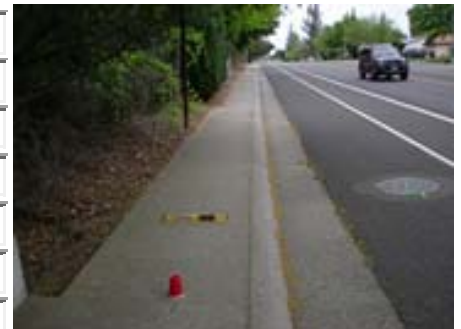
Field Date:	4/19/2011	Report Date:	4/19/2011	Barrier #:	7071A
Location:	Fair Oaks Blvd - West				
X Coordinate:	-121.26246				
Y Coordinate:	38.68856				
Barrier Area:	Sidewalks				
Barrier Type:	Cross Slope - Existing (4.1% to 4.9%)				
Code Ref:	CBC 1133B.7.1.3 and ADA/ABA 403.3

As Built Meas:	691	Quantity:	LF
Description:	Cross slope exceeds 2.0% (4.1% to 4.9%)		
As Built Desc:	4.8% cross slope		
Solution:	Demolish existing and construct new route		
Bar. Severity:	2 Recommended	Cost Estimate:	\$86,375.00
Implementation Priority:	1	Facility Function:	
Implementation Phase:		Implementation Date:	
Official Responsible:			
Notes:

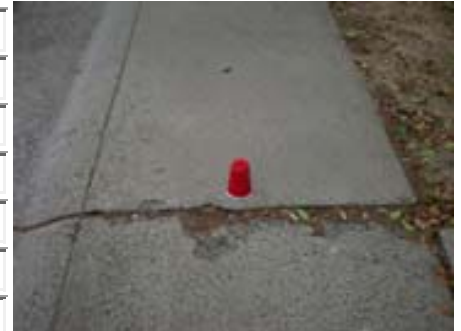
Field Date:	4/19/2011	Report Date:	4/19/2011	Barrier #:	7071B
Location:	Fair Oaks Blvd - West				
X Coordinate:	-121.26248				
Y Coordinate:	38.68937				
Barrier Area:	Sidewalks				
Barrier Type:	Surface Condition - Damaged				
Code Ref:	CBC 1133B.7.1 and ADA/ABA 302.1

As Built Meas:	4	Quantity:	LF
Description:	Surface is not firm and stable (cracked, broken or loose soil, etc.)		
As Built Desc:	Cracked concrete		
Solution:	Repair surface to make firm and stable		
Bar. Severity:	1 Necessary	Cost Estimate:	\$500.00
Implementation Priority:	1	Facility Function:	
Implementation Phase:		Implementation Date:	
Official Responsible:			
Notes:

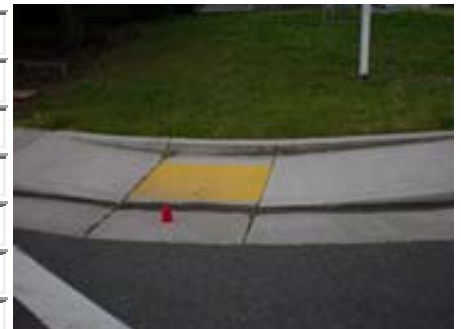
Field Date:	4/19/2011	Report Date:	4/19/2011	Barrier #:	7072
Location:	Fair Oaks Blvd and Woodmore Oaks - Corner D				
X Coordinate:	-121.26247				
Y Coordinate:	38.69197				
Barrier Area:	Curb Ramps				
Barrier Type:	12" Grooves - Existing (4.1% to 4.9%)				
Code Ref:	CBC 1127B.5.6

As Built Meas:	1	Quantity:	EACH
Description:	12" grooves at top of curb ramp are not level (4.1% to 4.9%)		
As Built Desc:	4.2% at 12" grooves		
Solution:	Demolish existing and construct new curb ramp		
Bar. Severity:	2 Recommended	Cost Estimate:	\$2,500.00
Implementation Priority:	1	Facility Function:	
Implementation Phase:		Implementation Date:	
Official Responsible:			
Notes:	Two -way intersection corners A,D. Corner D compliant

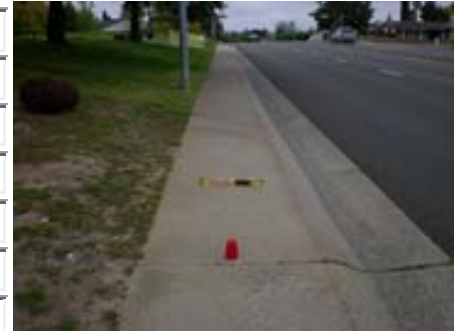
Field Date:	4/19/2011	Report Date:	4/19/2011	Barrier #:	7073
Location:	Fair Oaks Blvd - West				
X Coordinate:	-121.26249				
Y Coordinate:	38.69229				
Barrier Area:	Sidewalks				
Barrier Type:	Cross Slope - Existing (2.1% to 3.0%)				
Code Ref:	CBC 1133B.7.1.3 and ADA/ABA 403.3

As Built Meas:	165	Quantity:	LF
Description:	Cross slope exceeds 2.0% (2.1% to 3.0%)		
As Built Desc:	3.0% cross slope		
Solution:	Low severity barrier - no remediation recommended		
Bar. Severity:	4 Low Severity	Cost Estimate:	\$0.00
Implementation Priority:	1	Facility Function:	
Implementation Phase:		Implementation Date:	
Official Responsible:

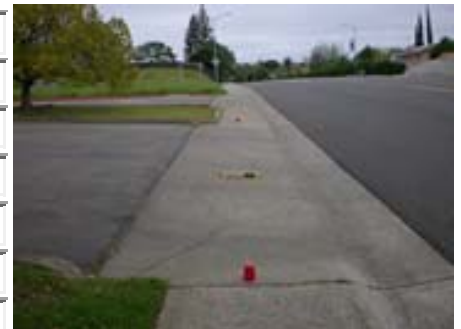
Field Date:	4/19/2011	Report Date:	4/19/2011	Barrier #:	7074
Location:	Fair Oaks Blvd - West				
X Coordinate:	-121.26249				
Y Coordinate:	38.69295				
Barrier Area:	Sidewalks				
Barrier Type:	Driveway - Existing (5.0% or more)				
Code Ref:	CBC 1133B.7.1.3 and ADA/ABA 403.3

As Built Meas:	36	Quantity:	LF
Description:	Driveway cross slope exceeds 2.0% (5.0% or more)		
As Built Desc:	7.8% cross slope		
Solution:	Provide min. 48" wide level walkway through driveway		
Bar. Severity:	4 Low Severity	Cost Estimate:	\$4,500.00
Implementation Priority:	1	Facility Function:	
Implementation Phase:		Implementation Date:	
Official Responsible:

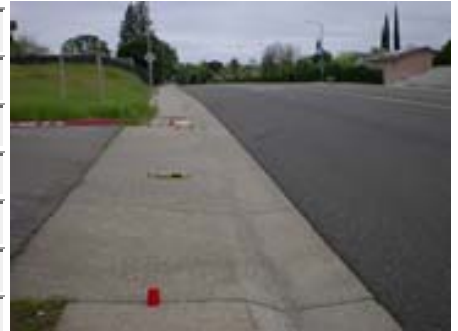
Field Date:	4/19/2011	Report Date:	4/19/2011	Barrier #:	7075
Location:	Fair Oaks Blvd - West				
X Coordinate:	-121.26248				
Y Coordinate:	38.6931				
Barrier Area:	Sidewalks				
Barrier Type:	Driveway - Existing (5.0% or more)				
Code Ref:	CBC 1133B.7.1.3 and ADA/ABA 403.3

As Built Meas:	36	Quantity:	LF
Description:	Driveway cross slope exceeds 2.0% (5.0% or more)		
As Built Desc:	9.3% cross slope		
Solution:	Provide min. 48" wide level walkway through driveway		
Bar. Severity:	4 Low Severity	Cost Estimate:	\$4,500.00
Implementation Priority:	1	Facility Function:	
Implementation Phase:		Implementation Date:	
Official Responsible:

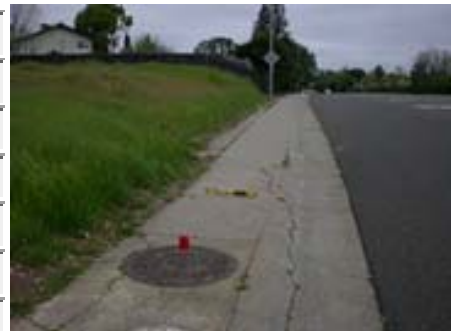
Field Date:	4/19/2011	Report Date:	4/19/2011	Barrier #:	7076
Location:	Fair Oaks Blvd - West				
X Coordinate:	-121.26248				
Y Coordinate:	38.69319				
Barrier Area:	Sidewalks				
Barrier Type:	Cross Slope - Existing (5.0% or more)				
Code Ref:	CBC 1133B.7.1.3 and ADA/ABA 403.3

As Built Meas:	150	Quantity:	LF
Description:	Cross slope exceeds 2.0% (5.0% or more)		
As Built Desc:	5.5% cross slope		
Solution:	Demolish existing and construct new route		
Bar. Severity:	1 Necessary	Cost Estimate:	\$18,750.00
Implementation Priority:	1	Facility Function:	
Implementation Phase:		Implementation Date:	
Official Responsible:

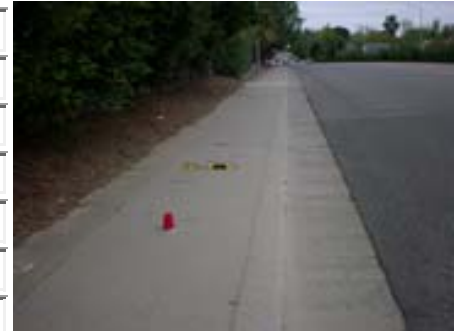
Field Date:	4/19/2011	Report Date:	4/19/2011	Barrier #:	7077
Location:	Fair Oaks Blvd - West				
X Coordinate:	-121.2625				
Y Coordinate:	38.69373				
Barrier Area:	Sidewalks				
Barrier Type:	Cross Slope - Existing (5.0% or more)				
Code Ref:	CBC 1133B.7.1.3 and ADA/ABA 403.3

As Built Meas:	704	Quantity:	LF
Description:	Cross slope exceeds 2.0% (5.0% or more)		
As Built Desc:	6.0% cross slope		
Solution:	Demolish existing and construct new route		
Bar. Severity:	1 Necessary	Cost Estimate:	\$88,000.00
Implementation Priority:	1	Facility Function:	
Implementation Phase:		Implementation Date:	
Official Responsible:

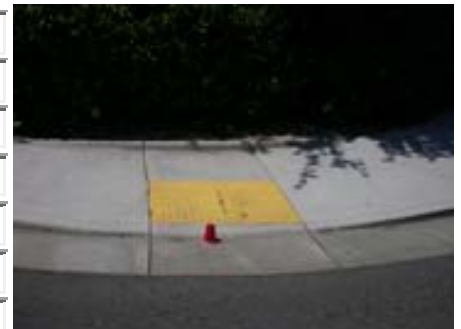
Field Date:	4/19/2011	Report Date:	4/19/2011	Barrier #:	7078
Location:	Fair Oaks Blvd and Copperfield Dr - Corner D				
X Coordinate:	-121.26265				
Y Coordinate:	38.69569				
Barrier Area:	Curb Ramps				
Barrier Type:	12" Grooves - Existing (3.1% to 4.0%)				
Code Ref:	CBC 1127B.5.6

As Built Meas:	1	Quantity:	EACH
Description:	12" grooves at top of curb ramp are not level (3.1% to 4.0%)		
As Built Desc:	3.2% at 12" grooves		
Solution:	Demolish existing and construct new curb ramp		
Bar. Severity:	3 Hindrance	Cost Estimate:	\$2,500.00
Implementation Priority:	1	Facility Function:	
Implementation Phase:		Implementation Date:	
Official Responsible:

Notes:	Two - way intersection corners A,D. Corner A compliant
--------	--

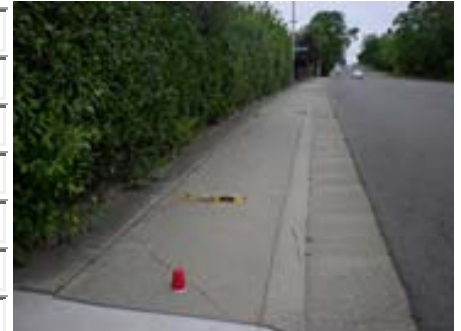
Field Date:	4/19/2011	Report Date:	4/19/2011	Barrier #:	7079A
Location:	Fair Oaks Blvd - West				
X Coordinate:	-121.26262				
Y Coordinate:	38.69589				
Barrier Area:	Sidewalks				
Barrier Type:	Cross Slope - Existing (3.1% to 4.0%)				
Code Ref:	CBC 1133B.7.1.3 and ADA/ABA 403.3

As Built Meas:	460	Quantity:	LF
Description:	Cross slope exceeds 2.0% (3.1% to 4.0%)		
As Built Desc:	3.7% cross slope		
Solution:	Demolish existing and construct new route		
Bar. Severity:	3 Hindrance	Cost Estimate:	\$57,500.00
Implementation Priority:	1	Facility Function:	
Implementation Phase:		Implementation Date:	
Official Responsible:

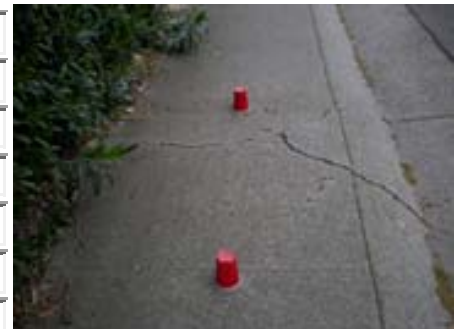
Field Date:	4/19/2011	Report Date:	4/19/2011	Barrier #:	7079B
Location:	Fair Oaks Blvd - West				
X Coordinate:	-121.26263				
Y Coordinate:	38.69688				
Barrier Area:	Sidewalks				
Barrier Type:	Abrupt Change in Level - Tree Heaves				
Code Ref:	CBC 1133B.7.1 and ADA/ABA 303.3

As Built Meas:	4	Quantity:	LF
Description:	Change in level greater than 1/2"		
As Built Desc:	1" lip due to tree heaves		
Solution:	Grind or repair sidewalk to remove trip hazard		
Bar. Severity:	1 Necessary	Cost Estimate:	\$1,000.00
Implementation Priority:	1	Facility Function:	
Implementation Phase:		Implementation Date:	
Official Responsible:

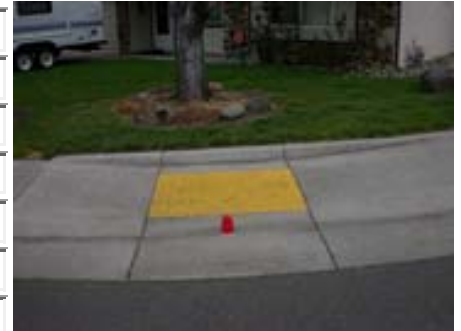
Field Date:	4/19/2011	Report Date:	4/19/2011	Barrier #:	7080
Location:	Fair Oaks Blvd and San Consume Dr - Corner A				
X Coordinate:	-121.26268				
Y Coordinate:	38.6973				
Barrier Area:	Curb Ramps				
Barrier Type:	12" Grooves - Existing (4.1% to 4.9%)				
Code Ref:	CBC 1127B.5.6

As Built Meas:	1	Quantity:	EACH
Description:	12" grooves at top of curb ramp are not level (4.1% to 4.9%)		
As Built Desc:	4.6% at 12" grooves		
Solution:	Demolish existing and construct new curb ramp		
Bar. Severity:	2 Recommended	Cost Estimate:	\$2,500.00
Implementation Priority:	1	Facility Function:	
Implementation Phase:		Implementation Date:	
Official Responsible:

Notes: Two - way intersection corners A,D. Corner D compliant

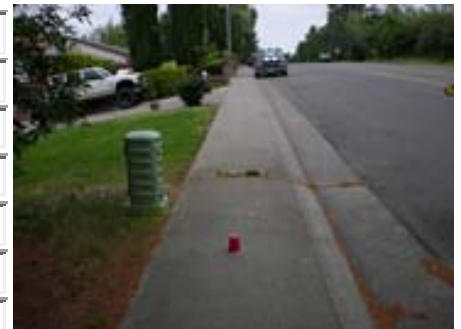
Field Date:	4/19/2011	Report Date:	4/19/2011	Barrier #:	7081
Location:	Fair Oaks Blvd - West				
X Coordinate:	-121.26263				
Y Coordinate:	38.69835				
Barrier Area:	Sidewalks				
Barrier Type:	Cross Slope - Existing (4.1% to 4.9%)				
Code Ref:	CBC 1133B.7.1.3 and ADA/ABA 403.3

As Built Meas:	132	Quantity:	LF
Description:	Cross slope exceeds 2.0% (4.1% to 4.9%)		
As Built Desc:	4.1% cross slope		
Solution:	Demolish existing and construct new route		
Bar. Severity:	2 Recommended	Cost Estimate:	\$16,500.00
Implementation Priority:	1	Facility Function:	
Implementation Phase:		Implementation Date:	
Official Responsible:

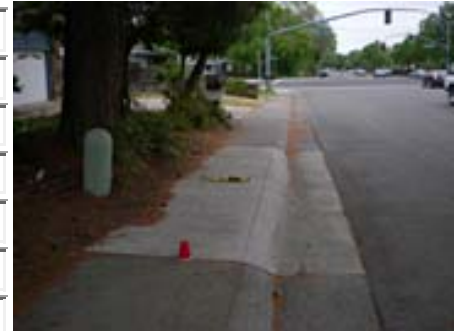
Field Date:	4/19/2011	Report Date:	4/19/2011	Barrier #:	7082
Location:	Fair Oaks Blvd - West				
X Coordinate:	-121.26265				
Y Coordinate:	38.69989				
Barrier Area:	Sidewalks				
Barrier Type:	Cross Slope - Existing (4.1% to 4.9%)				
Code Ref:	CBC 1133B.7.1.3 and ADA/ABA 403.3

As Built Meas:	146	Quantity:	LF
Description:	Cross slope exceeds 2.0% (4.1% to 4.9%)		
As Built Desc:	4.1% cross slope		
Solution:	Demolish existing and construct new route		
Bar. Severity:	2 Recommended	Cost Estimate:	\$18,250.00
Implementation Priority:	1	Facility Function:	
Implementation Phase:		Implementation Date:	
Official Responsible:

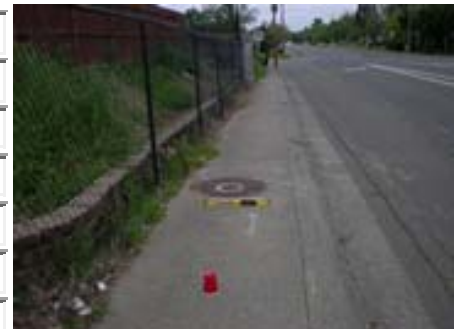
Field Date:	4/19/2011	Report Date:	4/19/2011	Barrier #:	7083A
Location:	Oak Ave - South				
X Coordinate:	-121.26277				
Y Coordinate:	38.70035				
Barrier Area:	Sidewalks				
Barrier Type:	Cross Slope - Existing (4.1% to 4.9%)				
Code Ref:	CBC 1133B.7.1.3 and ADA/ABA 403.3

As Built Meas:	178	Quantity:	LF
Description:	Cross slope exceeds 2.0% (4.1% to 4.9%)		
As Built Desc:	4.2% cross slope		
Solution:	Demolish existing and construct new route		
Bar. Severity:	2 Recommended	Cost Estimate:	\$22,250.00
Implementation Priority:	1	Facility Function:	
Implementation Phase:		Implementation Date:	
Official Responsible:

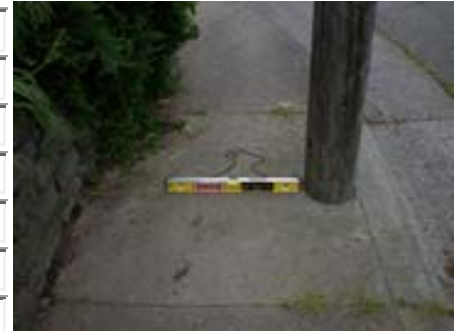
Barrier Type: Clear Width - Existing ($\leq 31"$ or less)

Description: Pedestrian route is not min. 48" wide ($\leq 31"$ or less)

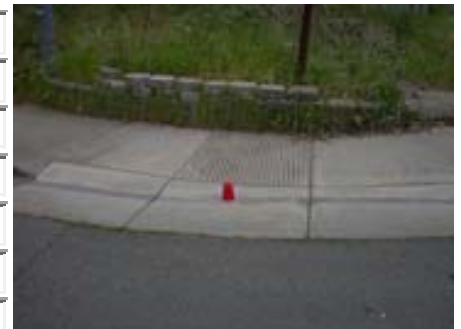
Barrier Type: 12" Grooves - Existing ($> 5.0\%$)

Description: 12" grooves at top of curb ramp are not level ($> 5.0\%$)

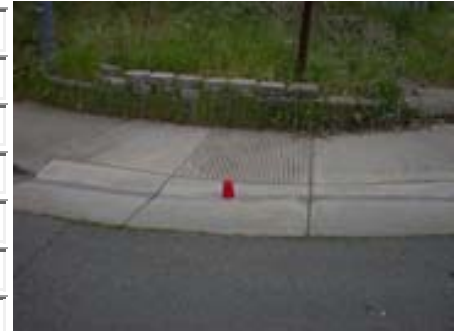
Field Date:	4/19/2011	Report Date:	4/19/2011	Barrier #:	7084B
Location:	Oak Ave and Single Ave - Corner C				
X Coordinate:	-121.26342				
Y Coordinate:	38.70032				
Barrier Area:	Curb Ramps				
Barrier Type:	Running Slope - Existing (9.0% to 9.4%)				
Code Ref:	CBC 1127B.5.3 and ADA/ABA 406.1

As Built Meas:	1	Quantity:	EACH
Description:	Ramp run cross slope exceeds 2.0% (9.0% to 9.4%)		
As Built Desc:	9.0% running slope		
Solution:	Demolish existing and construct new curb ramp		
Bar. Severity:	2 Recommended	Cost Estimate:	\$0.00
Implementation Priority:	1	Facility Function:	
Implementation Phase:		Implementation Date:	
Official Responsible:			
Notes:	Two - way intersection corners C,D

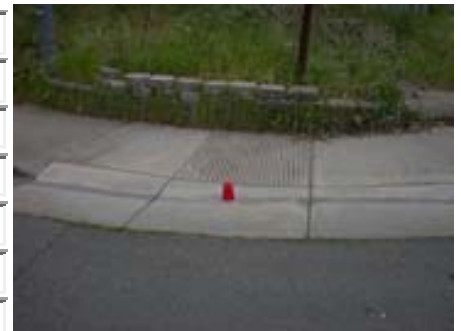
Field Date:	4/19/2011	Report Date:	4/19/2011	Barrier #:	7084C
Location:	Oak Ave and Single Ave - Corner C				
X Coordinate:	-121.26342				
Y Coordinate:	38.70032				
Barrier Area:	Curb Ramps				
Barrier Type:	Parallel Ramp Landing - Existing (3.1% to 4.0%)				
Code Ref:	CBC 1127B.5.4 and ADA/ABA 406.4

As Built Meas:	1	Quantity:	EACH
Description:	Curb ramp landing or pan not level (3.1% to 4.0%)		
As Built Desc:	4.0% landing slope		
Solution:	Demolish existing and construct new transition		
Bar. Severity:	3 Hindrance	Cost Estimate:	\$0.00
Implementation Priority:	1	Facility Function:	
Implementation Phase:		Implementation Date:	
Official Responsible:			
Notes:	Two - way intersection corners C,D

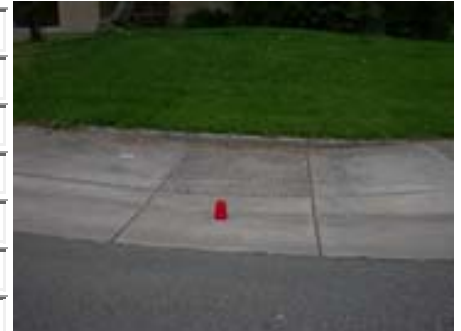
Field Date:	4/19/2011	Report Date:	4/19/2011	Barrier #:	7085A
Location:	Oak Ave and Single Ave - Corner D				
X Coordinate:	-121.26356				
Y Coordinate:	38.70032				
Barrier Area:	Curb Ramps				
Barrier Type:	12" Grooves - Existing (>5.0%)				
Code Ref:	CBC 1127B.5.6

As Built Meas:	1	Quantity:	EACH
Description:	12" grooves at top of curb ramp are not level (>5.0%)		
As Built Desc:	6.2% at 12" grooves		
Solution:	Demolish existing and construct new curb ramp		
Bar. Severity:	1 Necessary	Cost Estimate:	\$2,500.00
Implementation Priority:	1	Facility Function:	
Implementation Phase:		Implementation Date:	
Official Responsible:

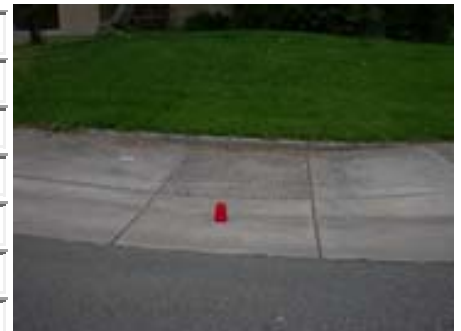
Field Date:	4/19/2011	Report Date:	4/19/2011	Barrier #:	7085B
Location:	Oak Ave and Single Ave - Corner D				
X Coordinate:	-121.26356				
Y Coordinate:	38.70032				
Barrier Area:	Curb Ramps				
Barrier Type:	Detectable Warnings - Truncated Domes				
Code Ref:	CBC 1127B.5.7 and ADA/ABA 705.1.3

As Built Meas:	1	Quantity:	EACH
Description:	No truncated domes provided at curb ramp		
As Built Desc:	No detectable warnings at curb ramp		
Solution:	Provide compliant truncated domes		
Bar. Severity:	2 Recommended	Cost Estimate:	\$0.00
Implementation Priority:	1	Facility Function:	
Implementation Phase:		Implementation Date:	
Official Responsible:

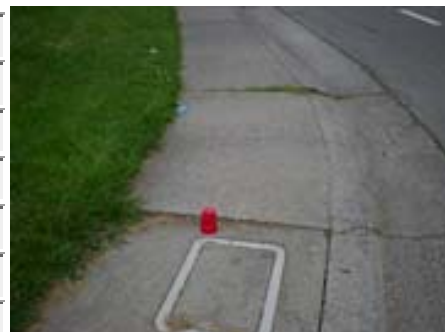
Field Date:	4/19/2011	Report Date:	4/19/2011	Barrier #:	7086
Location:	Oak Ave - South				
X Coordinate:	-121.26365				
Y Coordinate:	38.70035				
Barrier Area:	Sidewalks				
Barrier Type:	Abrupt Change in Level - > 1/2"				
Code Ref:	CBC 1133B.7.1 and ADA/ABA 303.3

As Built Meas:	8	Quantity:	LF
Description:	Change in level greater than 1/2"		
As Built Desc:	1/2" lip in sidewalk surface		
Solution:	Grind or repair sidewalk to remove trip hazard		
Bar. Severity:	1 Necessary	Cost Estimate:	\$2,000.00
Implementation Priority:	1	Facility Function:	
Implementation Phase:		Implementation Date:	
Official Responsible:			
Notes:

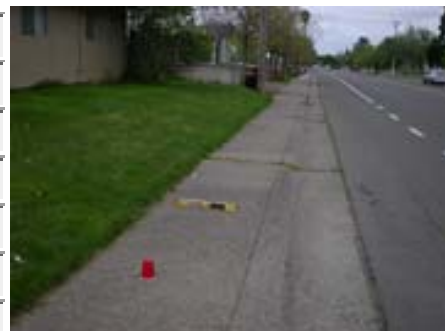
Field Date:	4/19/2011	Report Date:	4/19/2011	Barrier #:	7087
Location:	Oak Ave - South				
X Coordinate:	-121.26369				
Y Coordinate:	38.70037				
Barrier Area:	Sidewalks				
Barrier Type:	Cross Slope - Existing (5.0% or more)				
Code Ref:	CBC 1133B.7.1.3 and ADA/ABA 403.3

As Built Meas:	90	Quantity:	LF
Description:	Cross slope exceeds 2.0% (5.0% or more)		
As Built Desc:	6.2% cross slope		
Solution:	Demolish existing and construct new route		
Bar. Severity:	1 Necessary	Cost Estimate:	\$11,250.00
Implementation Priority:	1	Facility Function:	
Implementation Phase:		Implementation Date:	
Official Responsible:			
Notes:

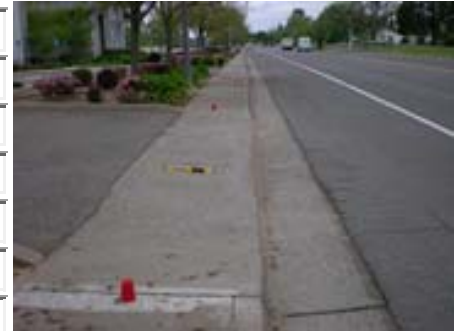
Barrier Type: Driveway - Existing (5.0% or more)

Description: Driveway cross slope exceeds 2.0% (5.0% or more)

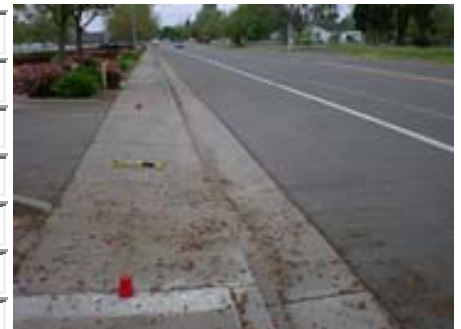
Barrier Type: Driveway - Existing (5.0% or more)

Description: Driveway cross slope exceeds 2.0% (5.0% or more)

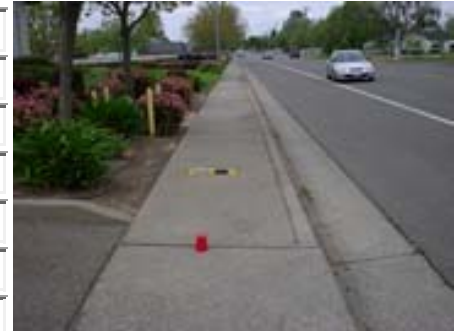
Field Date:	4/19/2011	Report Date:	4/19/2011	Barrier #:	7090
Location:	Oak Ave - South				
X Coordinate:	-121.26426				
Y Coordinate:	38.70035				
Barrier Area:	Sidewalks				
Barrier Type:	Cross Slope - Existing (3.1% to 4.0%)				
Code Ref:	CBC 1133B.7.1.3 and ADA/ABA 403.3

As Built Meas:	150	Quantity:	LF
Description:	Cross slope exceeds 2.0% (3.1% to 4.0%)		
As Built Desc:	3.5% cross slope		
Solution:	Demolish existing and construct new route		
Bar. Severity:	3 Hindrance	Cost Estimate:	\$18,750.00
Implementation Priority:	1	Facility Function:	
Implementation Phase:		Implementation Date:	
Official Responsible:

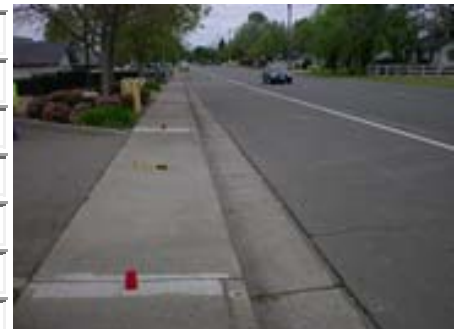
Field Date:	4/19/2011	Report Date:	4/19/2011	Barrier #:	7091
Location:	Oak Ave - South				
X Coordinate:	-121.2648				
Y Coordinate:	38.70034				
Barrier Area:	Sidewalks				
Barrier Type:	Driveway - Existing (5.0% or more)				
Code Ref:	CBC 1133B.7.1.3 and ADA/ABA 403.3

As Built Meas:	30	Quantity:	LF
Description:	Driveway cross slope exceeds 2.0% (5.0% or more)		
As Built Desc:	15.6% cross slope, 9.6% running slope		
Solution:	Provide min. 48" wide level walkway through driveway		
Bar. Severity:	1 Necessary	Cost Estimate:	\$3,750.00
Implementation Priority:	1	Facility Function:	
Implementation Phase:		Implementation Date:	
Official Responsible:

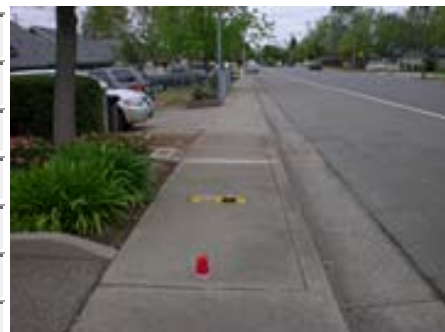
Field Date:	4/19/2011	Report Date:	4/19/2011	Barrier #:	7092
Location:	Oak Ave - South				
X Coordinate:	-121.26499				
Y Coordinate:	38.70033				
Barrier Area:	Sidewalks				
Barrier Type:	Driveway - Existing (5.0% or more)				
Code Ref:	CBC 1133B.7.1.3 and ADA/ABA 403.3

As Built Meas:	30	Quantity:	LF
Description:	Driveway cross slope exceeds 2.0% (5.0% or more)		
As Built Desc:	12.9% cross slope, 10.6% running slope		
Solution:	Provide min. 48" wide level walkway through driveway		
Bar. Severity:	1 Necessary	Cost Estimate:	\$3,750.00
Implementation Priority:	1	Facility Function:	
Implementation Phase:		Implementation Date:	
Official Responsible:			
Notes:

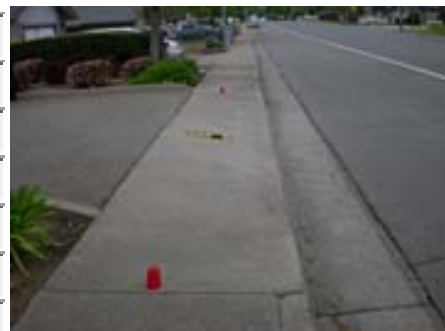
Field Date:	4/19/2011	Report Date:	4/19/2011	Barrier #:	7093A
Location:	Oak Ave - South				
X Coordinate:	-121.26506				
Y Coordinate:	38.70035				
Barrier Area:	Sidewalks				
Barrier Type:	Cross Slope - Existing (3.1% to 4.0%)				
Code Ref:	CBC 1133B.7.1.3 and ADA/ABA 403.3

As Built Meas:	306	Quantity:	LF
Description:	Cross slope exceeds 2.0% (3.1% to 4.0%)		
As Built Desc:	3.6% cross slope		
Solution:	Demolish existing and construct new route		
Bar. Severity:	3 Hindrance	Cost Estimate:	\$38,250.00
Implementation Priority:	1	Facility Function:	
Implementation Phase:		Implementation Date:	
Official Responsible:			
Notes:

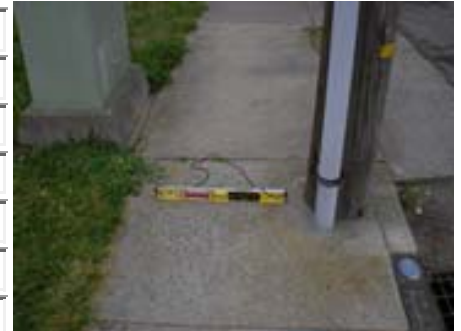
Field Date:	4/19/2011	Report Date:	4/19/2011	Barrier #:	7093B
Location:	Oak Ave - South				
X Coordinate:	-121.26593				
Y Coordinate:	38.70033				
Barrier Area:	Sidewalks				
Barrier Type:	Clear Width - Existing ($\leq 31"$ or less)				
Code Ref:	CBC 1133B.7.1

As Built Meas:	2	Quantity:	LF
Description:	Pedestrian route is not min. 48" wide ($\leq 31"$ or less)		
As Built Desc:	24" clear width due to pole		
Solution:	Demolish existing and construct new route		
Bar. Severity:	1 Necessary	Cost Estimate:	\$250.00
Implementation Priority:	1	Facility Function:	
Implementation Phase:		Implementation Date:	
Official Responsible:

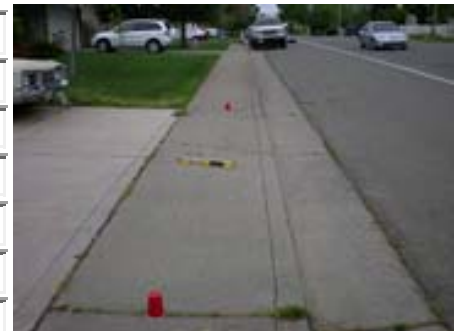
Field Date:	4/19/2011	Report Date:	4/19/2011	Barrier #:	7094
Location:	Oak Ave - South				
X Coordinate:	-121.26613				
Y Coordinate:	38.70034				
Barrier Area:	Sidewalks				
Barrier Type:	Driveway - Existing (5.0% or more)				
Code Ref:	CBC 1133B.7.1.3 and ADA/ABA 403.3

As Built Meas:	21	Quantity:	LF
Description:	Driveway cross slope exceeds 2.0% (5.0% or more)		
As Built Desc:	10.6% cross slope		
Solution:	Provide min. 48" wide level walkway through driveway		
Bar. Severity:	4 Low Severity	Cost Estimate:	\$2,625.00
Implementation Priority:	1	Facility Function:	
Implementation Phase:		Implementation Date:	
Official Responsible:

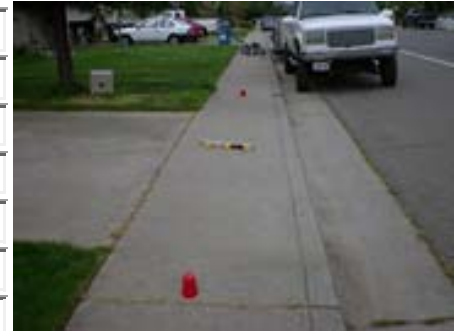
Field Date:	4/19/2011	Report Date:	4/19/2011	Barrier #:	7095
Location:	Oak Ave - South				
X Coordinate:	-121.26641				
Y Coordinate:	38.70032				
Barrier Area:	Sidewalks				
Barrier Type:	Driveway - Existing (5.0% or more)				
Code Ref:	CBC 1133B.7.1.3 and ADA/ABA 403.3

As Built Meas:	21	Quantity:	LF
Description:	Driveway cross slope exceeds 2.0% (5.0% or more)		
As Built Desc:	12.0% cross slope, 10.8% running slope		
Solution:	Provide min. 48" wide level walkway through driveway		
Bar. Severity:	1 Necessary	Cost Estimate:	\$2,625.00
Implementation Priority:	1	Facility Function:	
Implementation Phase:		Implementation Date:	
Official Responsible:

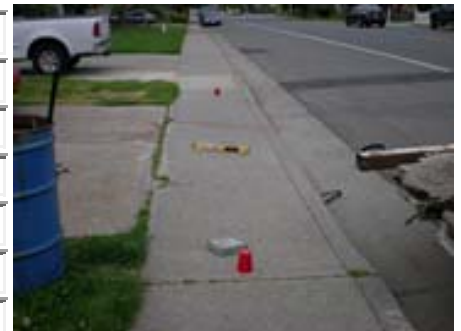
Field Date:	4/19/2011	Report Date:	4/19/2011	Barrier #:	7096
Location:	Oak Ave - South				
X Coordinate:	-121.26663				
Y Coordinate:	38.70033				
Barrier Area:	Sidewalks				
Barrier Type:	Driveway - Existing (5.0% or more)				
Code Ref:	CBC 1133B.7.1.3 and ADA/ABA 403.3

As Built Meas:	20	Quantity:	LF
Description:	Driveway cross slope exceeds 2.0% (5.0% or more)		
As Built Desc:	12.4% cross slope, 15.7% running slope		
Solution:	Provide min. 48" wide level walkway through driveway		
Bar. Severity:	1 Necessary	Cost Estimate:	\$2,500.00
Implementation Priority:	1	Facility Function:	
Implementation Phase:		Implementation Date:	
Official Responsible:

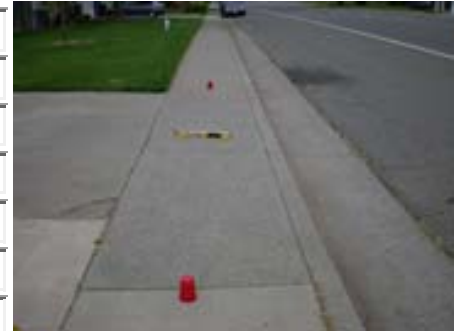
Field Date:	4/19/2011	Report Date:	4/19/2011	Barrier #:	7097
Location:	Oak Ave - South				
X Coordinate:	-121.26677				
Y Coordinate:	38.70032				
Barrier Area:	Sidewalks				
Barrier Type:	Driveway - Existing (5.0% or more)				
Code Ref:	CBC 1133B.7.1.3 and ADA/ABA 403.3

As Built Meas:	20	Quantity:	LF
Description:	Driveway cross slope exceeds 2.0% (5.0% or more)		
As Built Desc:	12.1% cross slope, 11.3% running slope		
Solution:	Provide min. 48" wide level walkway through driveway		
Bar. Severity:	1 Necessary	Cost Estimate:	\$2,500.00
Implementation Priority:	1	Facility Function:	
Implementation Phase:		Implementation Date:	
Official Responsible:

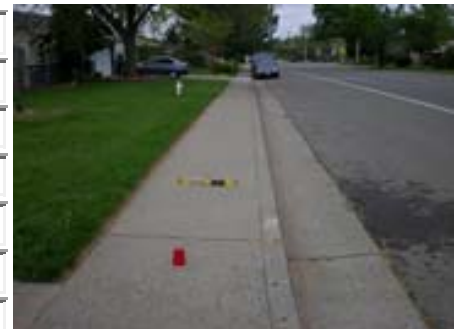
Field Date:	4/19/2011	Report Date:	4/19/2011	Barrier #:	7098
Location:	Oak Ave - South				
X Coordinate:	-121.26678				
Y Coordinate:	38.70033				
Barrier Area:	Sidewalks				
Barrier Type:	Cross Slope - Existing (4.1% to 4.9%)				
Code Ref:	CBC 1133B.7.1.3 and ADA/ABA 403.3

As Built Meas:	94	Quantity:	LF
Description:	Cross slope exceeds 2.0% (4.1% to 4.9%)		
As Built Desc:	4.1% cross slope		
Solution:	Demolish existing and construct new route		
Bar. Severity:	2 Recommended	Cost Estimate:	\$11,750.00
Implementation Priority:	1	Facility Function:	
Implementation Phase:		Implementation Date:	
Official Responsible:
