DRAFT ADA TRANSITION PLAN UPDATE
NEIGHBORHOOD AREA 9 SONA
SEPTEMBER 20, 2011

CITY OF CITRUS HEIGHTS

The Sunrise Oaks Neighborhood Association (SONA)

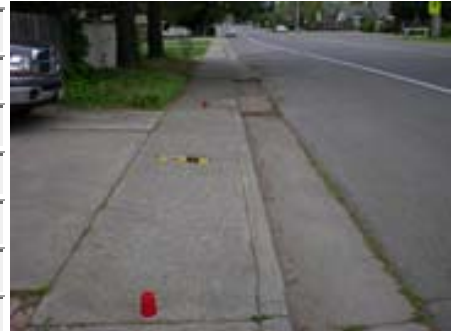
Field Date:	4/19/2011	Report Date:	4/19/2011	Barrier #:	7099
Location:	Oak Ave - South				
X Coordinate:	-121.26713				
Y Coordinate:	38.70032				
Barrier Area:	Sidewalks				
Barrier Type:	Driveway - Existing (5.0% or more)				
Code Ref:	CBC 1133B.7.1.3 and ADA/ABA 403.3

As Built Meas:	21	Quantity:	LF
Description:	Driveway cross slope exceeds 2.0% (5.0% or more)		
As Built Desc:	11.6% cross slope, 13.8% running slope		
Solution:	Provide min. 48" wide level walkway through driveway		
Bar. Severity:	1 Necessary	Cost Estimate:	\$2,625.00
Implementation Priority:	1	Facility Function:	
Implementation Phase:		Implementation Date:	
Official Responsible:

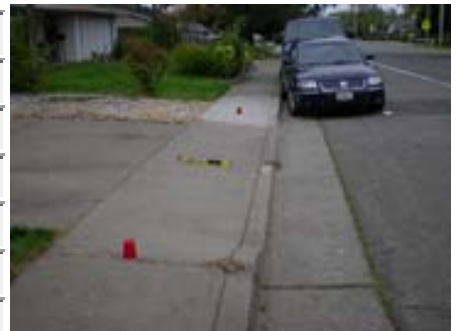
Field Date:	4/19/2011	Report Date:	4/19/2011	Barrier #:	7100
Location:	Oak Ave - South				
X Coordinate:	-121.26738				
Y Coordinate:	38.70031				
Barrier Area:	Sidewalks				
Barrier Type:	Driveway - Existing (5.0% or more)				
Code Ref:	CBC 1133B.7.1.3 and ADA/ABA 403.3

As Built Meas:	24	Quantity:	LF
Description:	Driveway cross slope exceeds 2.0% (5.0% or more)		
As Built Desc:	11.0% cross slope, 12.0% running slope		
Solution:	Provide min. 48" wide level walkway through driveway		
Bar. Severity:	1 Necessary	Cost Estimate:	\$3,000.00
Implementation Priority:	1	Facility Function:	
Implementation Phase:		Implementation Date:	
Official Responsible:

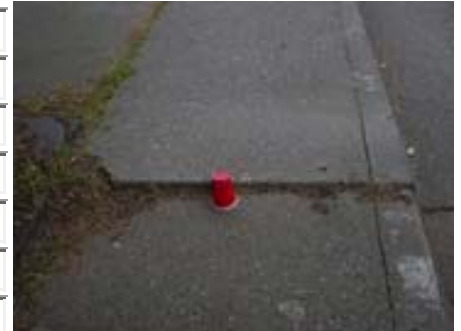
Field Date:	4/19/2011	Report Date:	4/19/2011	Barrier #:	7101
Location:	Oak Ave - South				
X Coordinate:	-121.26746				
Y Coordinate:	38.70031				
Barrier Area:	Sidewalks				
Barrier Type:	Abrupt Change in Level - > 1/2"				
Code Ref:	CBC 1133B.7.1 and ADA/ABA 303.3

As Built Meas:	4	Quantity:	LF
Description:	Change in level greater than 1/2"		
As Built Desc:	1/2" lip in sidewalk surface		
Solution:	Grind or repair sidewalk to remove trip hazard		
Bar. Severity:	1 Necessary	Cost Estimate:	\$1,000.00
Implementation Priority:	1	Facility Function:	
Implementation Phase:		Implementation Date:	
Official Responsible:			
Notes:

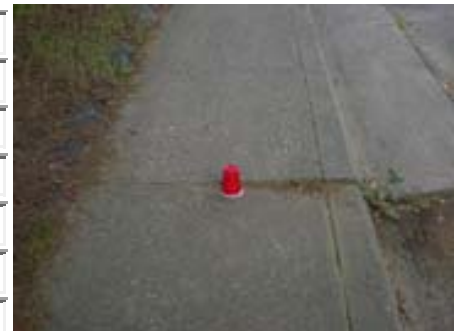
Field Date:	4/19/2011	Report Date:	4/19/2011	Barrier #:	7102
Location:	Oak Ave - South				
X Coordinate:	-121.26757				
Y Coordinate:	38.70032				
Barrier Area:	Sidewalks				
Barrier Type:	Abrupt Change in Level - > 1/2"				
Code Ref:	CBC 1133B.7.1 and ADA/ABA 303.3

As Built Meas:	4	Quantity:	LF
Description:	Change in level greater than 1/2"		
As Built Desc:	1/2" lip in sidewalk surface		
Solution:	Grind or repair sidewalk to remove trip hazard		
Bar. Severity:	1 Necessary	Cost Estimate:	\$1,000.00
Implementation Priority:	1	Facility Function:	
Implementation Phase:		Implementation Date:	
Official Responsible:			
Notes:

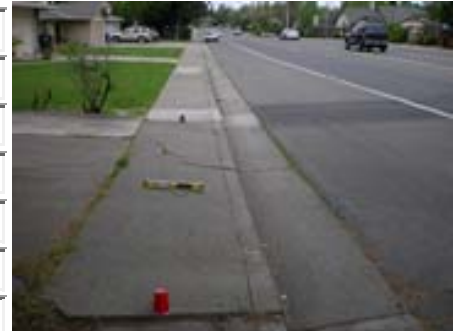
Field Date:	4/19/2011	Report Date:	4/19/2011	Barrier #:	7103
Location:	Oak Ave - South				
X Coordinate:	-121.26767				
Y Coordinate:	38.70031				
Barrier Area:	Sidewalks				
Barrier Type:	Cross Slope - Existing (5.0% or more)				
Code Ref:	CBC 1133B.7.1.3 and ADA/ABA 403.3

As Built Meas:	21	Quantity:	LF
Description:	Cross slope exceeds 2.0% (5.0% or more)		
As Built Desc:	10.8% cross slope, 15.4% running slope		
Solution:	Demolish existing and construct new route		
Bar. Severity:	1 Necessary	Cost Estimate:	\$2,625.00
Implementation Priority:	1	Facility Function:	
Implementation Phase:		Implementation Date:	
Official Responsible:

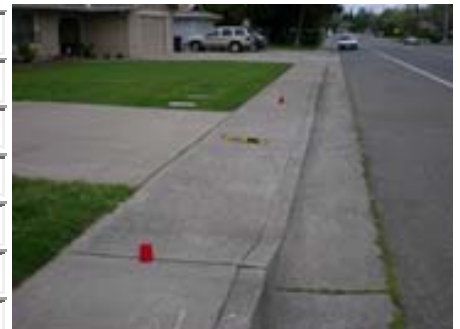
Field Date:	4/19/2011	Report Date:	4/19/2011	Barrier #:	7104
Location:	Oak Ave - South				
X Coordinate:	-121.26791				
Y Coordinate:	38.70029				
Barrier Area:	Sidewalks				
Barrier Type:	Driveway - Existing (5.0% or more)				
Code Ref:	CBC 1133B.7.1.3 and ADA/ABA 403.3

As Built Meas:	24	Quantity:	LF
Description:	Driveway cross slope exceeds 2.0% (5.0% or more)		
As Built Desc:	9.8% cross slope, 13.6% running slope		
Solution:	Provide min. 48" wide level walkway through driveway		
Bar. Severity:	1 Necessary	Cost Estimate:	\$3,000.00
Implementation Priority:	1	Facility Function:	
Implementation Phase:		Implementation Date:	
Official Responsible:

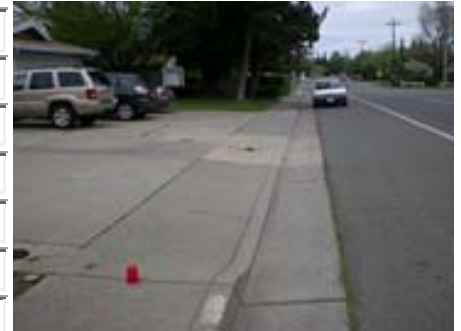
Field Date:	4/19/2011	Report Date:	4/19/2011	Barrier #:	7105
Location:	Oak Ave - South				
X Coordinate:	-121.26816				
Y Coordinate:	38.7003				
Barrier Area:	Sidewalks				
Barrier Type:	Driveway - Existing (5.0% or more)				
Code Ref:	CBC 1133B.7.1.3 and ADA/ABA 403.3

As Built Meas:	60	Quantity:	LF
Description:	Driveway cross slope exceeds 2.0% (5.0% or more)		
As Built Desc:	11.4% cross slope, 13.8% running slope		
Solution:	Provide min. 48" wide level walkway through driveway		
Bar. Severity:	1 Necessary	Cost Estimate:	\$7,500.00
Implementation Priority:	1	Facility Function:	
Implementation Phase:		Implementation Date:	
Official Responsible:

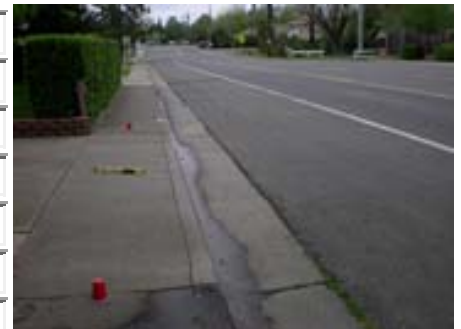
Field Date:	4/19/2011	Report Date:	4/19/2011	Barrier #:	7106
Location:	Oak Ave - South				
X Coordinate:	-121.26845				
Y Coordinate:	38.7003				
Barrier Area:	Sidewalks				
Barrier Type:	Driveway - Existing (5.0% or more)				
Code Ref:	CBC 1133B.7.1.3 and ADA/ABA 403.3

As Built Meas:	22	Quantity:	LF
Description:	Driveway cross slope exceeds 2.0% (5.0% or more)		
As Built Desc:	9.8% cross slope, 11.8% running slope		
Solution:	Provide min. 48" wide level walkway through driveway		
Bar. Severity:	1 Necessary	Cost Estimate:	\$2,750.00
Implementation Priority:	1	Facility Function:	
Implementation Phase:		Implementation Date:	
Official Responsible:

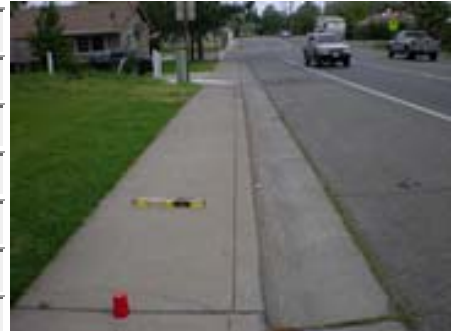
Field Date:	4/19/2011	Report Date:	4/19/2011	Barrier #:	7107
Location:	Oak Ave - South				
X Coordinate:	-121.26869				
Y Coordinate:	38.7003				
Barrier Area:	Sidewalks				
Barrier Type:	Driveway - Existing (5.0% or more)				
Code Ref:	CBC 1133B.7.1.3 and ADA/ABA 403.3

As Built Meas:	22	Quantity:	LF
Description:	Driveway cross slope exceeds 2.0% (5.0% or more)		
As Built Desc:	11.9% cross slope, 15.6% running slope		
Solution:	Provide min. 48" wide level walkway through driveway		
Bar. Severity:	1 Necessary	Cost Estimate:	\$2,750.00
Implementation Priority:	1	Facility Function:	
Implementation Phase:		Implementation Date:	
Official Responsible:

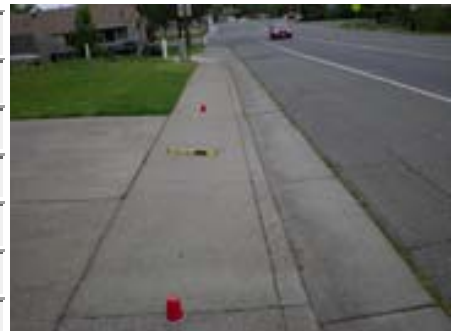
Field Date:	4/19/2011	Report Date:	4/19/2011	Barrier #:	7108
Location:	Oak Ave - South				
X Coordinate:	-121.2688				
Y Coordinate:	38.7003				
Barrier Area:	Sidewalks				
Barrier Type:	Cross Slope - Existing (3.1% to 4.0%)				
Code Ref:	CBC 1133B.7.1.3 and ADA/ABA 403.3

As Built Meas:	53	Quantity:	LF
Description:	Cross slope exceeds 2.0% (3.1% to 4.0%)		
As Built Desc:	3.5% cross slope		
Solution:	Demolish existing and construct new route		
Bar. Severity:	3 Hindrance	Cost Estimate:	\$6,625.00
Implementation Priority:	1	Facility Function:	
Implementation Phase:		Implementation Date:	
Official Responsible:

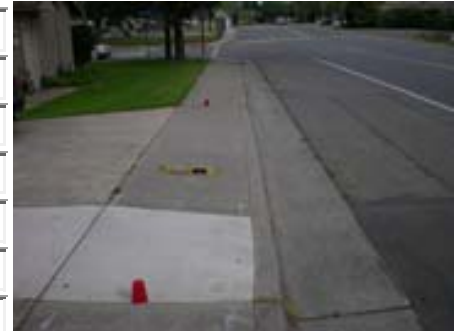
Field Date:	4/19/2011	Report Date:	4/19/2011	Barrier #:	7109
Location:	Oak Ave - South				
X Coordinate:	-121.269				
Y Coordinate:	38.70029				
Barrier Area:	Sidewalks				
Barrier Type:	Driveway - Existing (5.0% or more)				
Code Ref:	CBC 1133B.7.1.3 and ADA/ABA 403.3

As Built Meas:	24	Quantity:	LF
Description:	Driveway cross slope exceeds 2.0% (5.0% or more)		
As Built Desc:	10.4% cross slope		
Solution:	Provide min. 48" wide level walkway through driveway		
Bar. Severity:	4 Low Severity	Cost Estimate:	\$3,000.00
Implementation Priority:	1	Facility Function:	
Implementation Phase:		Implementation Date:	
Official Responsible:

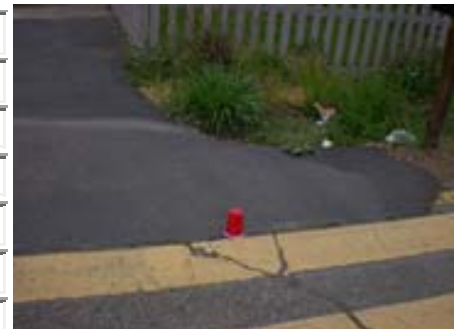
Field Date:	4/19/2011	Report Date:	4/19/2011	Barrier #:	7110
Location:	Oak Ave and Canelo Hills Dr -Corner A				
X Coordinate:	-121.26949				
Y Coordinate:	38.7004				
Barrier Area:	Blended Transitions				
Barrier Type:	Detectable Warnings - Truncated Domes				
Code Ref:	CBC 1127B.5.3

As Built Meas:	1	Quantity:	EACH
Description:	No truncated domes provided at transition into roadway		
As Built Desc:	No detectable warning provided		
Solution:	Provide compliant truncated domes		
Bar. Severity:	2 Recommended	Cost Estimate:	\$1,400.00
Implementation Priority:	1	Facility Function:	
Implementation Phase:		Implementation Date:	
Official Responsible:

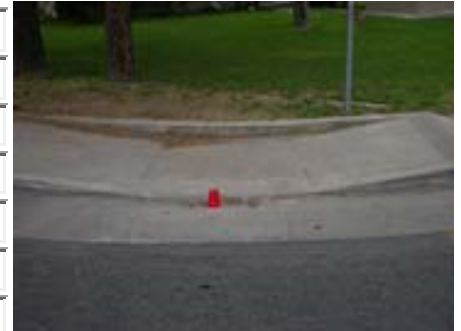
Field Date:	4/19/2011	Report Date:	4/19/2011	Barrier #:	7111A
Location:	Oak Ave and Canelo Hills Dr -Corner C				
X Coordinate:	-121.26927				
Y Coordinate:	38.70023				
Barrier Area:	Curb Ramps				
Barrier Type:	12" Grooves - Existing (>5.0%)				
Code Ref:	CBC 1127B.5.6

As Built Meas:	1	Quantity:	EACH
Description:	12" grooves at top of curb ramp are not level (>5.0%)		
As Built Desc:	5.8% at 12" grooves		
Solution:	Demolish existing and construct new curb ramp		
Bar. Severity:	1 Necessary	Cost Estimate:	\$2,500.00
Implementation Priority:	1	Facility Function:	
Implementation Phase:		Implementation Date:	
Official Responsible:			
Notes:	Three - way intersection corners A,C,D

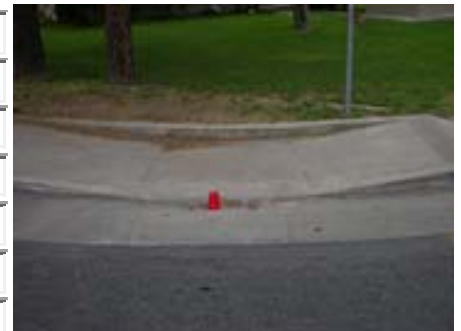
Field Date:	4/19/2011	Report Date:	4/19/2011	Barrier #:	7111B
Location:	Oak Ave and Canelo Hills Dr -Corner C				
X Coordinate:	-121.26927				
Y Coordinate:	38.70023				
Barrier Area:	Curb Ramps				
Barrier Type:	Detectable Warnings - Truncated Domes				
Code Ref:	CBC 1127B.5.7 and ADA/ABA 705.1.3

As Built Meas:	1	Quantity:	EACH
Description:	No truncated domes provided at curb ramp		
As Built Desc:	No detectable warnings at curb ramp		
Solution:	Provide compliant truncated domes		
Bar. Severity:	2 Recommended	Cost Estimate:	\$0.00
Implementation Priority:	1	Facility Function:	
Implementation Phase:		Implementation Date:	
Official Responsible:			
Notes:	Three - way intersection corners A,C,D

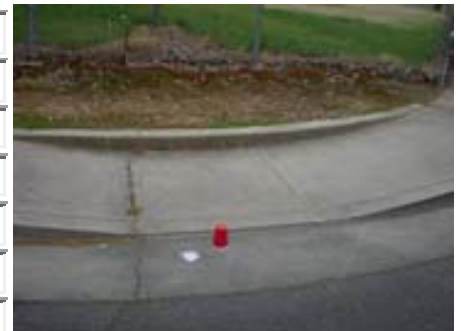
Field Date:	4/19/2011	Report Date:	4/19/2011	Barrier #:	7112
Location:	Oak Ave and Canelo Hills Dr -Corner D				
X Coordinate:	-121.26947				
Y Coordinate:	38.70025				
Barrier Area:	Curb Ramps				
Barrier Type:	Detectable Warnings - Truncated Domes				
Code Ref:	CBC 1127B.5.7 and ADA/ABA 705.1.3

As Built Meas:	1	Quantity:	EACH
Description:	No truncated domes provided at curb ramp		
As Built Desc:	No detectable warnings at curb ramp		
Solution:	Provide compliant truncated domes		
Bar. Severity:	2 Recommended	Cost Estimate:	\$1,400.00
Implementation Priority:	1	Facility Function:	
Implementation Phase:		Implementation Date:	
Official Responsible:			
Notes:	Three - way intersection corners A,C,D

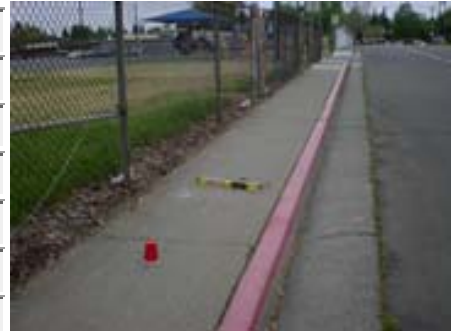
Field Date:	4/19/2011	Report Date:	4/19/2011	Barrier #:	7113
Location:	Oak Ave - South				
X Coordinate:	-121.26955				
Y Coordinate:	38.70026				
Barrier Area:	Sidewalks				
Barrier Type:	Cross Slope - Existing (4.1% to 4.9%)				
Code Ref:	CBC 1133B.7.1.3 and ADA/ABA 403.3

As Built Meas:	80	Quantity:	LF
Description:	Cross slope exceeds 2.0% (4.1% to 4.9%)		
As Built Desc:	4.5% cross slope		
Solution:	Demolish existing and construct new route		
Bar. Severity:	2 Recommended	Cost Estimate:	\$10,000.00
Implementation Priority:	1	Facility Function:	
Implementation Phase:		Implementation Date:	
Official Responsible:

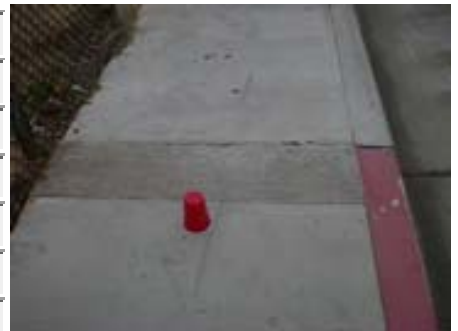
Field Date:	4/19/2011	Report Date:	4/19/2011	Barrier #:	7114
Location:	Oak Ave - South				
X Coordinate:	-121.26985				
Y Coordinate:	38.70027				
Barrier Area:	Sidewalks				
Barrier Type:	Driveway -12" Grooves Incorrect Application				
Code Ref:	CBC 1127B.5.6

As Built Meas:	1	Quantity:	JOB
Description:	12" grooves required only at curb ramps identified at transition into driveway		
As Built Desc:	12" grooves incorrectly provided where no curb ramp exists		
Solution:	No remediation recommended, until new construction is performed in area		
Bar. Severity:	4 Low Severity	Cost Estimate:	\$0.00
Implementation Priority:	1	Facility Function:	
Implementation Phase:		Implementation Date:	
Official Responsible:

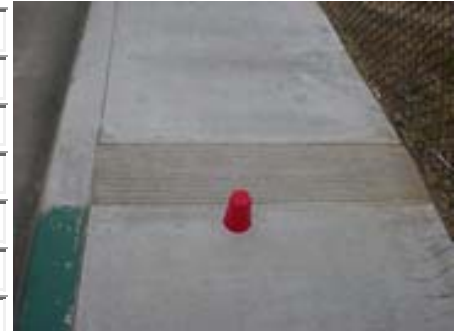
Field Date:	4/19/2011	Report Date:	4/19/2011	Barrier #:	7115
Location:	Oak Ave - South				
X Coordinate:	-121.26999				
Y Coordinate:	38.70026				
Barrier Area:	Sidewalks				
Barrier Type:	Driveway -12" Grooves Incorrect Application				
Code Ref:	CBC 1127B.5.6

As Built Meas:	1	Quantity:	JOB
Description:	12" grooves required only at curb ramps identified at transition into driveway		
As Built Desc:	12" grooves incorrectly provided where no curb ramp exists		
Solution:	No remediation recommended, until new construction is performed in area		
Bar. Severity:	4 Low Severity	Cost Estimate:	\$0.00
Implementation Priority:	1	Facility Function:	
Implementation Phase:		Implementation Date:	
Official Responsible:

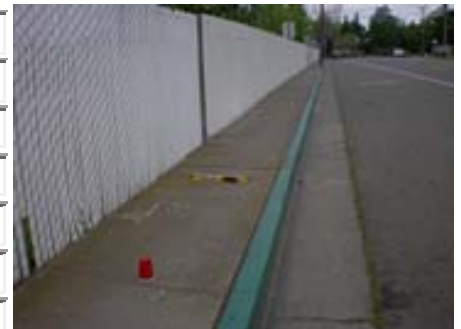
Field Date:	4/19/2011	Report Date:	4/19/2011	Barrier #:	7116A
Location:	Oak Ave - South				
X Coordinate:	-121.27002				
Y Coordinate:	38.70026				
Barrier Area:	Sidewalks				
Barrier Type:	Cross Slope - Existing (4.1% to 4.9%)				
Code Ref:	CBC 1133B.7.1.3 and ADA/ABA 403.3

As Built Meas:	454	Quantity:	LF
Description:	Cross slope exceeds 2.0% (4.1% to 4.9%)		
As Built Desc:	4.3% cross slope		
Solution:	Demolish existing and construct new route		
Bar. Severity:	2 Recommended	Cost Estimate:	\$56,750.00
Implementation Priority:	1	Facility Function:	
Implementation Phase:		Implementation Date:	
Official Responsible:

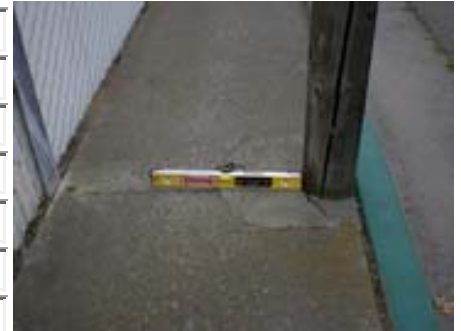
Field Date:	4/19/2011	Report Date:	4/19/2011	Barrier #:	7116B
Location:	Oak Ave - South				
X Coordinate:	-121.27049				
Y Coordinate:	38.70027				
Barrier Area:	Sidewalks				
Barrier Type:	Clear Width - Existing ($\leq 31"$ or less)				
Code Ref:	CBC 1133B.7.1

As Built Meas:	2	Quantity:	LF
Description:	Pedestrian route is not min. 48" wide ($\leq 31"$ or less)		
As Built Desc:	24" clear width due to pole		
Solution:	Demolish existing and construct new route		
Bar. Severity:	1 Necessary	Cost Estimate:	\$250.00
Implementation Priority:	1	Facility Function:	
Implementation Phase:		Implementation Date:	
Official Responsible:			
Notes:

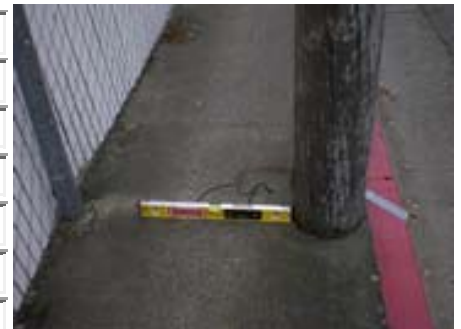
Field Date:	4/19/2011	Report Date:	4/19/2011	Barrier #:	7116C
Location:	Oak Ave - South				
X Coordinate:	-121.27092				
Y Coordinate:	38.70026				
Barrier Area:	Sidewalks				
Barrier Type:	Clear Width - Existing ($\leq 31"$ or less)				
Code Ref:	CBC 1133B.7.1

As Built Meas:	2	Quantity:	LF
Description:	Pedestrian route is not min. 48" wide ($\leq 31"$ or less)		
As Built Desc:	24" clear width due to pole		
Solution:	Demolish existing and construct new route		
Bar. Severity:	1 Necessary	Cost Estimate:	\$250.00
Implementation Priority:	1	Facility Function:	
Implementation Phase:		Implementation Date:	
Official Responsible:			
Notes:

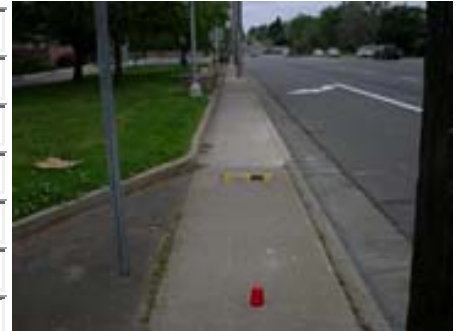
Barrier Type: Cross Slope - Existing (4.1% to 4.9%)

Code Ref: CBC 1133B.7.1.3 and ADA/ABA 403.3

As Built Meas: 139 Quantity: LF

Description: Cross slope exceeds 2.0% (4.1% to 4.9%)

Bar. Severity: 2 Recommended Cost Estimate: \$17,375.00 Status:

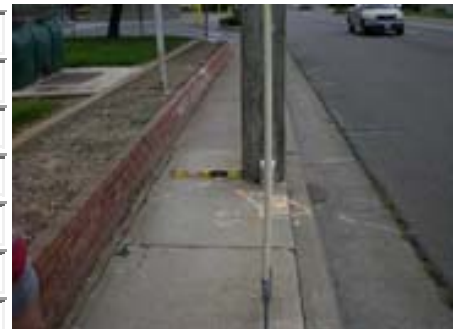
Barrier Type: Clear Width - Existing ($\leq 31"$ or less)

Code Ref: CBC 1133B.7.1

As Built Meas: 8 Quantity: LF

Description: Pedestrian route is not min. 48" wide ($\leq 31"$ or less)

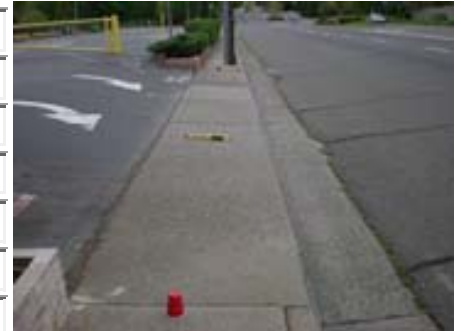
Field Date:	4/19/2011	Report Date:	4/19/2011	Barrier #:	7119
Location:	Sunrise Blvd - East				
X Coordinate:	-121.27167				
Y Coordinate:	38.69971				
Barrier Area:	Sidewalks				
Barrier Type:	Driveway - Existing (5.0% or more)				
Code Ref:	CBC 1133B.7.1.3 and ADA/ABA 403.3

As Built Meas:	40	Quantity:	LF
Description:	Driveway cross slope exceeds 2.0% (5.0% or more)		
As Built Desc:	12.9% cross slope, 13.4% running slope		
Solution:	Provide min. 48" wide level walkway through driveway		
Bar. Severity:	1 Necessary	Cost Estimate:	\$5,000.00
Implementation Priority:	1	Facility Function:	
Implementation Phase:		Implementation Date:	
Official Responsible:

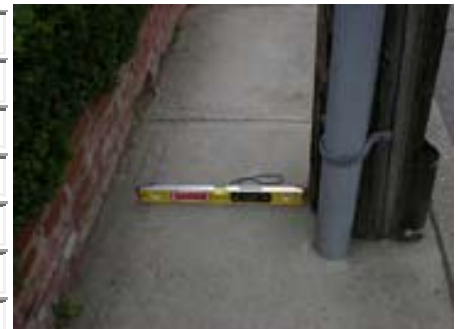
Field Date:	4/19/2011	Report Date:	4/19/2011	Barrier #:	7120
Location:	Sunrise Blvd - East				
X Coordinate:	-121.27168				
Y Coordinate:	38.69961				
Barrier Area:	Sidewalks				
Barrier Type:	Clear Width - Existing ($\leq 31"$ or less)				
Code Ref:	CBC 1133B.7.1

As Built Meas:	2	Quantity:	LF
Description:	Pedestrian route is not min. 48" wide ($\leq 31"$ or less)		
As Built Desc:	24" clear width due to pole		
Solution:	Demolish existing and construct new route		
Bar. Severity:	1 Necessary	Cost Estimate:	\$250.00
Implementation Priority:	1	Facility Function:	
Implementation Phase:		Implementation Date:	
Official Responsible:

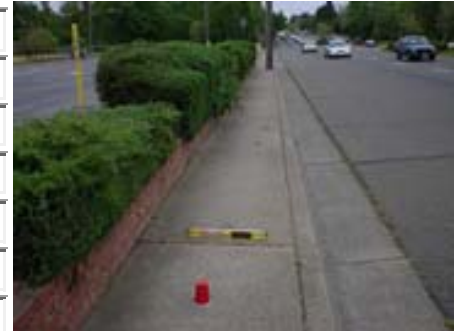
Field Date:	4/19/2011	Report Date:	4/19/2011	Barrier #:	7121A
Location:	Sunrise Blvd - East				
X Coordinate:	-121.27166				
Y Coordinate:	38.69957				
Barrier Area:	Sidewalks				
Barrier Type:	Cross Slope - Existing (4.1% to 4.9%)				
Code Ref:	CBC 1133B.7.1.3 and ADA/ABA 403.3

As Built Meas:	112	Quantity:	LF
Description:	Cross slope exceeds 2.0% (4.1% to 4.9%)		
As Built Desc:	4.4% cross slope		
Solution:	Demolish existing and construct new route		
Bar. Severity:	2 Recommended	Cost Estimate:	\$14,000.00
Implementation Priority:	1	Facility Function:	
Implementation Phase:		Implementation Date:	
Official Responsible:

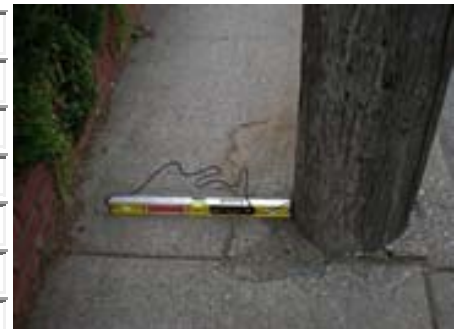
Field Date:	4/19/2011	Report Date:	4/19/2011	Barrier #:	7121B
Location:	Sunrise Blvd - East				
X Coordinate:	-121.27166				
Y Coordinate:	38.69937				
Barrier Area:	Sidewalks				
Barrier Type:	Clear Width - Existing ($\leq 31"$ or less)				
Code Ref:	CBC 1133B.7.1

As Built Meas:	2	Quantity:	LF
Description:	Pedestrian route is not min. 48" wide ($\leq 31"$ or less)		
As Built Desc:	24" clear width due to pole		
Solution:	Demolish existing and construct new route		
Bar. Severity:	1 Necessary	Cost Estimate:	\$250.00
Implementation Priority:	1	Facility Function:	
Implementation Phase:		Implementation Date:	
Official Responsible:

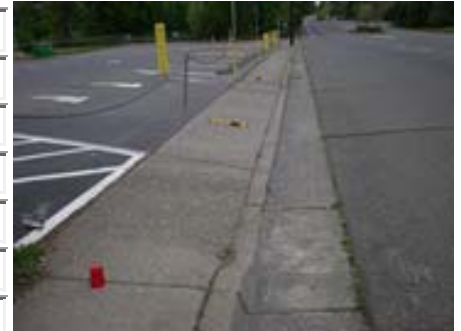
Field Date:	4/19/2011	Report Date:	4/19/2011	Barrier #:	7122
Location:	Sunrise Blvd - East				
X Coordinate:	-121.27164				
Y Coordinate:	38.69924				
Barrier Area:	Sidewalks				
Barrier Type:	Driveway - Existing (5.0% or more)				
Code Ref:	CBC 1133B.7.1.3 and ADA/ABA 403.3

As Built Meas:	40	Quantity:	LF
Description:	Driveway cross slope exceeds 2.0% (5.0% or more)		
As Built Desc:	16.7% cross slope, 8.9% running slope		
Solution:	Provide min. 48" wide level walkway through driveway		
Bar. Severity:	1 Necessary	Cost Estimate:	\$5,000.00
Implementation Priority:	1	Facility Function:	
Implementation Phase:		Implementation Date:	
Official Responsible:			
Notes:

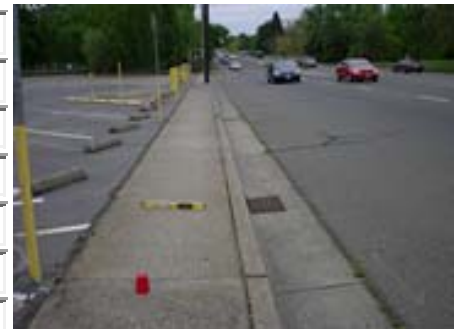
Field Date:	4/19/2011	Report Date:	4/19/2011	Barrier #:	7123
Location:	Sunrise Blvd - East				
X Coordinate:	-121.27165				
Y Coordinate:	38.69919				
Barrier Area:	Sidewalks				
Barrier Type:	Cross Slope - Existing (4.1% to 4.9%)				
Code Ref:	CBC 1133B.7.1.3 and ADA/ABA 403.3

As Built Meas:	77	Quantity:	LF
Description:	Cross slope exceeds 2.0% (4.1% to 4.9%)		
As Built Desc:	4.2% cross slope		
Solution:	Demolish existing and construct new route		
Bar. Severity:	2 Recommended	Cost Estimate:	\$9,625.00
Implementation Priority:	1	Facility Function:	
Implementation Phase:		Implementation Date:	
Official Responsible:			
Notes:

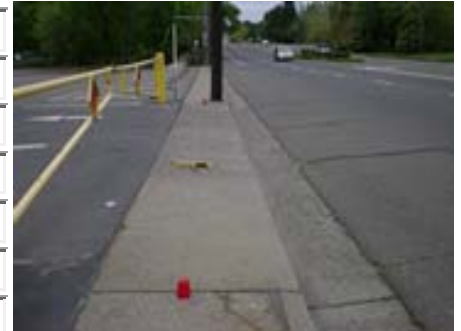
Field Date:	4/19/2011	Report Date:	4/19/2011	Barrier #:	7124
Location:	Sunrise Blvd - East				
X Coordinate:	-121.27164				
Y Coordinate:	38.69892				
Barrier Area:	Sidewalks				
Barrier Type:	Driveway - Existing (5.0% or more)				
Code Ref:	CBC 1133B.7.1.3 and ADA/ABA 403.3

As Built Meas:	40	Quantity:	LF
Description:	Driveway cross slope exceeds 2.0% (5.0% or more)		
As Built Desc:	11.7% cross slope, 11.7% running slope		
Solution:	Provide min. 48" wide level walkway through driveway		
Bar. Severity:	1 Necessary	Cost Estimate:	\$5,000.00
Implementation Priority:	1	Facility Function:	
Implementation Phase:		Implementation Date:	
Official Responsible:			
Notes:

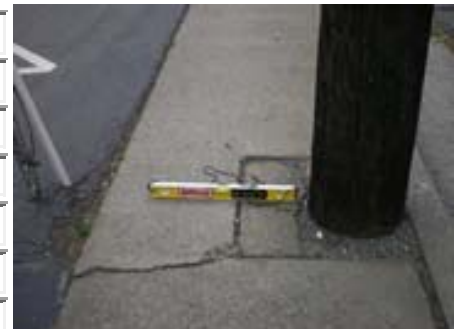
Field Date:	4/19/2011	Report Date:	4/19/2011	Barrier #:	7125
Location:	Sunrise Blvd - East				
X Coordinate:	-121.27164				
Y Coordinate:	38.69887				
Barrier Area:	Sidewalks				
Barrier Type:	Clear Width - Existing ($\leq 31"$ or less)				
Code Ref:	CBC 1133B.7.1

As Built Meas:	2	Quantity:	LF
Description:	Pedestrian route is not min. 48" wide ($\leq 31"$ or less)		
As Built Desc:	24" clear width due to pole		
Solution:	Demolish existing and construct new route		
Bar. Severity:	1 Necessary	Cost Estimate:	\$250.00
Implementation Priority:	1	Facility Function:	
Implementation Phase:		Implementation Date:	
Official Responsible:			
Notes:

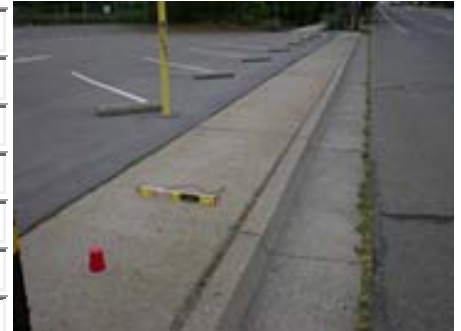
Field Date:	4/19/2011	Report Date:	4/19/2011	Barrier #:	7126
Location:	Sunrise Blvd - East				
X Coordinate:	-121.27164				
Y Coordinate:	38.69885				
Barrier Area:	Sidewalks				
Barrier Type:	Cross Slope - Existing (3.1% to 4.0%)				
Code Ref:	CBC 1133B.7.1.3 and ADA/ABA 403.3

As Built Meas:	133	Quantity:	LF
Description:	Cross slope exceeds 2.0% (3.1% to 4.0%)		
As Built Desc:	3.5% cross slope		
Solution:	Demolish existing and construct new route		
Bar. Severity:	3 Hindrance	Cost Estimate:	\$16,625.00
Implementation Priority:	1	Facility Function:	
Implementation Phase:		Implementation Date:	
Official Responsible:

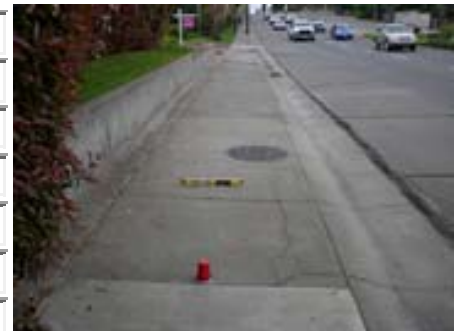
Field Date:	4/19/2011	Report Date:	4/19/2011	Barrier #:	7127
Location:	Sunrise Blvd - East				
X Coordinate:	-121.27157				
Y Coordinate:	38.69669				
Barrier Area:	Sidewalks				
Barrier Type:	Cross Slope - Existing (4.1% to 4.9%)				
Code Ref:	CBC 1133B.7.1.3 and ADA/ABA 403.3

As Built Meas:	87	Quantity:	LF
Description:	Cross slope exceeds 2.0% (4.1% to 4.9%)		
As Built Desc:	4.2% cross slope		
Solution:	Demolish existing and construct new route		
Bar. Severity:	2 Recommended	Cost Estimate:	\$10,875.00
Implementation Priority:	1	Facility Function:	
Implementation Phase:		Implementation Date:	
Official Responsible:

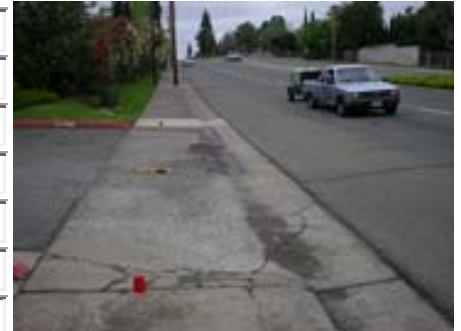
Field Date:	4/19/2011	Report Date:	4/19/2011	Barrier #:	7128
Location:	Sunrise Blvd - East				
X Coordinate:	-121.27156				
Y Coordinate:	38.69641				
Barrier Area:	Sidewalks				
Barrier Type:	Driveway - Existing (5.0% or more)				
Code Ref:	CBC 1133B.7.1.3 and ADA/ABA 403.3

As Built Meas:	35	Quantity:	LF
Description:	Driveway cross slope exceeds 2.0% (5.0% or more)		
As Built Desc:	6.9% cross slope, 9.5% running slope		
Solution:	Provide min. 48" wide level walkway through driveway		
Bar. Severity:	1 Necessary	Cost Estimate:	\$4,375.00
Implementation Priority:	1	Facility Function:	
Implementation Phase:		Implementation Date:	
Official Responsible:			
Notes:

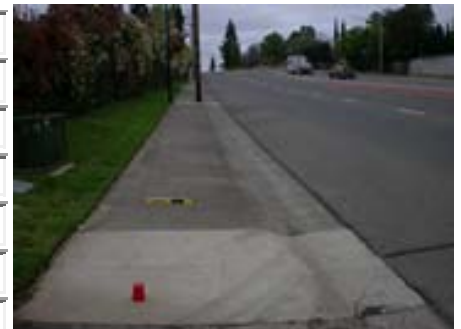
Field Date:	4/19/2011	Report Date:	4/19/2011	Barrier #:	7129
Location:	Sunrise Blvd - East				
X Coordinate:	-121.27155				
Y Coordinate:	38.69632				
Barrier Area:	Sidewalks				
Barrier Type:	Cross Slope - Existing (3.1% to 4.0%)				
Code Ref:	CBC 1133B.7.1.3 and ADA/ABA 403.3

As Built Meas:	232	Quantity:	LF
Description:	Cross slope exceeds 2.0% (3.1% to 4.0%)		
As Built Desc:	3.2% cross slope		
Solution:	Demolish existing and construct new route		
Bar. Severity:	3 Hindrance	Cost Estimate:	\$29,000.00
Implementation Priority:	1	Facility Function:	
Implementation Phase:		Implementation Date:	
Official Responsible:			
Notes:

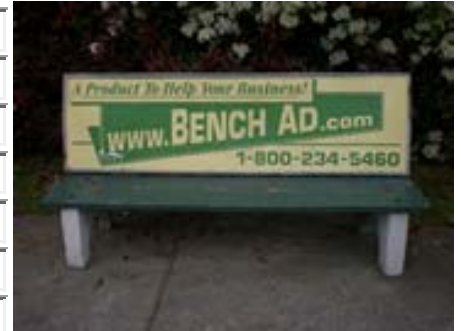
Field Date:	4/19/2011	Report Date:	4/19/2011	Barrier #:	7130A
Location:	Sunrise Blvd - East				
X Coordinate:	-121.27155				
Y Coordinate:	38.69573				
Barrier Area:	Bus Stops and Shelters				
Barrier Type:	Cross Slope - Existing (5.0% or more)				
Code Ref:	CBC 1121B.2.1 and ADAAG 10.2.1(1)

As Built Meas:	4	Quantity:	LF
Description:	Cross slope at bus pad or shelter exceeds 2.0% (5.0% or more)		
As Built Desc:	8.0% cross slope		
Solution:	Demolish existing and construct new bus pad or shelter pad		
Bar. Severity:	1 Necessary	Cost Estimate:	\$500.00
Implementation Priority:	1	Facility Function:	
Implementation Phase:		Implementation Date:	
Official Responsible:			
Notes:

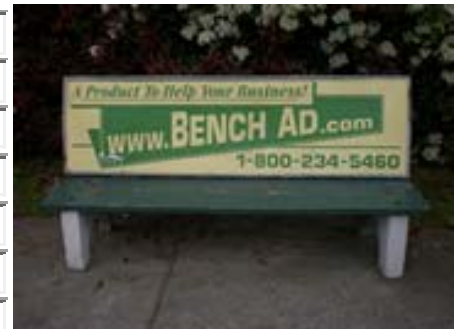
Field Date:	4/19/2011	Report Date:	4/19/2011	Barrier #:	7130B
Location:	Sunrise Blvd - East				
X Coordinate:	-121.27155				
Y Coordinate:	38.69573				
Barrier Area:	Bus Stops and Shelters				
Barrier Type:	Bench Seat Depth				
Code Ref:	ADAAG 4.37.1 and ADA/ABA 903.4

As Built Meas:	1	Quantity:	EACH
Description:	Bench seat depth not 20" - 24" deep		
As Built Desc:	18" bench seat depth		
Solution:	Provide min. 1 accessible bench at bench stop		
Bar. Severity:	3 Hindrance	Cost Estimate:	\$775.00
Implementation Priority:	1	Facility Function:	
Implementation Phase:		Implementation Date:	
Official Responsible:			
Notes:

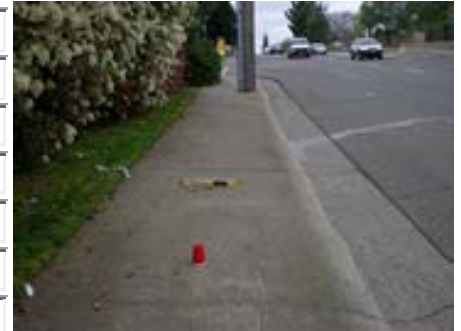
Field Date:	4/19/2011	Report Date:	4/19/2011	Barrier #:	7131
Location:	Sunrise Blvd - East				
X Coordinate:	-121.27156				
Y Coordinate:	38.69571				
Barrier Area:	Sidewalks				
Barrier Type:	Cross Slope - Existing (3.1% to 4.0%)				
Code Ref:	CBC 1133B.7.1.3 and ADA/ABA 403.3

As Built Meas:	74	Quantity:	LF
Description:	Cross slope exceeds 2.0% (3.1% to 4.0%)		
As Built Desc:	3.1% cross slope		
Solution:	Demolish existing and construct new route		
Bar. Severity:	3 Hindrance	Cost Estimate:	\$9,250.00
Implementation Priority:	1	Facility Function:	
Implementation Phase:		Implementation Date:	
Official Responsible:

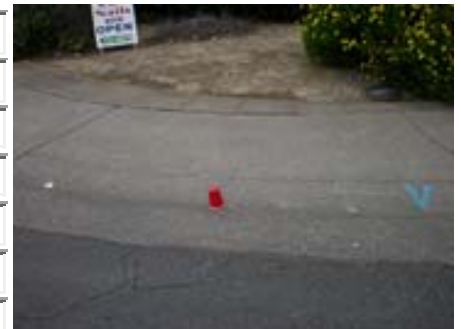
Field Date:	4/19/2011	Report Date:	4/19/2011	Barrier #:	7132
Location:	Sunrise Blvd and Sundgarden Dr - Corner B				
X Coordinate:	-121.2715				
Y Coordinate:	38.69547				
Barrier Area:	Curb Ramps				
Barrier Type:	No Curb Ramp				
Code Ref:	CBC 1127B.5.1 and ADA/ABA 402.2

As Built Meas:	1	Quantity:	EACH
Description:	No curb cut at corner (intersection)		
As Built Desc:	No curb ramp at corner		
Solution:	Demolish existing and construct curb cut		
Bar. Severity:	1 Necessary	Cost Estimate:	\$2,500.00
Implementation Priority:	1	Facility Function:	
Implementation Phase:		Implementation Date:	
Official Responsible:

Notes:	Two - way intersection corners B,C
--------	------------------------------------

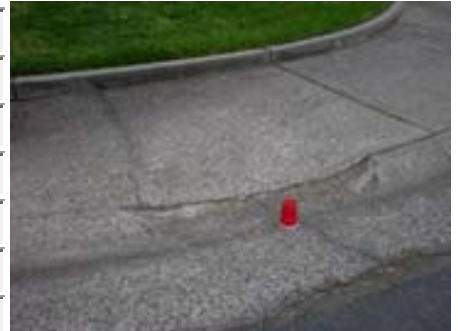
Field Date:	4/19/2011	Report Date:	4/19/2011	Barrier #:	7133
Location:	Sunrise Blvd and Sundgarden Dr - Corner C				
X Coordinate:	-121.27152				
Y Coordinate:	38.69529				
Barrier Area:	Curb Ramps				
Barrier Type:	No Curb Ramp - Depressed Existing Curb				
Code Ref:	CBC 1127B.5.1 and ADA/ABA 402.2

As Built Meas:	1	Quantity:	EACH
Description:	No compliant curb cut at corner (intersection)		
As Built Desc:	5.0% running slope at depressed area		
Solution:	Demolish existing and construct curb cut		
Bar. Severity:	1 Necessary	Cost Estimate:	\$2,500.00
Implementation Priority:	1	Facility Function:	
Implementation Phase:		Implementation Date:	
Official Responsible:			
Notes:	Two - way intersection corners B,C

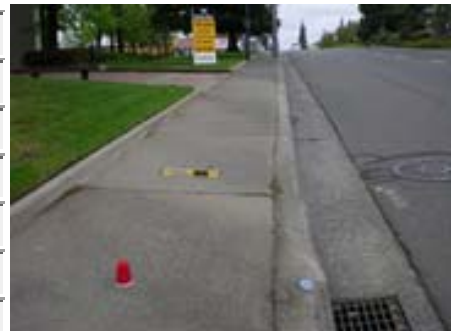
Field Date:	4/19/2011	Report Date:	4/19/2011	Barrier #:	7134
Location:	Sunrise Blvd - East				
X Coordinate:	-121.27154				
Y Coordinate:	38.69522				
Barrier Area:	Sidewalks				
Barrier Type:	Cross Slope - Existing (3.1% to 4.0%)				
Code Ref:	CBC 1133B.7.1.3 and ADA/ABA 403.3

As Built Meas:	181	Quantity:	LF
Description:	Cross slope exceeds 2.0% (3.1% to 4.0%)		
As Built Desc:	3.4% cross slope		
Solution:	Demolish existing and construct new route		
Bar. Severity:	3 Hindrance	Cost Estimate:	\$22,625.00
Implementation Priority:	1	Facility Function:	
Implementation Phase:		Implementation Date:	
Official Responsible:			
Notes:

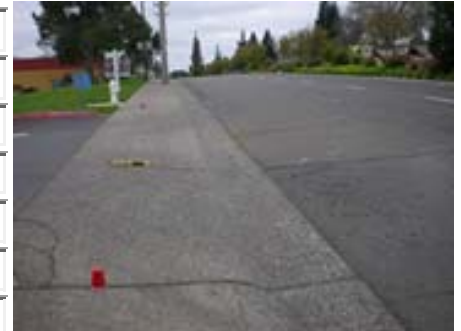
Field Date:	4/19/2011	Report Date:	4/19/2011	Barrier #:	7135
Location:	Sunrise Blvd - East				
X Coordinate:	-121.27149				
Y Coordinate:	38.6947				
Barrier Area:	Sidewalks				
Barrier Type:	Driveway - Existing (5.0% or more)				
Code Ref:	CBC 1133B.7.1.3 and ADA/ABA 403.3

As Built Meas:	40	Quantity:	LF
Description:	Driveway cross slope exceeds 2.0% (5.0% or more)		
As Built Desc:	7.5% cross slope		
Solution:	Provide min. 48" wide level walkway through driveway		
Bar. Severity:	4 Low Severity	Cost Estimate:	\$5,000.00
Implementation Priority:	1	Facility Function:	
Implementation Phase:		Implementation Date:	
Official Responsible:			
Notes:

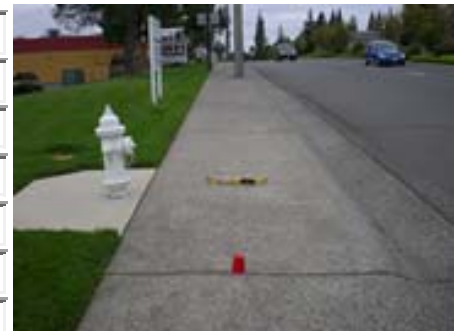
Field Date:	4/19/2011	Report Date:	4/19/2011	Barrier #:	7136
Location:	Sunrise Blvd - East				
X Coordinate:	-121.27151				
Y Coordinate:	38.69461				
Barrier Area:	Sidewalks				
Barrier Type:	Cross Slope - Existing (4.1% to 4.9%)				
Code Ref:	CBC 1133B.7.1.3 and ADA/ABA 403.3

As Built Meas:	438	Quantity:	LF
Description:	Cross slope exceeds 2.0% (4.1% to 4.9%)		
As Built Desc:	4.2% cross slope		
Solution:	Demolish existing and construct new route		
Bar. Severity:	2 Recommended	Cost Estimate:	\$54,750.00
Implementation Priority:	1	Facility Function:	
Implementation Phase:		Implementation Date:	
Official Responsible:			
Notes:

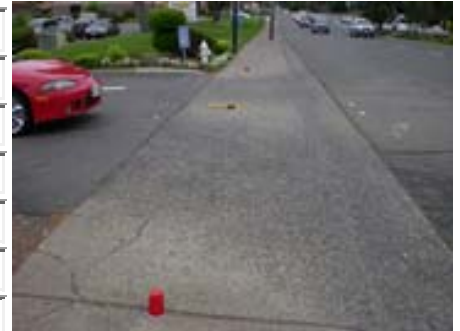
Field Date: 4/19/2011 Report Date: 4/19/2011 Barrier #: 7137

Barrier Type: Driveway - Existing (4.1% to 4.9%)

Code Ref: CBC 1133B.7.1.3 and ADA/ABA 403.3

As Built Meas: 40 Quantity: LF

Description: Driveway cross slope exceeds 2.0% (4.1% to 4.9%)

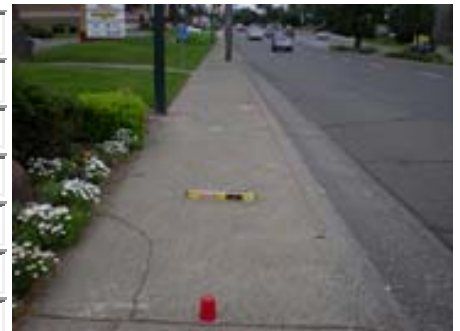
Barrier Type: Cross Slope - Existing (3.1% to 4.0%)

Code Ref: CBC 1133B.7.1.3 and ADA/ABA 403.3

As Built Meas: 233 Quantity: LF

Description: Cross slope exceeds 2.0% (3.1% to 4.0%)

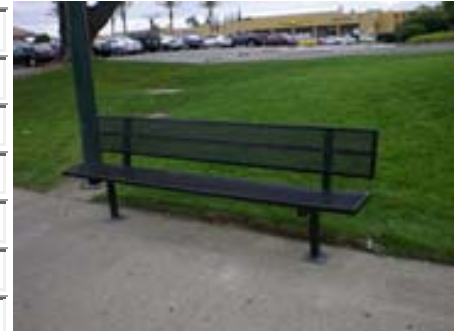
Field Date:	4/19/2011	Report Date:	4/19/2011	Barrier #:	7139A
Location:	Sunrise Blvd - East				
X Coordinate:	-121.27148				
Y Coordinate:	38.69266				
Barrier Area:	Bus Stops and Shelters				
Barrier Type:	Bench Seat Depth				
Code Ref:	ADAAG 4.37.1 and ADA/ABA 903.4

As Built Meas:	1	Quantity:	EACH
Description:	Bench seat depth not 20" - 24" deep		
As Built Desc:	12" bench seat depth		
Solution:	Provide min. 1 accessible bench at bench stop		
Bar. Severity:	3 Hindrance	Cost Estimate:	\$775.00
Implementation Priority:	1	Facility Function:	
Implementation Phase:		Implementation Date:	
Official Responsible:			
Notes:

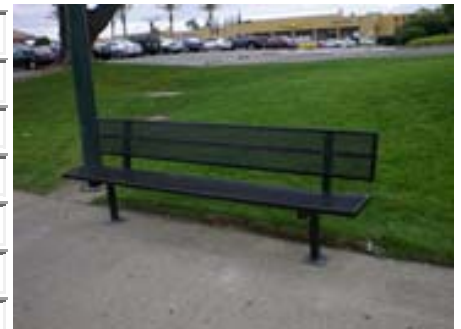
Field Date:	4/19/2011	Report Date:	4/19/2011	Barrier #:	7139B
Location:	Sunrise Blvd - East				
X Coordinate:	-121.27148				
Y Coordinate:	38.69266				
Barrier Area:	Bus Stops and Shelters				
Barrier Type:	Bench Seat Height				
Code Ref:	ADAAG 4.37.3* and ADA/ABA 903.4

As Built Meas:	1	Quantity:	EACH
Description:	Bench seat height not between 17" - 19"		
As Built Desc:	16" bench seat height		
Solution:	Provide new compliant bench or remount at compliant height where possible		
Bar. Severity:	3 Hindrance	Cost Estimate:	\$0.00
Implementation Priority:	1	Facility Function:	
Implementation Phase:		Implementation Date:	
Official Responsible:			
Notes:

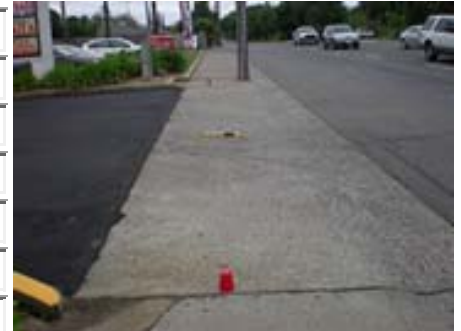
Field Date:	4/19/2011	Report Date:	4/19/2011	Barrier #:	7140
Location:	Sunrise Blvd - East				
X Coordinate:	-121.27147				
Y Coordinate:	38.69176				
Barrier Area:	Sidewalks				
Barrier Type:	Driveway - Existing (5.0% or more)				
Code Ref:	CBC 1133B.7.1.3 and ADA/ABA 403.3

As Built Meas:	40	Quantity:	LF
Description:	Driveway cross slope exceeds 2.0% (5.0% or more)		
As Built Desc:	5.3% cross slope		
Solution:	Provide min. 48" wide level walkway through driveway		
Bar. Severity:	4 Low Severity	Cost Estimate:	\$5,000.00
Implementation Priority:	1	Facility Function:	
Implementation Phase:		Implementation Date:	
Official Responsible:

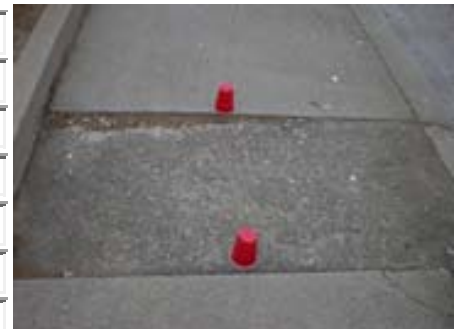
Field Date:	4/19/2011	Report Date:	4/19/2011	Barrier #:	7141
Location:	Sunrise Blvd - East				
X Coordinate:	-121.27147				
Y Coordinate:	38.69166				
Barrier Area:	Sidewalks				
Barrier Type:	Surface Condition - Damaged				
Code Ref:	CBC 1133B.7.1 and ADA/ABA 302.1

As Built Meas:	4	Quantity:	LF
Description:	Surface is not firm and stable (cracked, broken or loose soil, etc.)		
As Built Desc:	Cracked concrete		
Solution:	Repair surface to make firm and stable		
Bar. Severity:	1 Necessary	Cost Estimate:	\$500.00
Implementation Priority:	1	Facility Function:	
Implementation Phase:		Implementation Date:	
Official Responsible:

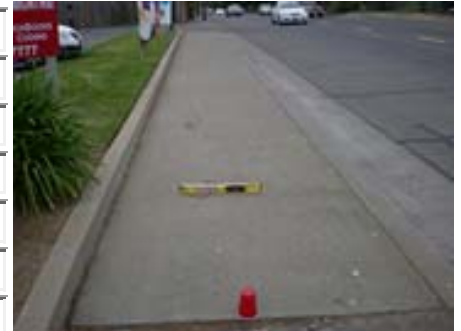
Field Date:	4/19/2011	Report Date:	4/19/2011	Barrier #:	7142
Location:	Sunrise Blvd - East				
X Coordinate:	-121.27147				
Y Coordinate:	38.69169				
Barrier Area:	Sidewalks				
Barrier Type:	Cross Slope - Existing (3.1% to 4.0%)				
Code Ref:	CBC 1133B.7.1.3 and ADA/ABA 403.3

As Built Meas:	76	Quantity:	LF
Description:	Cross slope exceeds 2.0% (3.1% to 4.0%)		
As Built Desc:	3.5% cross slope		
Solution:	Demolish existing and construct new route		
Bar. Severity:	3 Hindrance	Cost Estimate:	\$9,500.00
Implementation Priority:	1	Facility Function:	
Implementation Phase:		Implementation Date:	
Official Responsible:

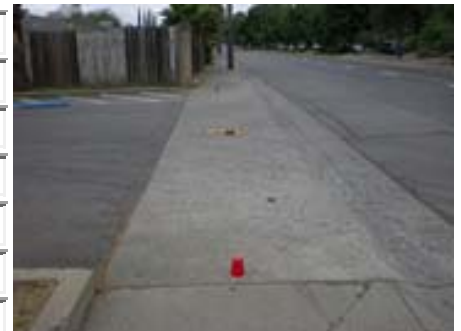
Field Date:	4/19/2011	Report Date:	4/19/2011	Barrier #:	7143
Location:	Sunrise Blvd - East				
X Coordinate:	-121.27148				
Y Coordinate:	38.69139				
Barrier Area:	Sidewalks				
Barrier Type:	Driveway - Existing (5.0% or more)				
Code Ref:	CBC 1133B.7.1.3 and ADA/ABA 403.3

As Built Meas:	40	Quantity:	LF
Description:	Driveway cross slope exceeds 2.0% (5.0% or more)		
As Built Desc:	5.5% cross slope		
Solution:	Provide min. 48" wide level walkway through driveway		
Bar. Severity:	4 Low Severity	Cost Estimate:	\$5,000.00
Implementation Priority:	1	Facility Function:	
Implementation Phase:		Implementation Date:	
Official Responsible:

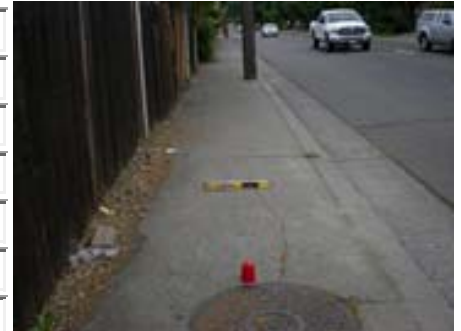
Field Date:	4/19/2011	Report Date:	4/19/2011	Barrier #:	7144A
Location:	Sunrise Blvd - East				
X Coordinate:	-121.27148				
Y Coordinate:	38.69129				
Barrier Area:	Sidewalks				
Barrier Type:	Cross Slope - Existing (3.1% to 4.0%)				
Code Ref:	CBC 1133B.7.1.3 and ADA/ABA 403.3

As Built Meas:	79	Quantity:	LF
Description:	Cross slope exceeds 2.0% (3.1% to 4.0%)		
As Built Desc:	3.5% cross slope		
Solution:	Demolish existing and construct new route		
Bar. Severity:	3 Hindrance	Cost Estimate:	\$9,875.00
Implementation Priority:	1	Facility Function:	
Implementation Phase:		Implementation Date:	
Official Responsible:

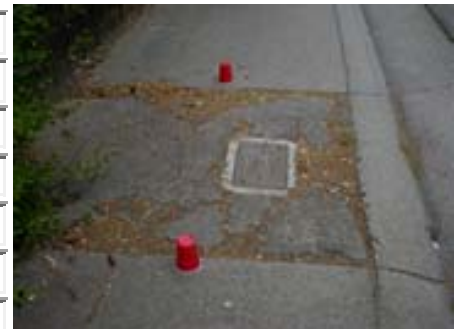
Field Date:	4/19/2011	Report Date:	4/19/2011	Barrier #:	7144B
Location:	Sunrise Blvd - East				
X Coordinate:	-121.2715				
Y Coordinate:	38.69111				
Barrier Area:	Sidewalks				
Barrier Type:	Surface Condition - Damaged				
Code Ref:	CBC 1133B.7.1 and ADA/ABA 302.1

As Built Meas:	4	Quantity:	LF
Description:	Surface is not firm and stable (cracked, broken or loose soil, etc.)		
As Built Desc:	Cracked concrete		
Solution:	Repair surface to make firm and stable		
Bar. Severity:	1 Necessary	Cost Estimate:	\$500.00
Implementation Priority:	1	Facility Function:	
Implementation Phase:		Implementation Date:	
Official Responsible:

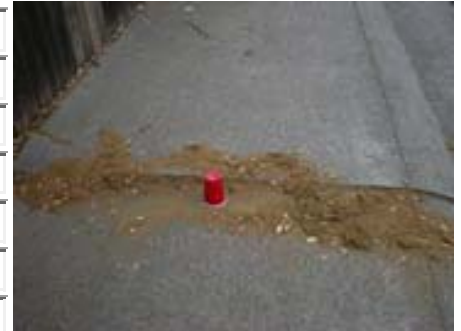
Field Date:	4/19/2011	Report Date:	4/19/2011	Barrier #:	7145
Location:	Sunrise Blvd - East				
X Coordinate:	-121.27149				
Y Coordinate:	38.69094				
Barrier Area:	Sidewalks				
Barrier Type:	Abrupt Change in Level - > 1/2"				
Code Ref:	CBC 1133B.7.1 and ADA/ABA 303.3

As Built Meas:	5	Quantity:	LF
Description:	Change in level greater than 1/2"		
As Built Desc:	1/2" lip in sidewalk surface		
Solution:	Grind or repair sidewalk to remove trip hazard		
Bar. Severity:	1 Necessary	Cost Estimate:	\$1,250.00
Implementation Priority:	1	Facility Function:	
Implementation Phase:		Implementation Date:	
Official Responsible:

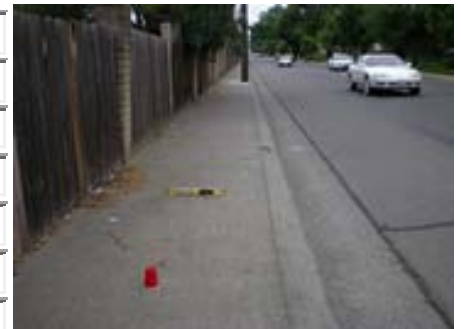
Field Date:	4/19/2011	Report Date:	4/19/2011	Barrier #:	7146A
Location:	Sunrise Blvd - East				
X Coordinate:	-121.27149				
Y Coordinate:	38.69092				
Barrier Area:	Sidewalks				
Barrier Type:	Cross Slope - Existing (4.1% to 4.9%)				
Code Ref:	CBC 1133B.7.1.3 and ADA/ABA 403.3

As Built Meas:	333	Quantity:	LF
Description:	Cross slope exceeds 2.0% (4.1% to 4.9%)		
As Built Desc:	4.8% cross slope		
Solution:	Demolish existing and construct new route		
Bar. Severity:	2 Recommended	Cost Estimate:	\$41,625.00
Implementation Priority:	1	Facility Function:	
Implementation Phase:		Implementation Date:	
Official Responsible:

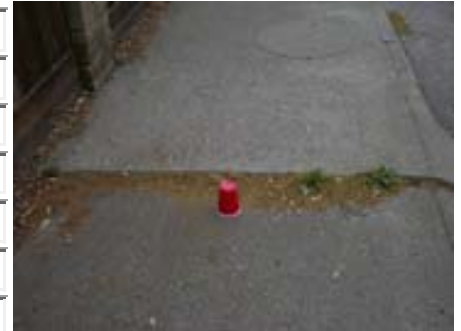
Field Date:	4/19/2011	Report Date:	4/19/2011	Barrier #:	7146B
Location:	Sunrise Blvd - East				
X Coordinate:	-121.27148				
Y Coordinate:	38.69007				
Barrier Area:	Sidewalks				
Barrier Type:	Abrupt Change in Level - > 1/2"				
Code Ref:	CBC 1133B.7.1 and ADA/ABA 303.3

As Built Meas:	5	Quantity:	LF
Description:	Change in level greater than 1/2"		
As Built Desc:	1/2" lip in sidewalk surface		
Solution:	Grind or repair sidewalk to remove trip hazard		
Bar. Severity:	1 Necessary	Cost Estimate:	\$1,250.00
Implementation Priority:	1	Facility Function:	
Implementation Phase:		Implementation Date:	
Official Responsible:

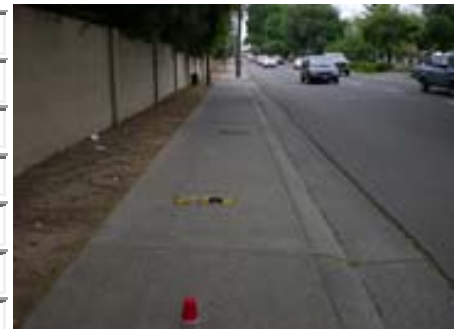
Field Date:	4/19/2011	Report Date:	4/19/2011	Barrier #:	7147
Location:	Sunrise Blvd - East				
X Coordinate:	-121.2715				
Y Coordinate:	38.68972				
Barrier Area:	Sidewalks				
Barrier Type:	Cross Slope - Existing (5.0% or more)				
Code Ref:	CBC 1133B.7.1.3 and ADA/ABA 403.3

As Built Meas:	1100	Quantity:	LF
Description:	Cross slope exceeds 2.0% (5.0% or more)		
As Built Desc:	5.0% cross slope		
Solution:	Demolish existing and construct new route		
Bar. Severity:	1 Necessary	Cost Estimate:	\$137,500.00
Implementation Priority:	1	Facility Function:	
Implementation Phase:		Implementation Date:	
Official Responsible:

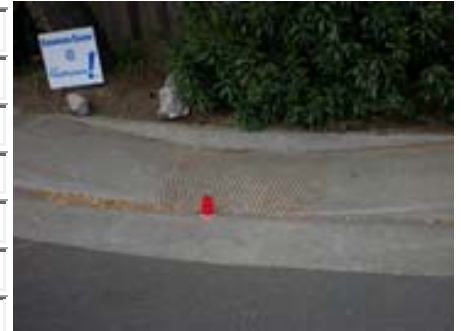
Field Date:	4/19/2011	Report Date:	4/19/2011	Barrier #:	7148A
Location:	Sunrise Blvd and Larwin Dr - Corner B				
X Coordinate:	-121.27143				
Y Coordinate:	38.68671				
Barrier Area:	Curb Ramps				
Barrier Type:	12" Grooves - Existing (>5.0%)				
Code Ref:	CBC 1127B.5.6

As Built Meas:	1	Quantity:	EACH
Description:	12" grooves at top of curb ramp are not level (>5.0%)		
As Built Desc:	6.4% at 12" grooves		
Solution:	Demolish existing and construct new curb ramp		
Bar. Severity:	1 Necessary	Cost Estimate:	\$2,500.00
Implementation Priority:	1	Facility Function:	
Implementation Phase:		Implementation Date:	
Official Responsible:			
Notes:	Two - way intersection corners B,C

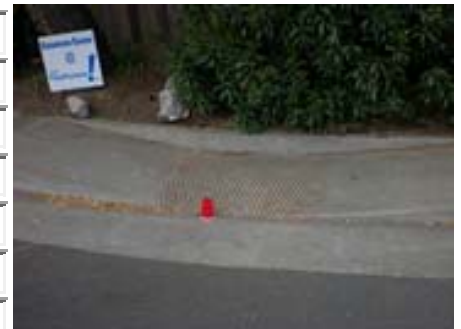
Field Date:	4/19/2011	Report Date:	4/19/2011	Barrier #:	7148B
Location:	Sunrise Blvd and Larwin Dr - Corner B				
X Coordinate:	-121.27143				
Y Coordinate:	38.68671				
Barrier Area:	Curb Ramps				
Barrier Type:	Running Slope - Existing (9.5% or more)				
Code Ref:	CBC 1127B.5.3 and ADA/ABA 406.1

As Built Meas:	1	Quantity:	EACH
Description:	Ramp run cross slope exceeds 2.0% (9.5% or more)		
As Built Desc:	15.7% running slope		
Solution:	Demolish existing and construct new curb ramp		
Bar. Severity:	1 Necessary	Cost Estimate:	\$0.00
Implementation Priority:	1	Facility Function:	
Implementation Phase:		Implementation Date:	
Official Responsible:			
Notes:	Two - way intersection corners B,C

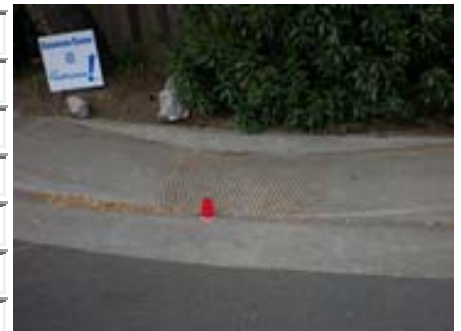
Field Date:	4/19/2011	Report Date:	4/19/2011	Barrier #:	7148D
Location:	Sunrise Blvd and Larwin Dr - Corner B				
X Coordinate:	-121.27143				
Y Coordinate:	38.68671				
Barrier Area:	Curb Ramps				
Barrier Type:	Detectable Warnings - Truncated Domes				
Code Ref:	CBC 1127B.5.7 and ADA/ABA 705.1.3

As Built Meas:	1	Quantity:	EACH
Description:	No truncated domes provided at curb ramp		
As Built Desc:	No detectable warnings at curb ramp		
Solution:	Provide compliant truncated domes		
Bar. Severity:	2 Recommended	Cost Estimate:	\$0.00
Implementation Priority:	1	Facility Function:	
Implementation Phase:		Implementation Date:	
Official Responsible:			
Notes:	Two - way intersection corners B,C

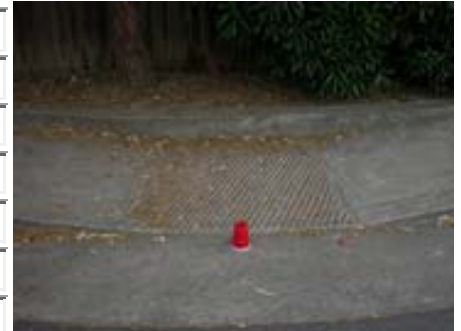
Field Date:	4/19/2011	Report Date:	4/19/2011	Barrier #:	7149A
Location:	Sunrise Blvd and Larwin Dr - Corner C				
X Coordinate:	-121.27144				
Y Coordinate:	38.68658				
Barrier Area:	Curb Ramps				
Barrier Type:	Parallel Ramp Landing - Existing (2.1% to 3.0%)				
Code Ref:	CBC 1127B.5.4 and ADA/ABA 406.4

As Built Meas:	1	Quantity:	EACH
Description:	Curb ramp landing or pan not level (2.1% to 3.0%)		
As Built Desc:	3.0% landing slope		
Solution:	Demolish existing and construct new transition		
Bar. Severity:	4 Low Severity	Cost Estimate:	\$250.00
Implementation Priority:	1	Facility Function:	
Implementation Phase:		Implementation Date:	
Official Responsible:

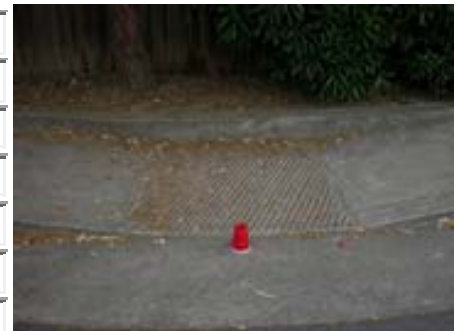
Field Date:	4/19/2011	Report Date:	4/19/2011	Barrier #:	7149B
Location:	Sunrise Blvd and Larwin Dr - Corner C				
X Coordinate:	-121.27144				
Y Coordinate:	38.68658				
Barrier Area:	Curb Ramps				
Barrier Type:	Detectable Warnings - Truncated Domes				
Code Ref:	CBC 1127B.5.7 and ADA/ABA 705.1.3

As Built Meas:	1	Quantity:	EACH
Description:	No truncated domes provided at curb ramp		
As Built Desc:	No detectable warnings at curb ramp		
Solution:	Provide compliant truncated domes		
Bar. Severity:	2 Recommended	Cost Estimate:	\$1,400.00
Implementation Priority:	1	Facility Function:	
Implementation Phase:		Implementation Date:	
Official Responsible:

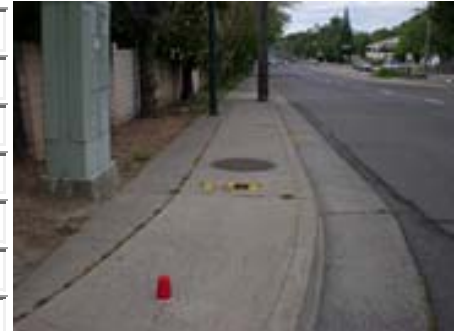
Field Date:	4/20/2011	Report Date:	4/20/2011	Barrier #:	7150
Location:	Sunrise Blvd - East				
X Coordinate:	-121.27144				
Y Coordinate:	38.68652				
Barrier Area:	Sidewalks				
Barrier Type:	Cross Slope - Existing (2.1% to 3.0%)				
Code Ref:	CBC 1133B.7.1.3 and ADA/ABA 403.3

As Built Meas:	108	Quantity:	LF
Description:	Cross slope exceeds 2.0% (2.1% to 3.0%)		
As Built Desc:	3.0% cross slope		
Solution:	Low severity barrier - no remediation recommended		
Bar. Severity:	4 Low Severity	Cost Estimate:	\$0.00
Implementation Priority:	1	Facility Function:	
Implementation Phase:		Implementation Date:	
Official Responsible:

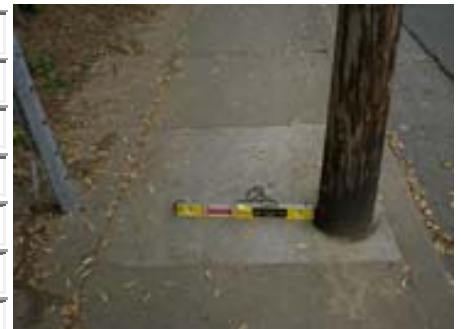
Field Date:	4/20/2011	Report Date:	4/20/2011	Barrier #:	7151
Location:	Sunrise Blvd - East				
X Coordinate:	-121.27132				
Y Coordinate:	38.68602				
Barrier Area:	Sidewalks				
Barrier Type:	Clear Width - Existing ($\leq 31"$ or less)				
Code Ref:	CBC 1133B.7.1

As Built Meas:	2	Quantity:	LF
Description:	Pedestrian route is not min. 48" wide ($\leq 31"$ or less)		
As Built Desc:	24" clear width due to pole		
Solution:	Demolish existing and construct new route		
Bar. Severity:	1 Necessary	Cost Estimate:	\$250.00
Implementation Priority:	1	Facility Function:	
Implementation Phase:		Implementation Date:	
Official Responsible:

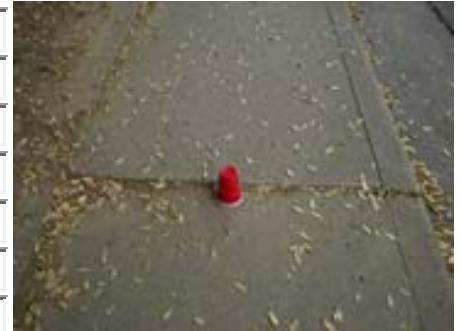
Field Date:	4/20/2011	Report Date:	4/20/2011	Barrier #:	7152
Location:	Sunrise Blvd - East				
X Coordinate:	-121.27131				
Y Coordinate:	38.68594				
Barrier Area:	Sidewalks				
Barrier Type:	Abrupt Change in Level - > 1/2"				
Code Ref:	CBC 1133B.7.1 and ADA/ABA 303.3

As Built Meas:	5	Quantity:	LF
Description:	Change in level greater than 1/2"		
As Built Desc:	1/2" lip in sidewalk surface		
Solution:	Grind or repair sidewalk to remove trip hazard		
Bar. Severity:	1 Necessary	Cost Estimate:	\$1,250.00
Implementation Priority:	1	Facility Function:	
Implementation Phase:		Implementation Date:	
Official Responsible:			
Notes:

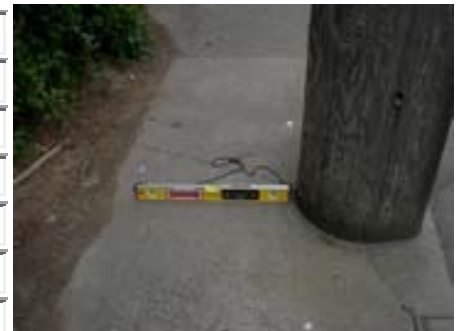
Field Date:	4/20/2011	Report Date:	4/20/2011	Barrier #:	7153
Location:	Sunrise Blvd - East				
X Coordinate:	-121.27129				
Y Coordinate:	38.68583				
Barrier Area:	Sidewalks				
Barrier Type:	Clear Width - Existing ($\leq 31"$ or less)				
Code Ref:	CBC 1133B.7.1

As Built Meas:	5	Quantity:	LF
Description:	Pedestrian route is not min. 48" wide ($\leq 31"$ or less)		
As Built Desc:	24" clear width due to pole		
Solution:	Demolish existing and construct new route		
Bar. Severity:	1 Necessary	Cost Estimate:	\$625.00
Implementation Priority:	1	Facility Function:	
Implementation Phase:		Implementation Date:	
Official Responsible:			
Notes:

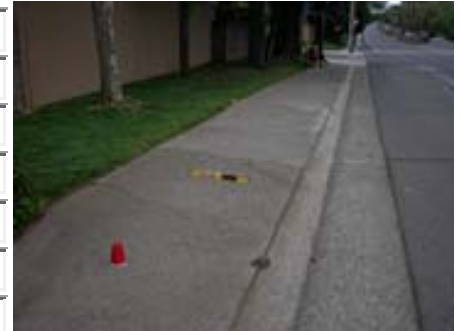
Field Date:	4/20/2011	Report Date:	4/20/2011	Barrier #:	7154
Location:	Sunrise Blvd - East				
X Coordinate:	-121.27129				
Y Coordinate:	38.68578				
Barrier Area:	Sidewalks				
Barrier Type:	Cross Slope - Existing (5.0% or more)				
Code Ref:	CBC 1133B.7.1.3 and ADA/ABA 403.3

As Built Meas:	88	Quantity:	LF
Description:	Cross slope exceeds 2.0% (5.0% or more)		
As Built Desc:	5.5% cross slope		
Solution:	Demolish existing and construct new route		
Bar. Severity:	1 Necessary	Cost Estimate:	\$11,000.00
Implementation Priority:	1	Facility Function:	
Implementation Phase:		Implementation Date:	
Official Responsible:
