DRAFT ADA TRANSITION PLAN UPDATE
NEIGHBORHOOD AREA 9 SONA
SEPTEMBER 20, 2011

CITY OF CITRUS HEIGHTS

The Sunrise Oaks Neighborhood Association (SONA)

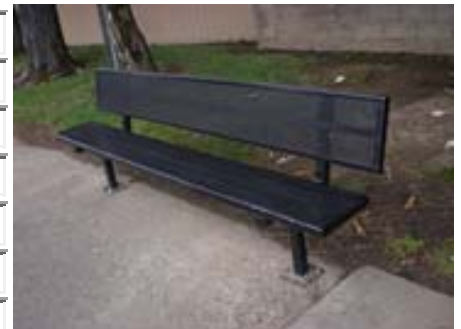
Field Date:	4/20/2011	Report Date:	4/20/2011	Barrier #:	7155A
Location:	Sunrise Blvd - East				
X Coordinate:	-121.27135				
Y Coordinate:	38.68558				
Barrier Area:	Bus Stops and Shelters				
Barrier Type:	Bench Seat Depth				
Code Ref:	ADAAG 4.37.1 and ADA/ABA 903.4

As Built Meas:	1	Quantity:	EACH
Description:	Bench seat depth not 20" - 24" deep		
As Built Desc:	12" bench seat depth		
Solution:	Provide min. 1 accessible bench at bench stop		
Bar. Severity:	3 Hindrance	Cost Estimate:	\$775.00
Implementation Priority:	1	Facility Function:	
Implementation Phase:		Implementation Date:	
Official Responsible:

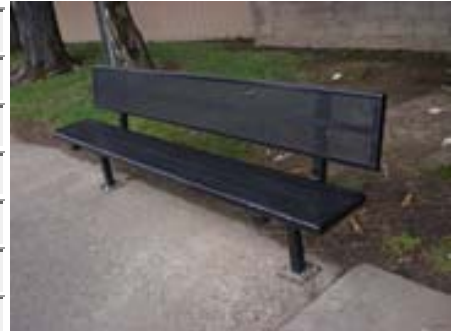
Field Date:	4/20/2011	Report Date:	4/20/2011	Barrier #:	7155B
Location:	Sunrise Blvd - East				
X Coordinate:	-121.27135				
Y Coordinate:	38.68558				
Barrier Area:	Bus Stops and Shelters				
Barrier Type:	Bench Back Support				
Code Ref:	ADAAG 4.37.4 and ADA/ABA 903.4

As Built Meas:	1	Quantity:	EACH
Description:	Bench has no back support of at least 18" high		
As Built Desc:	16" back support height"		
Solution:	Provide min. 1 accessible bench at bench stop or shelter		
Bar. Severity:	3 Hindrance	Cost Estimate:	\$0.00
Implementation Priority:	1	Facility Function:	
Implementation Phase:		Implementation Date:	
Official Responsible:

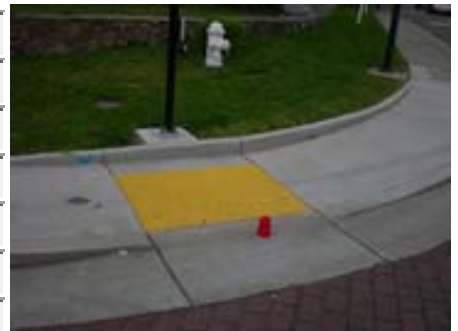
Field Date:	4/20/2011	Report Date:	4/20/2011	Barrier #:	7156
Location:	Sunrise Blvd and Sayonara Dr - Corner A				
X Coordinate:	-121.2717				
Y Coordinate:	38.68544				
Barrier Area:	Curb Ramps				
Barrier Type:	12" Grooves - Existing (>5.0%)				
Code Ref:	CBC 1127B.5.6

As Built Meas:	1	Quantity:	EACH
Description:	12" grooves at top of curb ramp are not level (>5.0%)		
As Built Desc:	10.7% at 12" grooves		
Solution:	Demolish existing and construct new curb ramp		
Bar. Severity:	1 Necessary	Cost Estimate:	\$2,500.00
Implementation Priority:	1	Facility Function:	
Implementation Phase:		Implementation Date:	
Official Responsible:

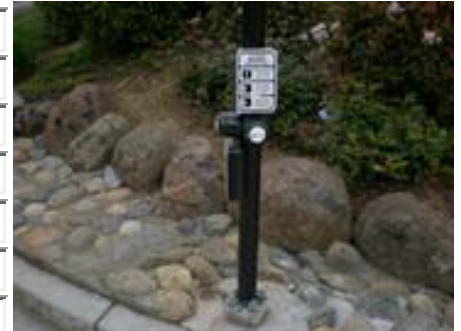
Field Date:	4/20/2011	Report Date:	4/20/2011	Barrier #:	7157
Location:	Sunrise Blvd and Sayonara Dr - corner D (A-B)				
X Coordinate:	-121.27173				
Y Coordinate:	38.68529				
Barrier Area:	Signalized Intersections				
Barrier Type:	APS Vibrotactile Control				
Code Ref:	PROWAG R306.2

As Built Meas:	1	Quantity:	JOB
Description:	No vibrotactile pedestrian buttons provided		
As Built Desc:	No level landing provided at ped buttons and no vibrotactile buttons provided		
Solution:	Recommended: Provide vibrotactile ped buttons		
Bar. Severity:	1 Necessary	Cost Estimate:	\$4,700.00
Implementation Priority:	1	Facility Function:	
Implementation Phase:		Implementation Date:	
Official Responsible:			
Notes:	Two - way intersection corners A,D

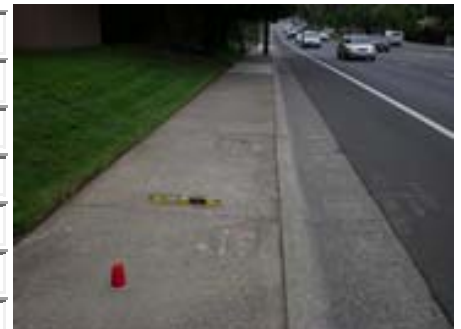
Field Date:	4/20/2011	Report Date:	4/20/2011	Barrier #:	7158A
Location:	Sunrise Blvd - East				
X Coordinate:	-121.27146				
Y Coordinate:	38.68527				
Barrier Area:	Sidewalks				
Barrier Type:	Cross Slope - Existing (4.1% to 4.9%)				
Code Ref:	CBC 1133B.7.1.3 and ADA/ABA 403.3

As Built Meas:	157	Quantity:	LF
Description:	Cross slope exceeds 2.0% (4.1% to 4.9%)		
As Built Desc:	4.4% cross slope		
Solution:	Demolish existing and construct new route		
Bar. Severity:	2 Recommended	Cost Estimate:	\$19,625.00
Implementation Priority:	1	Facility Function:	
Implementation Phase:		Implementation Date:	
Official Responsible:			
Notes:

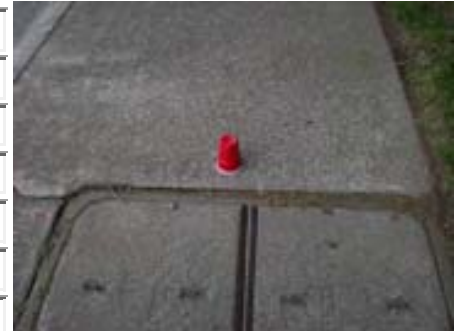
Field Date:	4/20/2011	Report Date:	4/20/2011	Barrier #:	7158B
Location:	Sunrise Blvd - East				
X Coordinate:	-121.27145				
Y Coordinate:	38.68497				
Barrier Area:	Sidewalks				
Barrier Type:	Abrupt Change in Level - > 1/2"				
Code Ref:	CBC 1133B.7.1 and ADA/ABA 303.3

As Built Meas:	5	Quantity:	LF
Description:	Change in level greater than 1/2"		
As Built Desc:	1/2" lip in sidewalk surface		
Solution:	Grind or repair sidewalk to remove trip hazard		
Bar. Severity:	1 Necessary	Cost Estimate:	\$1,250.00
Implementation Priority:	1	Facility Function:	
Implementation Phase:		Implementation Date:	
Official Responsible:			
Notes:

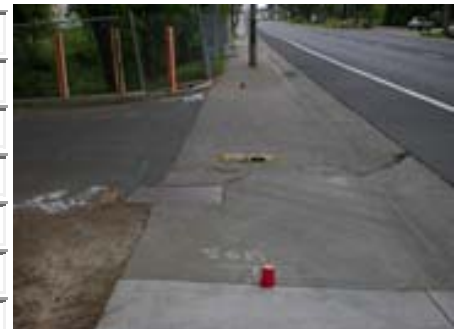
Field Date:	4/20/2011	Report Date:	4/20/2011	Barrier #:	7159
Location:	Sunrise Blvd - East				
X Coordinate:	-121.27145				
Y Coordinate:	38.68457				
Barrier Area:	Sidewalks				
Barrier Type:	Driveway - Existing (5.0% or more)				
Code Ref:	CBC 1133B.7.1.3 and ADA/ABA 403.3

As Built Meas:	32	Quantity:	LF
Description:	Driveway cross slope exceeds 2.0% (5.0% or more)		
As Built Desc:	5.9% cross slope		
Solution:	Provide min. 48" wide level walkway through driveway		
Bar. Severity:	4 Low Severity	Cost Estimate:	\$4,000.00
Implementation Priority:	1	Facility Function:	
Implementation Phase:		Implementation Date:	
Official Responsible:			
Notes:

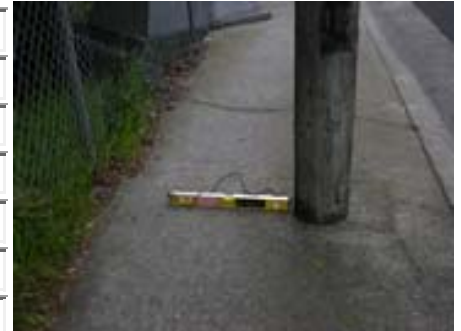
Field Date:	4/20/2011	Report Date:	4/20/2011	Barrier #:	7160
Location:	Sunrise Blvd - East				
X Coordinate:	-121.27146				
Y Coordinate:	38.68447				
Barrier Area:	Sidewalks				
Barrier Type:	Clear Width - Existing ($\leq 31"$ or less)				
Code Ref:	CBC 1133B.7.1

As Built Meas:	5	Quantity:	LF
Description:	Pedestrian route is not min. 48" wide ($\leq 31"$ or less)		
As Built Desc:	24" clear width due to pole		
Solution:	Demolish existing and construct new route		
Bar. Severity:	1 Necessary	Cost Estimate:	\$625.00
Implementation Priority:	1	Facility Function:	
Implementation Phase:		Implementation Date:	
Official Responsible:			
Notes:

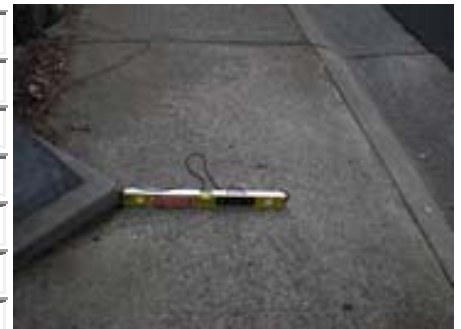
Field Date:	4/20/2011	Report Date:	4/20/2011	Barrier #:	7161
Location:	Sunrise Blvd - East				
X Coordinate:	-121.27146				
Y Coordinate:	38.68443				
Barrier Area:	Sidewalks				
Barrier Type:	Clear Width - Existing ($\leq 31"$ or less)				
Code Ref:	CBC 1133B.7.1

As Built Meas:	5	Quantity:	LF
Description:	Pedestrian route is not min. 48" wide ($\leq 31"$ or less)		
As Built Desc:	24" clear width due to pole		
Solution:	Demolish existing and construct new route		
Bar. Severity:	1 Necessary	Cost Estimate:	\$625.00
Implementation Priority:	1	Facility Function:	
Implementation Phase:		Implementation Date:	
Official Responsible:			
Notes:

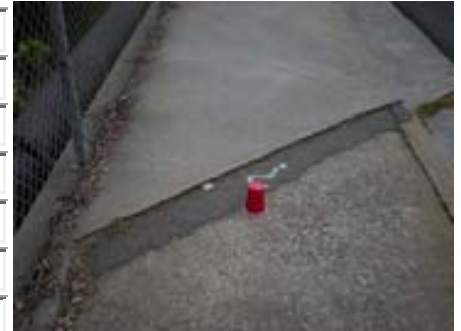
Field Date:	4/20/2011	Report Date:	4/20/2011	Barrier #:	7162
Location:	Sunrise Blvd - East				
X Coordinate:	-121.2715				
Y Coordinate:	38.68436				
Barrier Area:	Sidewalks				
Barrier Type:	Abrupt Change in Level - > 1/2"				
Code Ref:	CBC 1133B.7.1 and ADA/ABA 303.3

As Built Meas:	5	Quantity:	LF
Description:	Change in level greater than 1/2"		
As Built Desc:	1/2" lip in sidewalk surface		
Solution:	Grind or repair sidewalk to remove trip hazard		
Bar. Severity:	1 Necessary	Cost Estimate:	\$1,250.00
Implementation Priority:	1	Facility Function:	
Implementation Phase:		Implementation Date:	
Official Responsible:			
Notes:

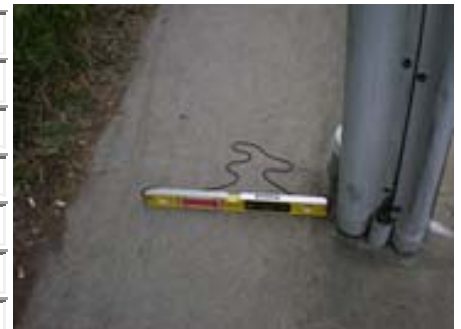
Field Date:	4/20/2011	Report Date:	4/20/2011	Barrier #:	7163
Location:	Sunrise Blvd - East				
X Coordinate:	-121.27146				
Y Coordinate:	38.68414				
Barrier Area:	Sidewalks				
Barrier Type:	Clear Width - Existing ($\leq 31"$ or less)				
Code Ref:	CBC 1133B.7.1

As Built Meas:	10	Quantity:	LF
Description:	Pedestrian route is not min. 48" wide ($\leq 31"$ or less)		
As Built Desc:	24" clear width due to pole and guide wire		
Solution:	Demolish existing and construct new route		
Bar. Severity:	1 Necessary	Cost Estimate:	\$1,250.00
Implementation Priority:	1	Facility Function:	
Implementation Phase:		Implementation Date:	
Official Responsible:			
Notes:

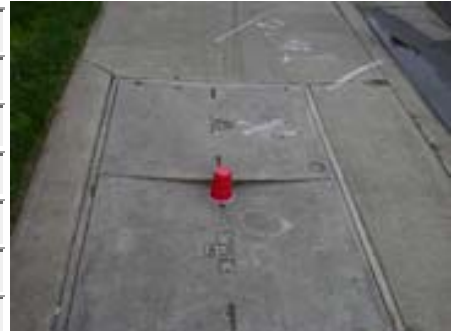
Field Date:	4/20/2011	Report Date:	4/20/2011	Barrier #:	7164
Location:	Sunrise Blvd - East				
X Coordinate:	-121.2714				
Y Coordinate:	38.68384				
Barrier Area:	Sidewalks				
Barrier Type:	Surface Condition - Damaged				
Code Ref:	CBC 1133B.7.1 and ADA/ABA 302.1

As Built Meas:	5	Quantity:	LF
Description:	Surface is not firm and stable (cracked, broken or loose soil, etc.)		
As Built Desc:	Cracked Utility Cover		
Solution:	Repair surface to make firm and stable		
Bar. Severity:	1 Necessary	Cost Estimate:	\$625.00
Implementation Priority:	1	Facility Function:	
Implementation Phase:		Implementation Date:	
Official Responsible:

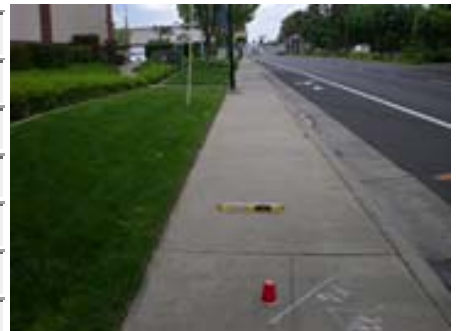
Field Date:	4/20/2011	Report Date:	4/20/2011	Barrier #:	7165
Location:	Sunrise Blvd - East				
X Coordinate:	-121.2714				
Y Coordinate:	38.68387				
Barrier Area:	Sidewalks				
Barrier Type:	Cross Slope - Existing (5.0% or more)				
Code Ref:	CBC 1133B.7.1.3 and ADA/ABA 403.3

As Built Meas:	136	Quantity:	LF
Description:	Cross slope exceeds 2.0% (5.0% or more)		
As Built Desc:	5.0% cross slope		
Solution:	Demolish existing and construct new route		
Bar. Severity:	1 Necessary	Cost Estimate:	\$17,000.00
Implementation Priority:	1	Facility Function:	
Implementation Phase:		Implementation Date:	
Official Responsible:

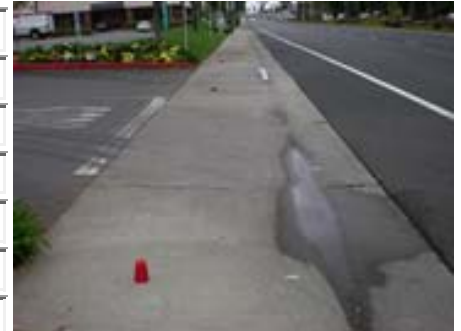
Barrier Type: Driveway - Existing (5.0% or more)

As Built Meas: 53 Quantity: LF

Description: Driveway cross slope exceeds 2.0% (5.0% or more)

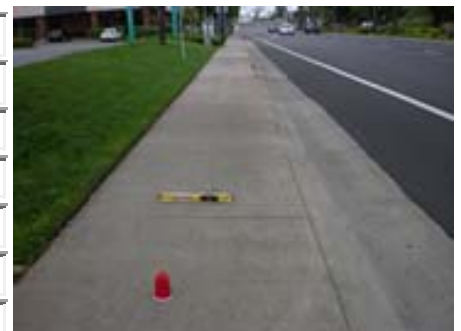
Barrier Type: Cross Slope - Existing (3.1% to 4.0%)

As Built Meas: 123 Quantity: LF

Description: Cross slope exceeds 2.0% (3.1% to 4.0%)

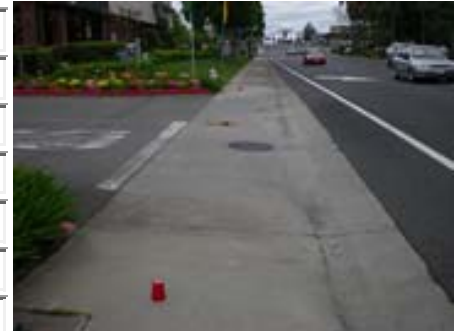
Barrier Type: Driveway - Existing (5.0% or more)

As Built Meas: 55 Quantity: LF

Description: Driveway cross slope exceeds 2.0% (5.0% or more)

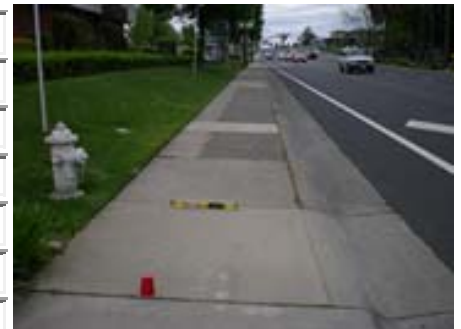
Barrier Type: Cross Slope - Existing (4.1% to 4.9%)

As Built Meas: 226 Quantity: LF

Description: Cross slope exceeds 2.0% (4.1% to 4.9%)

Bar. Severity: 2 Recommended Cost Estimate: \$28,250.00 Status:

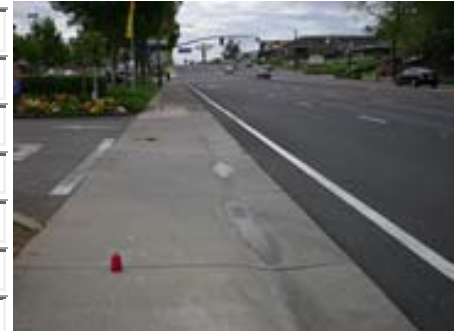
Barrier Type: Driveway - Existing (5.0% or more)

As Built Meas: 54 Quantity: LF

Description: Driveway cross slope exceeds 2.0% (5.0% or more)

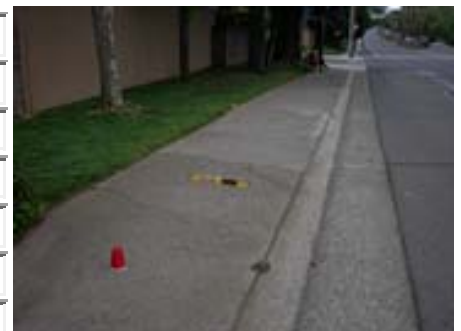
Barrier Type: Cross Slope - Existing (4.1% to 4.9%)

As Built Meas: 171 Quantity: LF

Description: Cross slope exceeds 2.0% (4.1% to 4.9%)

Bar. Severity: 2 Recommended Cost Estimate: \$21,375.00 Status:

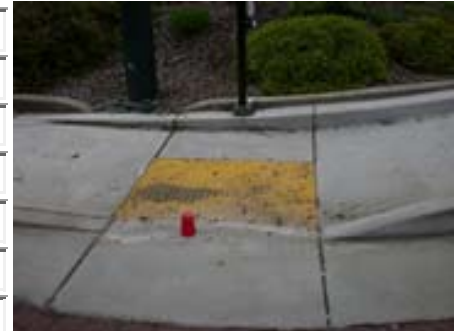
Field Date:	4/20/2011	Report Date:	4/20/2011	Barrier #:	7172
Location:	Sunrise Blvd and Arcadia Dr - Corner C (A-B)				
X Coordinate:	-121.27132				
Y Coordinate:	38.68124				
Barrier Area:	Curb Ramps				
Barrier Type:	Cross Slope - Existing (4.1% to 4.9%)				
Code Ref:	CBC 1127B.5.3 and ADA/ABA 406.2

As Built Meas:	1	Quantity:	EACH
Description:	Ramp run cross slope exceeds 2.0% (4.1% to 4.9%)		
As Built Desc:	4.8% cross slope		
Solution:	Demolish existing and construct new curb ramp		
Bar. Severity:	2 Recommended	Cost Estimate:	\$2,500.00
Implementation Priority:	1	Facility Function:	
Implementation Phase:		Implementation Date:	
Official Responsible:

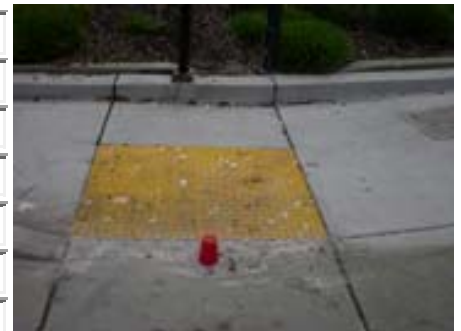
Field Date:	4/20/2011	Report Date:	4/20/2011	Barrier #:	7173
Location:	Sunrise Blvd and Arcadia Dr - Corner C (A-A)				
X Coordinate:	-121.27139				
Y Coordinate:	38.68119				
Barrier Area:	Curb Ramps				
Barrier Type:	12" Grooves - Existing (>5.0%)				
Code Ref:	CBC 1127B.5.6

As Built Meas:	1	Quantity:	EACH
Description:	12" grooves at top of curb ramp are not level (>5.0%)		
As Built Desc:	5.4% at 12" grooves		
Solution:	Demolish existing and construct new curb ramp		
Bar. Severity:	1 Necessary	Cost Estimate:	\$2,500.00
Implementation Priority:	1	Facility Function:	
Implementation Phase:		Implementation Date:	
Official Responsible:

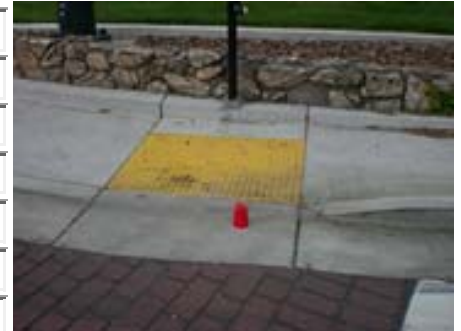
Field Date:	4/20/2011	Report Date:	4/20/2011	Barrier #:	7174A
Location:	Sunrise Blvd and Arcadia Dr - Corner D (A-B)				
X Coordinate:	-121.27174				
Y Coordinate:	38.6812				
Barrier Area:	Curb Ramps				
Barrier Type:	12" Grooves - Existing (3.1% to 4.0%)				
Code Ref:	CBC 1127B.5.6

As Built Meas:	1	Quantity:	EACH
Description:	12" grooves at top of curb ramp are not level (3.1% to 4.0%)		
As Built Desc:	3.7% at 12" grooves		
Solution:	Demolish existing and construct new curb ramp		
Bar. Severity:	3 Hindrance	Cost Estimate:	\$2,500.00
Implementation Priority:	1	Facility Function:	
Implementation Phase:		Implementation Date:	
Official Responsible:			
Notes:	Four - way intersection corners A, B, C, D

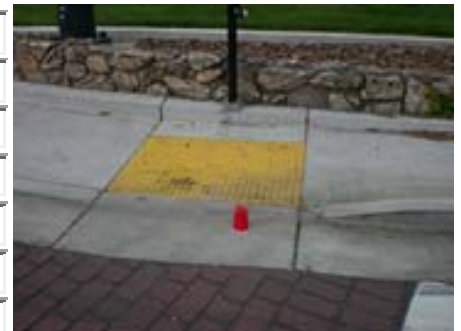
Field Date:	4/20/2011	Report Date:	4/20/2011	Barrier #:	7174B
Location:	Sunrise Blvd and Arcadia Dr - Corner D (A-A)				
X Coordinate:	-121.27174				
Y Coordinate:	38.6812				
Barrier Area:	Curb Ramps				
Barrier Type:	Running Slope - Existing (9.0% to 9.4%)				
Code Ref:	CBC 1127B.5.3 and ADA/ABA 406.1

As Built Meas:	1	Quantity:	EACH
Description:	Ramp run cross slope exceeds 2.0% (9.0% to 9.4%)		
As Built Desc:	9.2% running slope		
Solution:	Demolish existing and construct new curb ramp		
Bar. Severity:	2 Recommended	Cost Estimate:	\$2,500.00
Implementation Priority:	1	Facility Function:	
Implementation Phase:		Implementation Date:	
Official Responsible:			
Notes:	Four - way intersection corners A, B, C, D

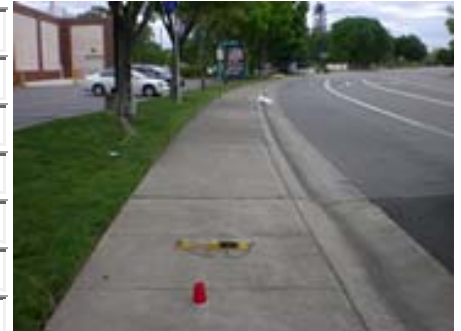
Field Date:	4/20/2011	Report Date:	4/20/2011	Barrier #:	7175
Location:	Arcadia Dr - North				
X Coordinate:	-121.27129				
Y Coordinate:	38.68144				
Barrier Area:	Sidewalks				
Barrier Type:	Cross Slope - Existing (3.1% to 4.0%)				
Code Ref:	CBC 1133B.7.1.3 and ADA/ABA 403.3

As Built Meas:	173	Quantity:	LF
Description:	Cross slope exceeds 2.0% (3.1% to 4.0%)		
As Built Desc:	3.5% cross slope		
Solution:	Demolish existing and construct new route		
Bar. Severity:	3 Hindrance	Cost Estimate:	\$21,625.00
Implementation Priority:	2	Facility Function:	
Implementation Phase:		Implementation Date:	
Official Responsible:

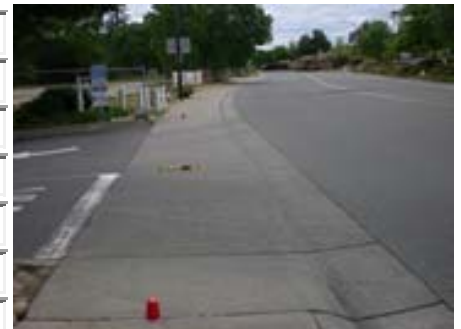
Field Date:	4/20/2011	Report Date:	4/20/2011	Barrier #:	7176
Location:	Arcadia Dr - North				
X Coordinate:	-121.27064				
Y Coordinate:	38.68134				
Barrier Area:	Sidewalks				
Barrier Type:	Driveway - Existing (3.1% to 4.0%)				
Code Ref:	CBC 1133B.7.1.3 and ADA/ABA 403.3

As Built Meas:	42	Quantity:	LF
Description:	Driveway cross slope exceeds 2.0% (3.1% to 4.0%)		
As Built Desc:	3.3% cross slope		
Solution:	Provide min. 48" wide level walkway through driveway		
Bar. Severity:	2 Recommended	Cost Estimate:	\$5,250.00
Implementation Priority:	2	Facility Function:	
Implementation Phase:		Implementation Date:	
Official Responsible:

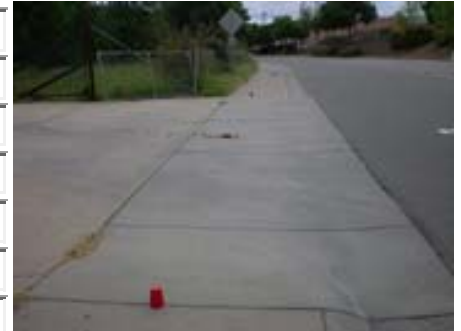
Field Date:	4/20/2011	Report Date:	4/20/2011	Barrier #:	7177
Location:	Arcadia Dr - North				
X Coordinate:	-121.27064				
Y Coordinate:	38.68132				
Barrier Area:	Sidewalks				
Barrier Type:	Driveway - Existing (2.1% to 3.0%)				
Code Ref:	CBC 1133B.7.1.3 and ADA/ABA 403.3

As Built Meas:	44	Quantity:	LF
Description:	Driveway cross slope exceeds 2.0% (2.1% to 3.0%)		
As Built Desc:	2.9% cross slope		
Solution:	Provide min. 48" wide level walkway through driveway		
Bar. Severity:	1 Necessary	Cost Estimate:	\$5,500.00
		Status:	
Implementation Priority:	2	Facility Function:	
Implementation Phase:		Implementation Date:	
Official Responsible:

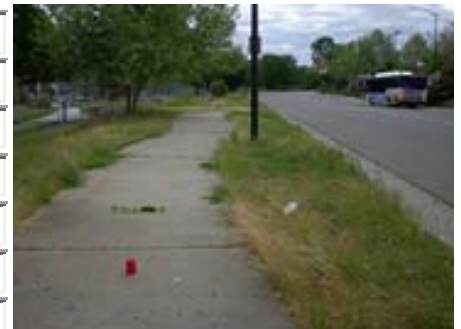
Field Date:	4/20/2011	Report Date:	4/20/2011	Barrier #:	7178
Location:	Arcadia Dr - North				
X Coordinate:	-121.26862				
Y Coordinate:	38.68059				
Barrier Area:	Sidewalks				
Barrier Type:	Driveway - Existing (3.1% to 4.0%)				
Code Ref:	CBC 1133B.7.1.3 and ADA/ABA 403.3

As Built Meas:	238	Quantity:	LF
Description:	Driveway cross slope exceeds 2.0% (3.1% to 4.0%)		
As Built Desc:	3.5% cross slope		
Solution:	Provide min. 48" wide level walkway through driveway		
Bar. Severity:	2 Recommended	Cost Estimate:	\$29,750.00
		Status:	
Implementation Priority:	2	Facility Function:	
Implementation Phase:		Implementation Date:	
Official Responsible:

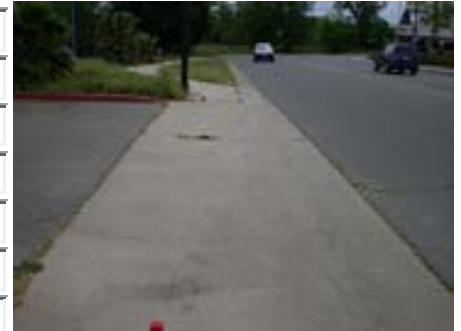
Barrier Type: Driveway - Existing (4.1% to 4.9%)

Code Ref: CBC 1133B.7.1.3 and ADA/ABA 403.3

As Built Meas: 37 Quantity: LF

Description: Driveway cross slope exceeds 2.0% (4.1% to 4.9%)

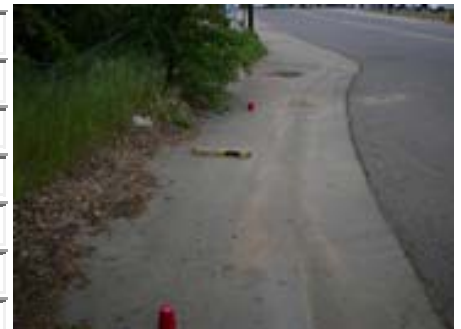
Barrier Type: Cross Slope - Existing (4.1% to 4.9%)

Code Ref: CBC 1133B.7.1.3 and ADA/ABA 403.3

As Built Meas: 34 Quantity: LF

Description: Cross slope exceeds 2.0% (4.1% to 4.9%)

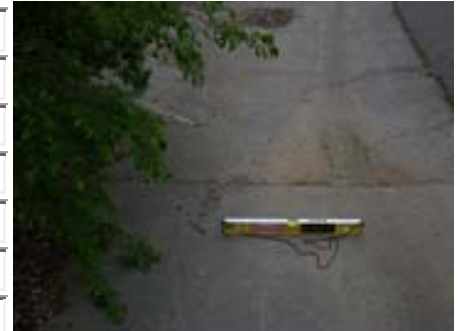
Field Date:	4/20/2011	Report Date:	4/20/2011	Barrier #:	7181
Location:	Arcadia Dr - East				
X Coordinate:	-121.26706				
Y Coordinate:	38.68008				
Barrier Area:	Sidewalks				
Barrier Type:	Clear Width - Existing ($\leq 31"$ or less)				
Code Ref:	CBC 1133B.7.1

As Built Meas:	1	Quantity:	LF
Description:	Pedestrian route is not min. 48" wide ($\leq 31"$ or less)		
As Built Desc:	24" clear width due to foliage		
Solution:	Trim foliage to provide min. 48" clear width		
Bar. Severity:	1 Necessary	Cost Estimate:	\$125.00
Implementation Priority:	2	Facility Function:	
Implementation Phase:		Implementation Date:	
Official Responsible:

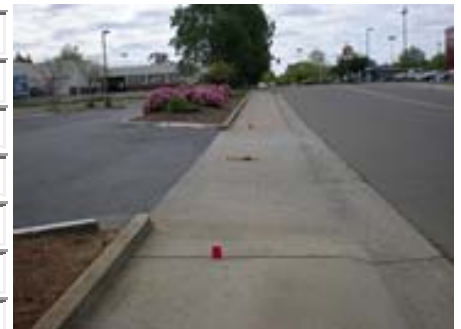
Field Date:	4/20/2011	Report Date:	4/20/2011	Barrier #:	7182
Location:	Arcadia Dr - East				
X Coordinate:	-121.26705				
Y Coordinate:	38.67978				
Barrier Area:	Sidewalks				
Barrier Type:	Driveway - Existing (5.0% or more)				
Code Ref:	CBC 1133B.7.1.3 and ADA/ABA 403.3

As Built Meas:	40	Quantity:	LF
Description:	Driveway cross slope exceeds 2.0% (5.0% or more)		
As Built Desc:	5.4% cross slope		
Solution:	Provide min. 48" wide level walkway through driveway		
Bar. Severity:	4 Low Severity	Cost Estimate:	\$5,000.00
Implementation Priority:	2	Facility Function:	
Implementation Phase:		Implementation Date:	
Official Responsible:

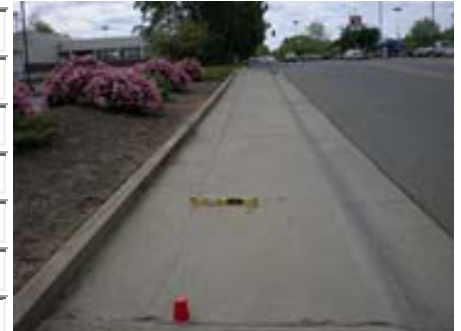
Field Date:	4/20/2011	Report Date:	4/20/2011	Barrier #:	7183A
Location:	Arcadia Dr - East				
X Coordinate:	-121.26703				
Y Coordinate:	38.6797				
Barrier Area:	Sidewalks				
Barrier Type:	Cross Slope - Existing (4.1% to 4.9%)				
Code Ref:	CBC 1133B.7.1.3 and ADA/ABA 403.3

As Built Meas:	90	Quantity:	LF
Description:	Cross slope exceeds 2.0% (4.1% to 4.9%)		
As Built Desc:	4.8% cross slope		
Solution:	Demolish existing and construct new route		
Bar. Severity:	2 Recommended	Cost Estimate:	\$11,250.00
Implementation Priority:	2	Facility Function:	
Implementation Phase:		Implementation Date:	
Official Responsible:

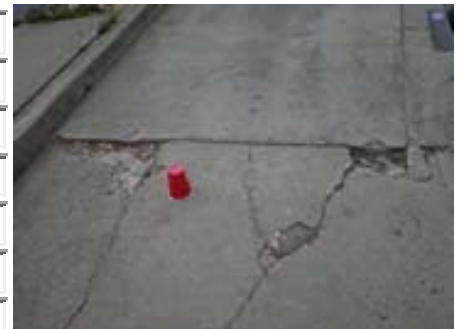
Field Date:	4/20/2011	Report Date:	4/20/2011	Barrier #:	7183B
Location:	Arcadia Dr - East				
X Coordinate:	-121.26704				
Y Coordinate:	38.67948				
Barrier Area:	Sidewalks				
Barrier Type:	Surface Condition - Damaged				
Code Ref:	CBC 1133B.7.1 and ADA/ABA 302.1

As Built Meas:	5	Quantity:	LF
Description:	Surface is not firm and stable (cracked, broken or loose soil, etc.)		
As Built Desc:	Cracked concrete		
Solution:	Repair surface to make firm and stable		
Bar. Severity:	1 Necessary	Cost Estimate:	\$625.00
Implementation Priority:	2	Facility Function:	
Implementation Phase:		Implementation Date:	
Official Responsible:

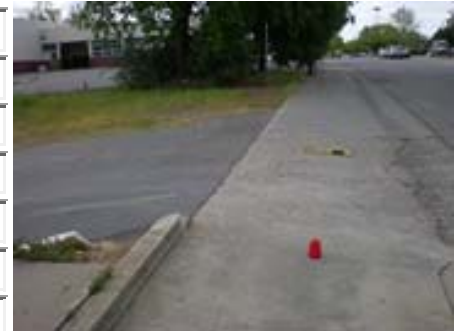
Field Date:	4/20/2011	Report Date:	4/20/2011	Barrier #:	7184
Location:	Arcadia Dr - East				
X Coordinate:	-121.26703				
Y Coordinate:	38.67936				
Barrier Area:	Sidewalks				
Barrier Type:	Driveway - Existing (5.0% or more)				
Code Ref:	CBC 1133B.7.1.3 and ADA/ABA 403.3

As Built Meas:	44	Quantity:	LF
Description:	Driveway cross slope exceeds 2.0% (5.0% or more)		
As Built Desc:	8.0% cross slope		
Solution:	Provide min. 48" wide level walkway through driveway		
Bar. Severity:	4 Low Severity	Cost Estimate:	\$5,500.00
Implementation Priority:	2	Facility Function:	
Implementation Phase:		Implementation Date:	
Official Responsible:

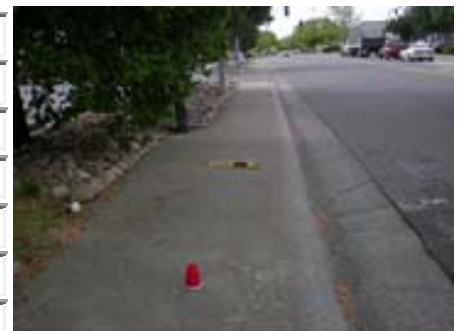
Field Date:	4/20/2011	Report Date:	4/20/2011	Barrier #:	7185A
Location:	Arcadia Dr - East				
X Coordinate:	-121.26704				
Y Coordinate:	38.67927				
Barrier Area:	Sidewalks				
Barrier Type:	Cross Slope - Existing (4.1% to 4.9%)				
Code Ref:	CBC 1133B.7.1.3 and ADA/ABA 403.3

As Built Meas:	65	Quantity:	LF
Description:	Cross slope exceeds 2.0% (4.1% to 4.9%)		
As Built Desc:	4.8% cross slope		
Solution:	Demolish existing and construct new route		
Bar. Severity:	2 Recommended	Cost Estimate:	\$8,125.00
Implementation Priority:	2	Facility Function:	
Implementation Phase:		Implementation Date:	
Official Responsible:

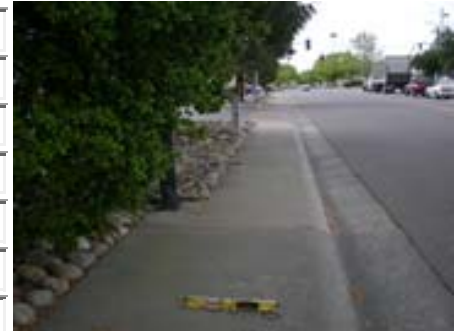
Field Date:	4/20/2011	Report Date:	4/20/2011	Barrier #:	7185B
Location:	Arcadia Dr - East				
X Coordinate:	-121.26704				
Y Coordinate:	38.67927				
Barrier Area:	Sidewalks				
Barrier Type:	Protruding Hazard				
Code Ref:	CBC 1133B.8.6.1 and ADA/ABA 307.2

As Built Meas:	1	Quantity:	JOB
Description:	Protruding object in route of travel between 27" and 80" high		
As Built Desc:	28" at tree branch		
Solution:	Remove object or provide detectable warning		
Bar. Severity:	1 Necessary	Cost Estimate:	\$1,400.00
Implementation Priority:	2	Facility Function:	
Implementation Phase:		Implementation Date:	
Official Responsible:

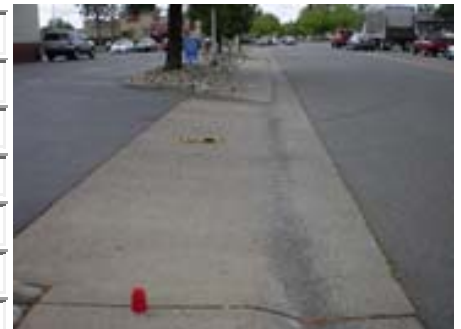
Field Date:	4/20/2011	Report Date:	4/20/2011	Barrier #:	7186
Location:	Arcadia Dr - East				
X Coordinate:	-121.26702				
Y Coordinate:	38.67903				
Barrier Area:	Sidewalks				
Barrier Type:	Cross Slope - Existing (4.1% to 4.9%)				
Code Ref:	CBC 1133B.7.1.3 and ADA/ABA 403.3

As Built Meas:	35	Quantity:	LF
Description:	Cross slope exceeds 2.0% (4.1% to 4.9%)		
As Built Desc:	4.9% cross slope		
Solution:	Demolish existing and construct new route		
Bar. Severity:	2 Recommended	Cost Estimate:	\$4,375.00
Implementation Priority:	2	Facility Function:	
Implementation Phase:		Implementation Date:	
Official Responsible:

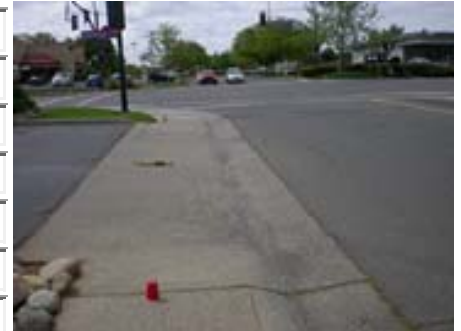
Field Date:	4/20/2011	Report Date:	4/20/2011	Barrier #:	7187
Location:	Arcadia Dr - East				
X Coordinate:	-121.26701				
Y Coordinate:	38.67876				
Barrier Area:	Sidewalks				
Barrier Type:	Cross Slope - Existing (5.0% or more)				
Code Ref:	CBC 1133B.7.1.3 and ADA/ABA 403.3

As Built Meas:	37	Quantity:	LF
Description:	Cross slope exceeds 2.0% (5.0% or more)		
As Built Desc:	6.9% cross slope		
Solution:	Demolish existing and construct new route		
Bar. Severity:	1 Necessary	Cost Estimate:	\$4,625.00
Implementation Priority:	2	Facility Function:	
Implementation Phase:		Implementation Date:	
Official Responsible:

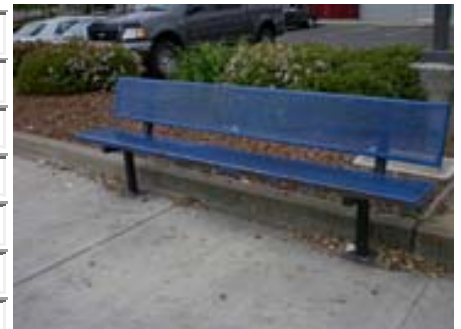
Field Date:	4/20/2011	Report Date:	4/20/2011	Barrier #:	7188A
Location:	Arcadia Dr - West				
X Coordinate:	-121.26727				
Y Coordinate:	38.67896				
Barrier Area:	Bus Stops and Shelters				
Barrier Type:	Bench Seat Depth				
Code Ref:	ADAAG 4.37.1 and ADA/ABA 903.4

As Built Meas:	1	Quantity:	EACH
Description:	Bench seat depth not 20" - 24" deep		
As Built Desc:	12" bench seat depth		
Solution:	Provide min. 1 accessible bench at bench stop		
Bar. Severity:	3 Hindrance	Cost Estimate:	\$775.00
Implementation Priority:	2	Facility Function:	
Implementation Phase:		Implementation Date:	
Official Responsible:

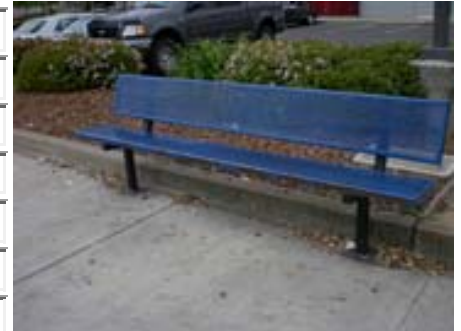
Field Date:	4/20/2011	Report Date:	4/20/2011	Barrier #:	7188B
Location:	Arcadia Dr - West				
X Coordinate:	-121.26727				
Y Coordinate:	38.67896				
Barrier Area:	Bus Stops and Shelters				
Barrier Type:	Bench Back Support				
Code Ref:	ADAAG 4.37.4 and ADA/ABA 903.4

As Built Meas:	1	Quantity:	EACH
Description:	Bench has no back support of at least 18" high		
As Built Desc:	17" back support height		
Solution:	Provide min. 1 accessible bench at bench stop or shelter		
Bar. Severity:	3 Hindrance	Cost Estimate:	\$0.00
Implementation Priority:	2	Facility Function:	
Implementation Phase:		Implementation Date:	
Official Responsible:			
Notes:

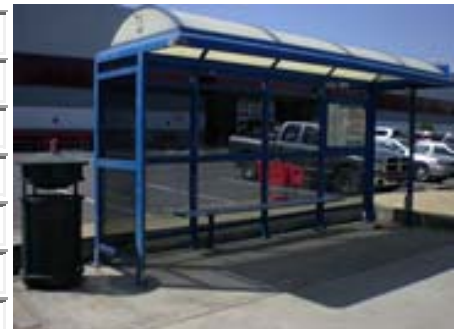
Field Date:	4/20/2011	Report Date:	4/20/2011	Barrier #:	7189A
Location:	Arcadia Dr - West				
X Coordinate:	-121.26727				
Y Coordinate:	38.67897				
Barrier Area:	Bus Stops and Shelters				
Barrier Type:	Bench Seat Height				
Code Ref:	ADAAG 4.37.3* and ADA/ABA 903.4

As Built Meas:	1	Quantity:	EACH
Description:	Bench seat height not between 17" - 19"		
As Built Desc:	20" bench seat height		
Solution:	Provide new compliant bench or remount at compliant height where possible		
Bar. Severity:	3 Hindrance	Cost Estimate:	\$775.00
Implementation Priority:	2	Facility Function:	
Implementation Phase:		Implementation Date:	
Official Responsible:			
Notes:

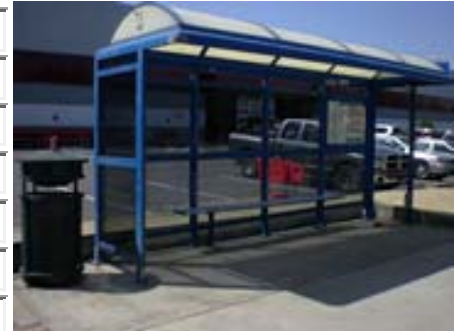
Field Date:	4/20/2011	Report Date:	4/20/2011	Barrier #:	7189B
Location:	Arcadia Dr - West				
X Coordinate:	-121.26727				
Y Coordinate:	38.67897				
Barrier Area:	Bus Stops and Shelters				
Barrier Type:	Bench Seat Depth				
Code Ref:	ADAAG 4.37.1 and ADA/ABA 903.4

As Built Meas:	1	Quantity:	EACH
Description:	Bench seat depth not 20" - 24" deep		
As Built Desc:	9-1/2" bench seat depth		
Solution:	Provide min. 1 accessible bench at bench stop		
Bar. Severity:	3 Hindrance	Cost Estimate:	\$0.00
Implementation Priority:	2	Facility Function:	
Implementation Phase:		Implementation Date:	
Official Responsible:			
Notes:

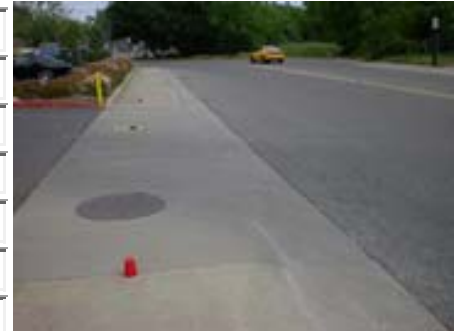
Barrier Type: Driveway - Existing (4.1% to 4.9%)

Code Ref: CBC 1133B.7.1.3 and ADA/ABA 403.3

As Built Meas: 40 Quantity: LF

Description: Driveway cross slope exceeds 2.0% (4.1% to 4.9%)

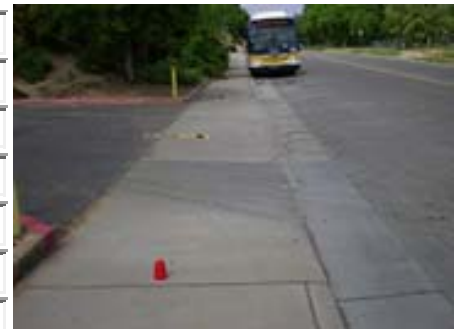
Barrier Type: Driveway - Existing (4.1% to 4.9%)

Code Ref: CBC 1133B.7.1.3 and ADA/ABA 403.3

As Built Meas: 42 Quantity: LF

Description: Driveway cross slope exceeds 2.0% (4.1% to 4.9%)

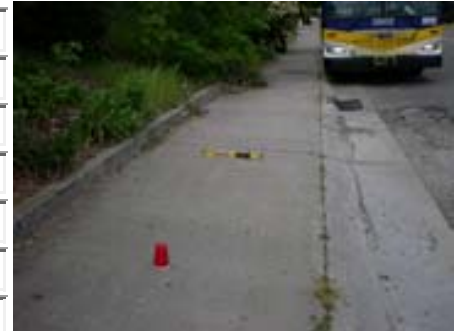
Field Date:	4/20/2011	Report Date:	4/20/2011	Barrier #:	7192A
Location:	Arcadia Dr - South				
X Coordinate:	-121.26803				
Y Coordinate:	38.68027				
Barrier Area:	Sidewalks				
Barrier Type:	Cross Slope - Existing (3.1% to 4.0%)				
Code Ref:	CBC 1133B.7.1.3 and ADA/ABA 403.3

As Built Meas:	153	Quantity:	LF
Description:	Cross slope exceeds 2.0% (3.1% to 4.0%)		
As Built Desc:	3.4% cross slope		
Solution:	Demolish existing and construct new route		
Bar. Severity:	3 Hindrance	Cost Estimate:	\$19,125.00
Implementation Priority:	2	Facility Function:	
Implementation Phase:		Implementation Date:	
Official Responsible:

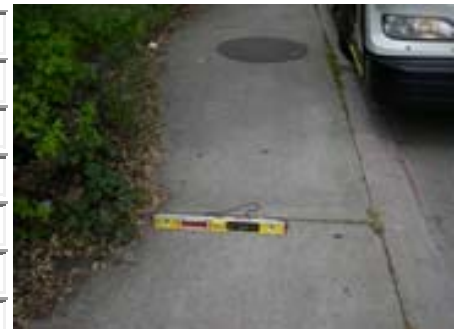
Field Date:	4/20/2011	Report Date:	4/20/2011	Barrier #:	7192B
Location:	Arcadia Dr - South				
X Coordinate:	-121.26857				
Y Coordinate:	38.68047				
Barrier Area:	Sidewalks				
Barrier Type:	Clear Width - Existing ($\leq 31"$ or less)				
Code Ref:	CBC 1133B.7.1

As Built Meas:	1	Quantity:	LF
Description:	Pedestrian route is not min. 48" wide ($\leq 31"$ or less)		
As Built Desc:	24" clear width due to foliage		
Solution:	Trim foliage to provide min. 48" clear width		
Bar. Severity:	1 Necessary	Cost Estimate:	\$125.00
Implementation Priority:	2	Facility Function:	
Implementation Phase:		Implementation Date:	
Official Responsible:

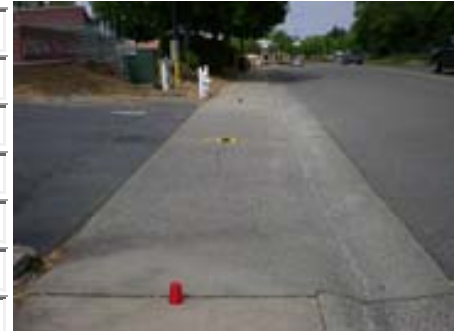
Field Date:	4/20/2011	Report Date:	4/20/2011	Barrier #:	7193
Location:	Arcadia Dr - South				
X Coordinate:	-121.26808				
Y Coordinate:	38.68033				
Barrier Area:	Sidewalks				
Barrier Type:	Driveway - Existing (4.1% to 4.9%)				
Code Ref:	CBC 1133B.7.1.3 and ADA/ABA 403.3

As Built Meas:	38	Quantity:	LF
Description:	Driveway cross slope exceeds 2.0% (4.1% to 4.9%)		
As Built Desc:	4.6% cross slope		
Solution:	Provide min. 48" wide level walkway through driveway		
Bar. Severity:	3 Hindrance	Cost Estimate:	\$4,750.00
Implementation Priority:	2	Facility Function:	
Implementation Phase:		Implementation Date:	
Official Responsible:

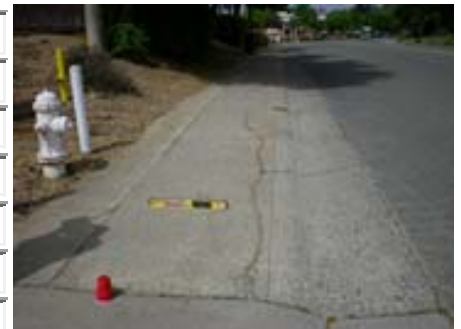
Field Date:	4/20/2011	Report Date:	4/20/2011	Barrier #:	7194
Location:	Arcadia Dr - South				
X Coordinate:	-121.26869				
Y Coordinate:	38.68049				
Barrier Area:	Sidewalks				
Barrier Type:	Cross Slope - Existing (4.1% to 4.9%)				
Code Ref:	CBC 1133B.7.1.3 and ADA/ABA 403.3

As Built Meas:	327	Quantity:	LF
Description:	Cross slope exceeds 2.0% (4.1% to 4.9%)		
As Built Desc:	4.9% cross slope		
Solution:	Demolish existing and construct new route		
Bar. Severity:	2 Recommended	Cost Estimate:	\$40,875.00
Implementation Priority:	2	Facility Function:	
Implementation Phase:		Implementation Date:	
Official Responsible:

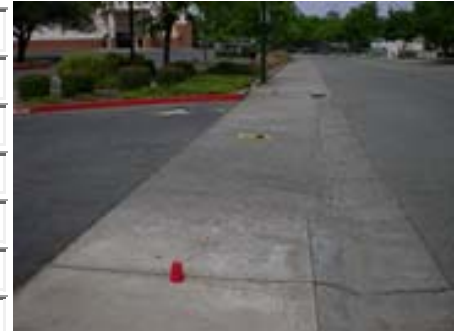
Field Date:	4/20/2011	Report Date:	4/20/2011	Barrier #:	7195
Location:	Arcadia Dr - South				
X Coordinate:	-121.26979				
Y Coordinate:	38.68078				
Barrier Area:	Sidewalks				
Barrier Type:	Driveway - Existing (3.1% to 4.0%)				
Code Ref:	CBC 1133B.7.1.3 and ADA/ABA 403.3

As Built Meas:	46	Quantity:	LF
Description:	Driveway cross slope exceeds 2.0% (3.1% to 4.0%)		
As Built Desc:	3.8% cross slope		
Solution:	Provide min. 48" wide level walkway through driveway		
Bar. Severity:	2 Recommended	Cost Estimate:	\$5,750.00
		Status:	
Implementation Priority:	2	Facility Function:	
Implementation Phase:		Implementation Date:	
Official Responsible:

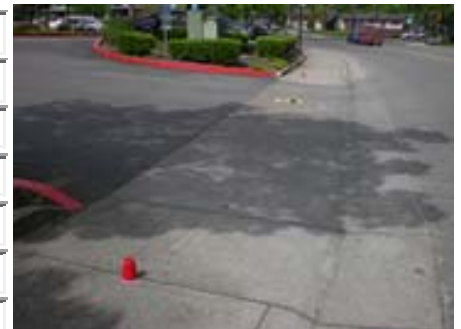
Field Date:	4/20/2011	Report Date:	4/20/2011	Barrier #:	7196
Location:	Arcadia Dr - South				
X Coordinate:	-121.27078				
Y Coordinate:	38.68121				
Barrier Area:	Sidewalks				
Barrier Type:	Driveway - Existing (3.1% to 4.0%)				
Code Ref:	CBC 1133B.7.1.3 and ADA/ABA 403.3

As Built Meas:	43	Quantity:	LF
Description:	Driveway cross slope exceeds 2.0% (3.1% to 4.0%)		
As Built Desc:	3.5% cross slope		
Solution:	Provide min. 48" wide level walkway through driveway		
Bar. Severity:	2 Recommended	Cost Estimate:	\$5,375.00
		Status:	
Implementation Priority:	2	Facility Function:	
Implementation Phase:		Implementation Date:	
Official Responsible:

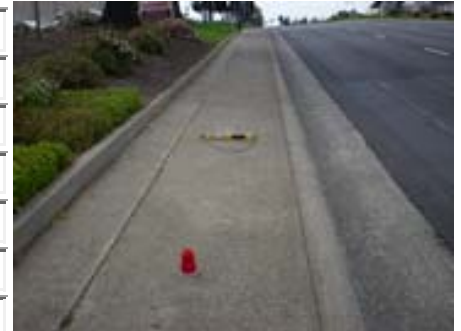
Field Date:	4/20/2011	Report Date:	4/20/2011	Barrier #:	7197
Location:	Sunrise Blvd - East				
X Coordinate:	-121.2714				
Y Coordinate:	38.68069				
Barrier Area:	Sidewalks				
Barrier Type:	Cross Slope - Existing (4.1% to 4.9%)				
Code Ref:	CBC 1133B.7.1.3 and ADA/ABA 403.3

As Built Meas:	143	Quantity:	LF
Description:	Cross slope exceeds 2.0% (4.1% to 4.9%)		
As Built Desc:	4.5% cross slope		
Solution:	Demolish existing and construct new route		
Bar. Severity:	2 Recommended	Cost Estimate:	\$17,875.00
Implementation Priority:	1	Facility Function:	
Implementation Phase:		Implementation Date:	
Official Responsible:

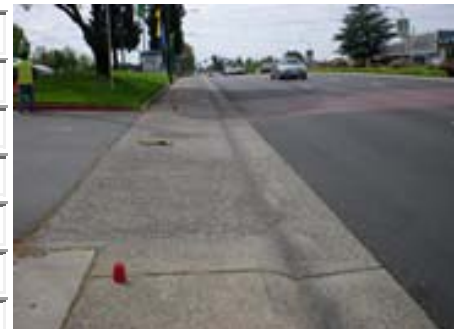
Field Date:	4/20/2011	Report Date:	4/20/2011	Barrier #:	7198
Location:	Sunrise Blvd - East				
X Coordinate:	-121.2714				
Y Coordinate:	38.68022				
Barrier Area:	Sidewalks				
Barrier Type:	Driveway - Existing (5.0% or more)				
Code Ref:	CBC 1133B.7.1.3 and ADA/ABA 403.3

As Built Meas:	36	Quantity:	LF
Description:	Driveway cross slope exceeds 2.0% (5.0% or more)		
As Built Desc:	7.0% cross slope		
Solution:	Provide min. 48" wide level walkway through driveway		
Bar. Severity:	4 Low Severity	Cost Estimate:	\$4,500.00
Implementation Priority:	1	Facility Function:	
Implementation Phase:		Implementation Date:	
Official Responsible:

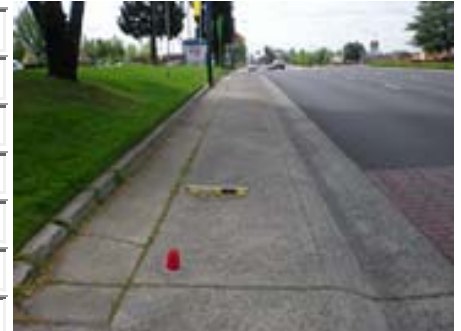
Field Date:	4/20/2011	Report Date:	4/20/2011	Barrier #:	7199
Location:	Sunrise Blvd - East				
X Coordinate:	-121.27137				
Y Coordinate:	38.67955				
Barrier Area:	Sidewalks				
Barrier Type:	Cross Slope - Existing (4.1% to 4.9%)				
Code Ref:	CBC 1133B.7.1.3 and ADA/ABA 403.3

As Built Meas:	319	Quantity:	LF
Description:	Cross slope exceeds 2.0% (4.1% to 4.9%)		
As Built Desc:	4.1% cross slope		
Solution:	Demolish existing and construct new route		
Bar. Severity:	2 Recommended	Cost Estimate:	\$39,875.00
Implementation Priority:	1	Facility Function:	
Implementation Phase:		Implementation Date:	
Official Responsible:

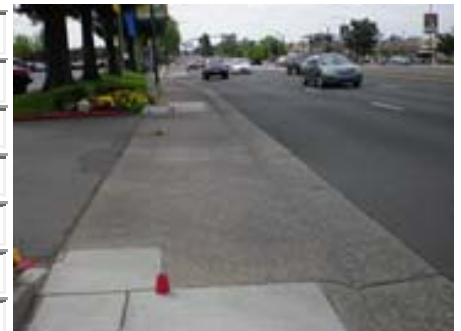
Field Date:	4/20/2011	Report Date:	4/20/2011	Barrier #:	7200
Location:	Sunrise Blvd - East				
X Coordinate:	-121.2714				
Y Coordinate:	38.68021				
Barrier Area:	Sidewalks				
Barrier Type:	Driveway - Existing (5.0% or more)				
Code Ref:	CBC 1133B.7.1.3 and ADA/ABA 403.3

As Built Meas:	36	Quantity:	LF
Description:	Driveway cross slope exceeds 2.0% (5.0% or more)		
As Built Desc:	6.5% cross slope		
Solution:	Provide min. 48" wide level walkway through driveway		
Bar. Severity:	4 Low Severity	Cost Estimate:	\$4,500.00
Implementation Priority:	1	Facility Function:	
Implementation Phase:		Implementation Date:	
Official Responsible:

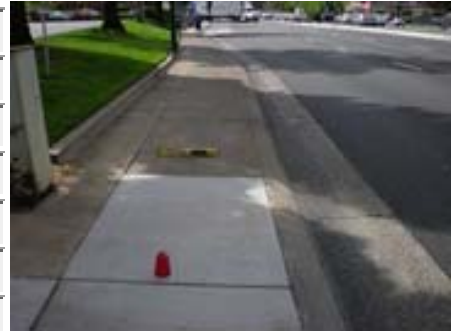
Field Date:	4/20/2011	Report Date:	4/20/2011	Barrier #:	7201
Location:	Sunrise Blvd - East				
X Coordinate:	-121.27139				
Y Coordinate:	38.6795				
Barrier Area:	Sidewalks				
Barrier Type:	Cross Slope - Existing (3.1% to 4.0%)				
Code Ref:	CBC 1133B.7.1.3 and ADA/ABA 403.3

As Built Meas:	200	Quantity:	LF
Description:	Cross slope exceeds 2.0% (3.1% to 4.0%)		
As Built Desc:	3.3% cross slope		
Solution:	Demolish existing and construct new route		
Bar. Severity:	3 Hindrance	Cost Estimate:	\$25,000.00
Implementation Priority:	1	Facility Function:	
Implementation Phase:		Implementation Date:	
Official Responsible:

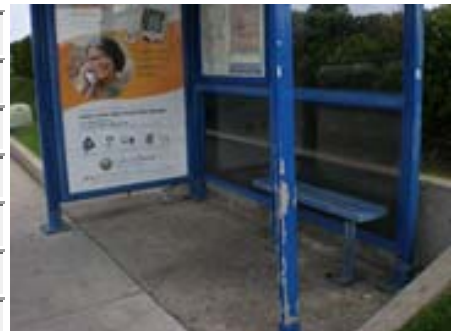
Field Date:	4/20/2011	Report Date:	4/20/2011	Barrier #:	7202A
Location:	Sunrise Blvd - East				
X Coordinate:	-121.27135				
Y Coordinate:	38.679				
Barrier Area:	Bus Stops and Shelters				
Barrier Type:	Cross Slope - Existing (3.1% to 4.0%)				
Code Ref:	CBC 1121B.2.1 and ADAAG 10.2.1(1)

As Built Meas:	4	Quantity:	LF
Description:	Cross slope at bus pad or shelter exceeds 2.0% (3.1% to 4.0%)		
As Built Desc:	3.5% cross slope		
Solution:	Demolish existing and construct new bus pad or shelter pad		
Bar. Severity:	3 Hindrance	Cost Estimate:	\$500.00
Implementation Priority:	1	Facility Function:	
Implementation Phase:		Implementation Date:	
Official Responsible:

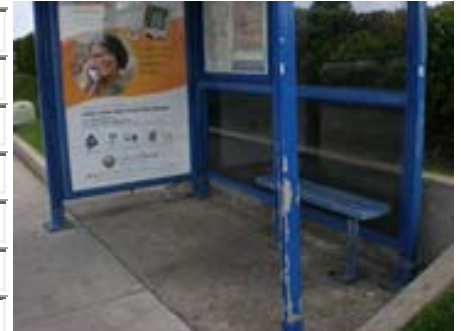
Field Date:	4/20/2011	Report Date:	4/20/2011	Barrier #:	7202B
Location:	Sunrise Blvd - East				
X Coordinate:	-121.27135				
Y Coordinate:	38.679				
Barrier Area:	Bus Stops and Shelters				
Barrier Type:	Bench Seat Height				
Code Ref:	ADAAG 4.37.3* and ADA/ABA 903.4

As Built Meas:	1	Quantity:	EACH
Description:	Bench seat height not between 17" - 19"		
As Built Desc:	20" bench seat height		
Solution:	Provide new compliant bench or remount at compliant height where possible		
Bar. Severity:	3 Hindrance	Cost Estimate:	\$775.00
Implementation Priority:	1	Facility Function:	
Implementation Phase:		Implementation Date:	
Official Responsible:			
Notes:

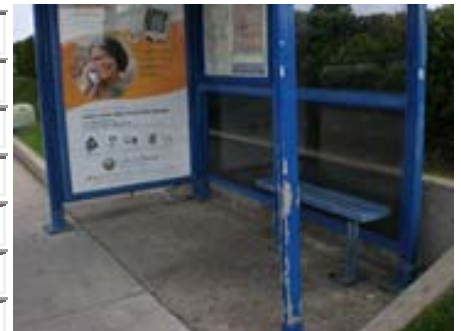
Field Date:	4/20/2011	Report Date:	4/20/2011	Barrier #:	7202C
Location:	Sunrise Blvd - East				
X Coordinate:	-121.27135				
Y Coordinate:	38.679				
Barrier Area:	Bus Stops and Shelters				
Barrier Type:	Bench Seat Depth				
Code Ref:	ADAAG 4.37.1 and ADA/ABA 903.4

As Built Meas:	1	Quantity:	EACH
Description:	Bench seat depth not 20" - 24" deep		
As Built Desc:	9-1/2" bench seat depth		
Solution:	Provide min. 1 accessible bench at bench stop		
Bar. Severity:	3 Hindrance	Cost Estimate:	\$0.00
Implementation Priority:	1	Facility Function:	
Implementation Phase:		Implementation Date:	
Official Responsible:			
Notes:

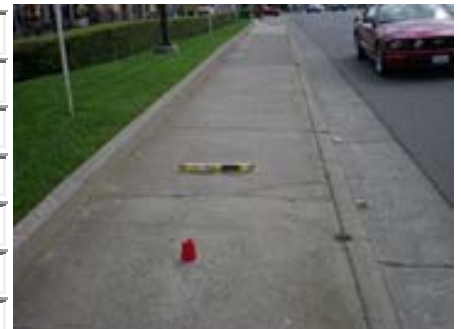
Field Date:	4/20/2011	Report Date:	4/20/2011	Barrier #:	7203
Location:	Greenback Ln - North				
X Coordinate:	-121.27123				
Y Coordinate:	38.67861				
Barrier Area:	Sidewalks				
Barrier Type:	Cross Slope - Existing (5.0% or more)				
Code Ref:	CBC 1133B.7.1.3 and ADA/ABA 403.3

As Built Meas:	178	Quantity:	LF
Description:	Cross slope exceeds 2.0% (5.0% or more)		
As Built Desc:	5.8% cross slope		
Solution:	Demolish existing and construct new route		
Bar. Severity:	1 Necessary	Cost Estimate:	\$22,250.00
Implementation Priority:	1	Facility Function:	
Implementation Phase:		Implementation Date:	
Official Responsible:			
Notes:

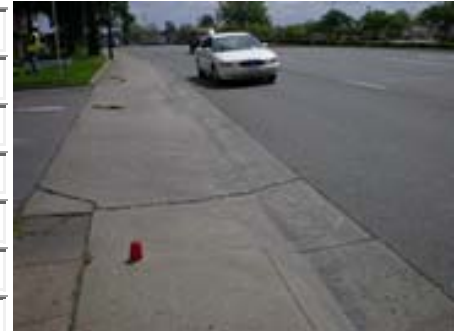
Field Date:	4/20/2011	Report Date:	4/20/2011	Barrier #:	7204
Location:	Greenback Ln - North				
X Coordinate:	-121.27051				
Y Coordinate:	38.67863				
Barrier Area:	Sidewalks				
Barrier Type:	Driveway - Existing (5.0% or more)				
Code Ref:	CBC 1133B.7.1.3 and ADA/ABA 403.3

As Built Meas:	48	Quantity:	LF
Description:	Driveway cross slope exceeds 2.0% (5.0% or more)		
As Built Desc:	8.8% cross slope		
Solution:	Provide min. 48" wide level walkway through driveway		
Bar. Severity:	4 Low Severity	Cost Estimate:	\$6,000.00
Implementation Priority:	1	Facility Function:	
Implementation Phase:		Implementation Date:	
Official Responsible:

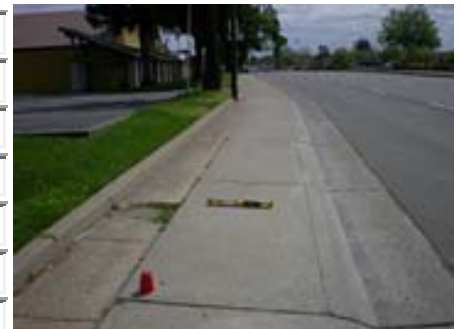
Field Date:	4/20/2011	Report Date:	4/20/2011	Barrier #:	7205
Location:	Greenback Ln - North				
X Coordinate:	-121.27046				
Y Coordinate:	38.67859				
Barrier Area:	Sidewalks				
Barrier Type:	Cross Slope - Existing (5.0% or more)				
Code Ref:	CBC 1133B.7.1.3 and ADA/ABA 403.3

As Built Meas:	322	Quantity:	LF
Description:	Cross slope exceeds 2.0% (5.0% or more)		
As Built Desc:	5.8% cross slope		
Solution:	Demolish existing and construct new route		
Bar. Severity:	1 Necessary	Cost Estimate:	\$40,250.00
Implementation Priority:	1	Facility Function:	
Implementation Phase:		Implementation Date:	
Official Responsible:

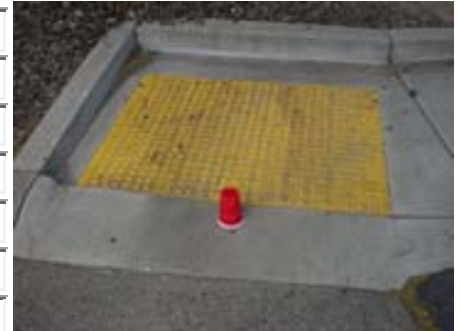
Field Date:	4/20/2011	Report Date:	4/20/2011	Barrier #:	7206
Location:	Greenback Ln and "Wendy's" Entrance - Corner A				
X Coordinate:	-121.26923				
Y Coordinate:	38.67861				
Barrier Area:	Curb Ramps				
Barrier Type:	12" Grooves - Existing (2.1% to 3.0%)				
Code Ref:	CBC 1127B.5.6

As Built Meas:	1	Quantity:	EACH
Description:	12" grooves at top of curb ramp are not level (2.1% to 3.0%)		
As Built Desc:	3.0% at 12" grooves		
Solution:	Demolish existing and construct new curb ramp		
Bar. Severity:	4 Low Severity	Cost Estimate:	\$2,500.00
Implementation Priority:	1	Facility Function:	
Implementation Phase:		Implementation Date:	
Official Responsible:			
Notes:	Two - way intersection corners A,B

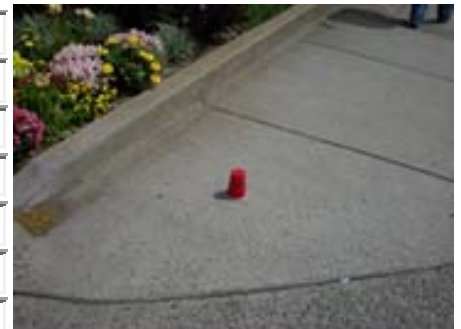
Field Date:	4/20/2011	Report Date:	4/20/2011	Barrier #:	7207
Location:	Greenback Ln and "Wendy's" Entrance - Corner B				
X Coordinate:	-121.26907				
Y Coordinate:	38.67862				
Barrier Area:	Blended Transitions				
Barrier Type:	Detectable Warnings - Truncated Domes				
Code Ref:	CBC 1127B.5.3

As Built Meas:	1	Quantity:	EACH
Description:	No truncated domes provided at transition into roadway		
As Built Desc:	No detectable warning provided		
Solution:	Provide compliant truncated domes		
Bar. Severity:	2 Recommended	Cost Estimate:	\$1,400.00
Implementation Priority:	1	Facility Function:	
Implementation Phase:		Implementation Date:	
Official Responsible:			
Notes:	Two - way intersection corners A,B

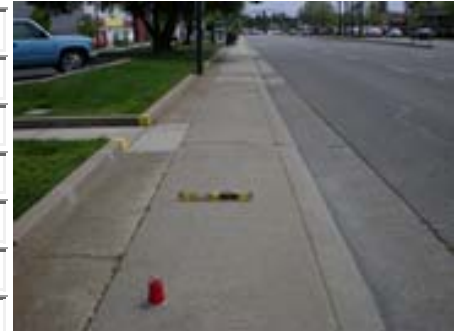
Barrier Type: Cross Slope - Existing (4.1% to 4.9%)

As Built Meas: 132 Quantity: LF

Description: Cross slope exceeds 2.0% (4.1% to 4.9%)

Bar. Severity: 2 Recommended Cost Estimate: \$16,500.00 Status:

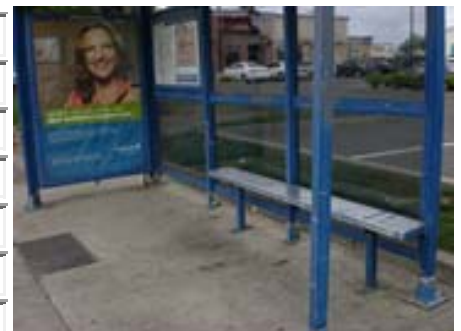
Barrier Type: Bench Seat Depth

As Built Meas: 1 Quantity: EACH

Description: Bench seat depth not 20" - 24" deep

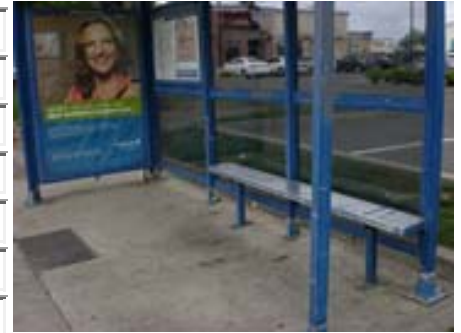
Barrier Type: Bench Seat Height

As Built Meas: 1 Quantity: EACH

Description: Bench seat height not between 17" - 19"

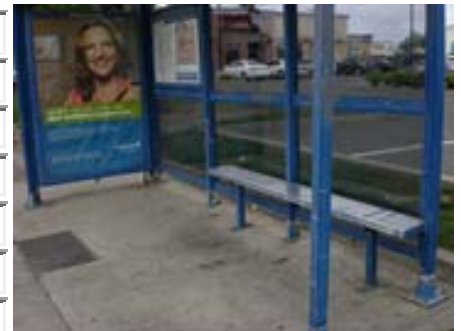
Barrier Type: Bench Back Support

As Built Meas: 1 Quantity: EACH

Description: Bench has no back support of at least 18" high

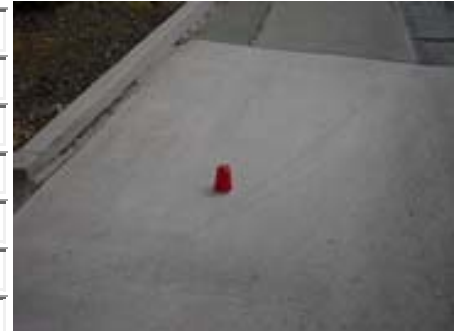
Field Date:	4/20/2011	Report Date:	4/20/2011	Barrier #:	7210
Location:	Greenback Ln and "Wise Buys" Entrance - Corner B				
X Coordinate:	-121.26807				
Y Coordinate:	38.67865				
Barrier Area:	Blended Transitions				
Barrier Type:	Detectable Warnings - Truncated Domes				
Code Ref:	CBC 1127B.5.3

As Built Meas:	1	Quantity:	EACH
Description:	No truncated domes provided at transition into roadway		
As Built Desc:	No detectable warning provided		
Solution:	Provide compliant truncated domes		
Bar. Severity:	2 Recommended	Cost Estimate:	\$1,400.00
Implementation Priority:	1	Facility Function:	
Implementation Phase:		Implementation Date:	
Official Responsible:			
Notes:	Two - way intersection corner A,B. Corner A compliant

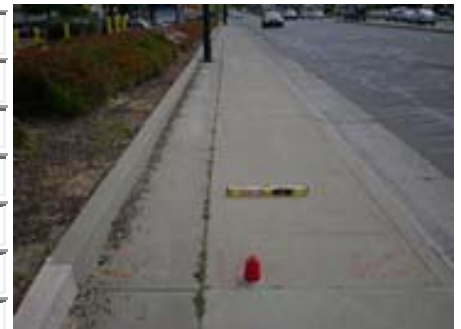
Field Date:	4/20/2011	Report Date:	4/20/2011	Barrier #:	7211
Location:	Greenback Ln - North				
X Coordinate:	-121.26801				
Y Coordinate:	38.67865				
Barrier Area:	Sidewalks				
Barrier Type:	Cross Slope - Existing (4.1% to 4.9%)				
Code Ref:	CBC 1133B.7.1.3 and ADA/ABA 403.3

As Built Meas:	206	Quantity:	LF
Description:	Cross slope exceeds 2.0% (4.1% to 4.9%)		
As Built Desc:	4.1% cross slope		
Solution:	Demolish existing and construct new route		
Bar. Severity:	2 Recommended	Cost Estimate:	\$25,750.00
Implementation Priority:	1	Facility Function:	
Implementation Phase:		Implementation Date:	
Official Responsible:			
Notes:

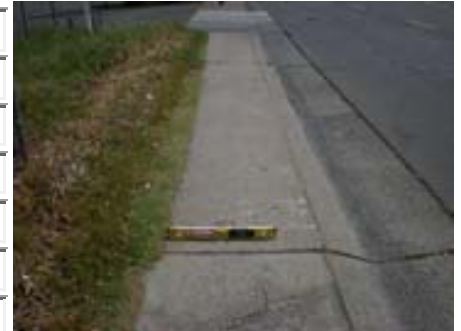
Field Date:	4/20/2011	Report Date:	4/20/2011	Barrier #:	7212
Location:	Greenback Ln - North				
X Coordinate:	-121.26613				
Y Coordinate:	38.67866				
Barrier Area:	Sidewalks				
Barrier Type:	Clear Width - Existing ($\leq 31"$ or less)				
Code Ref:	CBC 1133B.7.1

As Built Meas:	1	Quantity:	LF
Description:	Pedestrian route is not min. 48" wide ($\leq 31"$ or less)		
As Built Desc:	24" clear width due to foliage		
Solution:	Trim foliage to provide min. 48" clear width		
Bar. Severity:	1 Necessary	Cost Estimate:	\$125.00
Implementation Priority:	1	Facility Function:	
Implementation Phase:		Implementation Date:	
Official Responsible:			
Notes:

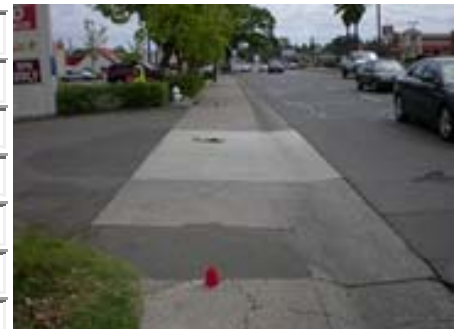
Field Date:	4/20/2011	Report Date:	4/20/2011	Barrier #:	7213
Location:	Greenback Ln - North				
X Coordinate:	-121.26636				
Y Coordinate:	38.67863				
Barrier Area:	Sidewalks				
Barrier Type:	Driveway - Existing (5.0% or more)				
Code Ref:	CBC 1133B.7.1.3 and ADA/ABA 403.3

As Built Meas:	43	Quantity:	LF
Description:	Driveway cross slope exceeds 2.0% (5.0% or more)		
As Built Desc:	6.5% cross slope		
Solution:	Provide min. 48" wide level walkway through driveway		
Bar. Severity:	4 Low Severity	Cost Estimate:	\$5,375.00
Implementation Priority:	1	Facility Function:	
Implementation Phase:		Implementation Date:	
Official Responsible:			
Notes:

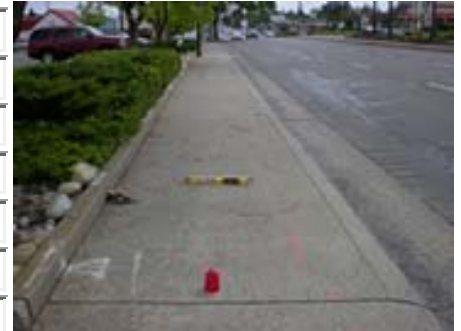
Field Date:	4/20/2011	Report Date:	4/20/2011	Barrier #:	7214
Location:	Greenback Ln - North				
X Coordinate:	-121.26602				
Y Coordinate:	38.67869				
Barrier Area:	Sidewalks				
Barrier Type:	Cross Slope - Existing (4.1% to 4.9%)				
Code Ref:	CBC 1133B.7.1.3 and ADA/ABA 403.3

As Built Meas:	152	Quantity:	LF
Description:	Cross slope exceeds 2.0% (4.1% to 4.9%)		
As Built Desc:	4.2% cross slope		
Solution:	Demolish existing and construct new route		
Bar. Severity:	2 Recommended	Cost Estimate:	\$19,000.00
Implementation Priority:	1	Facility Function:	
Implementation Phase:		Implementation Date:	
Official Responsible:
