DRAFT ADA TRANSITION PLAN UPDATE
NEIGHBORHOOD AREA 9 SONA
SEPTEMBER 20, 2011

CITY OF CITRUS HEIGHTS

The Sunrise Oaks Neighborhood Association (SONA)

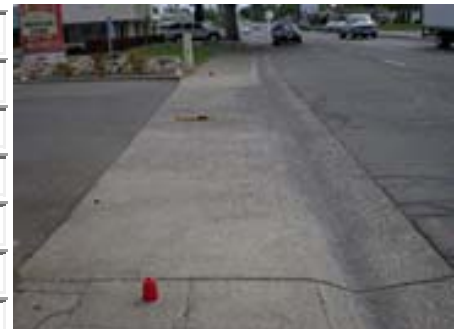
Field Date:	4/20/2011	Report Date:	4/20/2011	Barrier #:	7215
Location:	Greenback Ln - North				
X Coordinate:	-121.26545				
Y Coordinate:	38.67867				
Barrier Area:	Sidewalks				
Barrier Type:	Driveway - Existing (4.1% to 4.9%)				
Code Ref:	CBC 1133B.7.1.3 and ADA/ABA 403.3

As Built Meas:	38	Quantity:	LF
Description:	Driveway cross slope exceeds 2.0% (4.1% to 4.9%)		
As Built Desc:	4.2% cross slope, 9.0% running slope		
Solution:	Provide min. 48" wide level walkway through driveway		
Bar. Severity:	1 Necessary	Cost Estimate:	\$4,750.00
Implementation Priority:	1	Facility Function:	
Implementation Phase:		Implementation Date:	
Official Responsible:

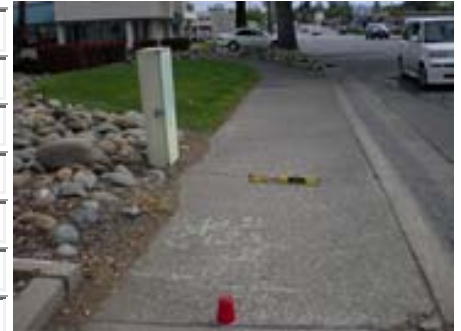
Barrier Type: Cross Slope - Existing (3.1% to 4.0%)

Description: Cross slope exceeds 2.0% (3.1% to 4.0%)

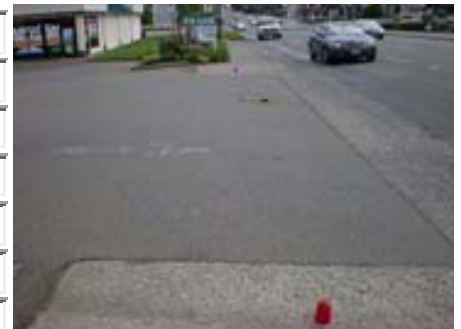
Barrier Type: Driveway - Existing (4.1% to 4.9%)

Description: Driveway cross slope exceeds 2.0% (4.1% to 4.9%)

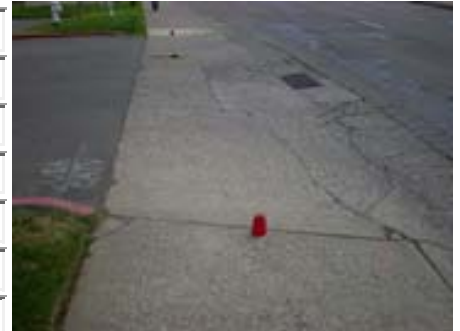
Field Date:	4/20/2011	Report Date:	4/20/2011	Barrier #:	7218
Location:	Greenback Ln - North				
X Coordinate:	-121.26363				
Y Coordinate:	38.67869				
Barrier Area:	Sidewalks				
Barrier Type:	Driveway - Existing (4.1% to 4.9%)				
Code Ref:	CBC 1133B.7.1.3 and ADA/ABA 403.3

As Built Meas:	36	Quantity:	LF
Description:	Driveway cross slope exceeds 2.0% (4.1% to 4.9%)		
As Built Desc:	4.7% cross slope		
Solution:	Provide min. 48" wide level walkway through driveway		
Bar. Severity:	3 Hindrance	Cost Estimate:	\$4,500.00
Implementation Priority:	1	Facility Function:	
Implementation Phase:		Implementation Date:	
Official Responsible:

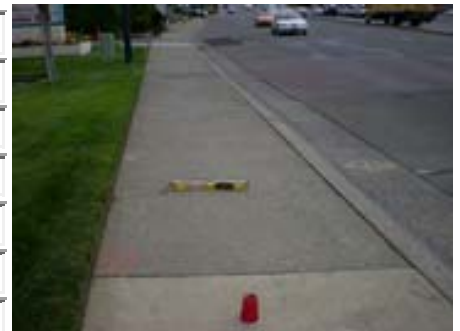
Field Date:	4/20/2011	Report Date:	4/20/2011	Barrier #:	7219
Location:	Greenback Ln - North				
X Coordinate:	-121.2635				
Y Coordinate:	38.67874				
Barrier Area:	Sidewalks				
Barrier Type:	Cross Slope - Existing (4.1% to 4.9%)				
Code Ref:	CBC 1133B.7.1.3 and ADA/ABA 403.3

As Built Meas:	77	Quantity:	LF
Description:	Cross slope exceeds 2.0% (4.1% to 4.9%)		
As Built Desc:	4.2% cross slope		
Solution:	Demolish existing and construct new route		
Bar. Severity:	2 Recommended	Cost Estimate:	\$9,625.00
Implementation Priority:	1	Facility Function:	
Implementation Phase:		Implementation Date:	
Official Responsible:

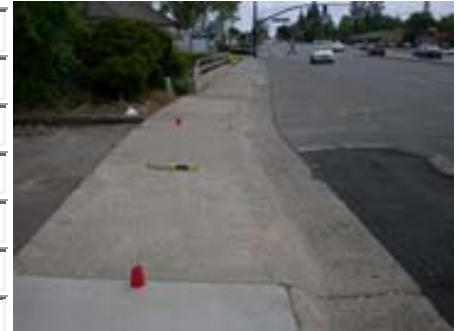
Field Date:	4/20/2011	Report Date:	4/20/2011	Barrier #:	7220
Location:	Greenback Ln - North				
X Coordinate:	-121.26326				
Y Coordinate:	38.67872				
Barrier Area:	Sidewalks				
Barrier Type:	Driveway - Existing (5.0% or more)				
Code Ref:	CBC 1133B.7.1.3 and ADA/ABA 403.3

As Built Meas:	22	Quantity:	LF
Description:	Driveway cross slope exceeds 2.0% (5.0% or more)		
As Built Desc:	8.0% cross slope, 12.1% running slope		
Solution:	Provide min. 48" wide level walkway through driveway		
Bar. Severity:	1 Necessary	Cost Estimate:	\$2,750.00
Implementation Priority:	1	Facility Function:	
Implementation Phase:		Implementation Date:	
Official Responsible:			
Notes:

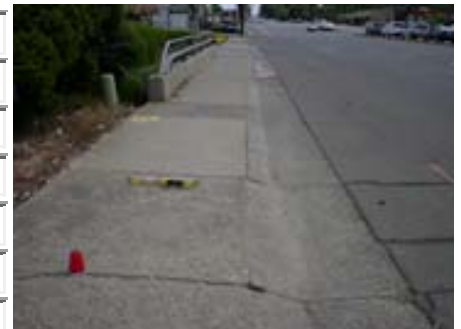
Field Date:	4/20/2011	Report Date:	4/20/2011	Barrier #:	7221
Location:	Greenback Ln - North				
X Coordinate:	-121.26317				
Y Coordinate:	38.67872				
Barrier Area:	Sidewalks				
Barrier Type:	Cross Slope - Existing (5.0% or more)				
Code Ref:	CBC 1133B.7.1.3 and ADA/ABA 403.3

As Built Meas:	77	Quantity:	LF
Description:	Cross slope exceeds 2.0% (5.0% or more)		
As Built Desc:	6.0% cross slope		
Solution:	Demolish existing and construct new route		
Bar. Severity:	1 Necessary	Cost Estimate:	\$9,625.00
Implementation Priority:	1	Facility Function:	
Implementation Phase:		Implementation Date:	
Official Responsible:			
Notes:

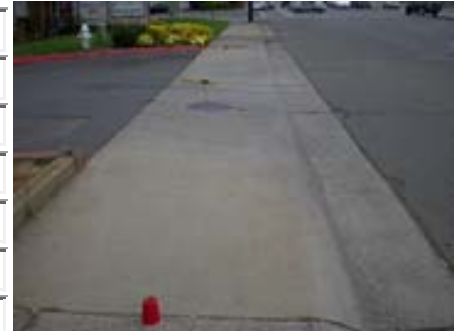
Field Date:	4/20/2011	Report Date:	4/20/2011	Barrier #:	7222
Location:	Greenback Ln - North				
X Coordinate:	-121.26284				
Y Coordinate:	38.67874				
Barrier Area:	Sidewalks				
Barrier Type:	Driveway - Existing (5.0% or more)				
Code Ref:	CBC 1133B.7.1.3 and ADA/ABA 403.3

As Built Meas:	48	Quantity:	LF
Description:	Driveway cross slope exceeds 2.0% (5.0% or more)		
As Built Desc:	7.4% cross slope		
Solution:	Provide min. 48" wide level walkway through driveway		
Bar. Severity:	4 Low Severity	Cost Estimate:	\$6,000.00
		Status:	
Implementation Priority:	1	Facility Function:	
Implementation Phase:		Implementation Date:	
Official Responsible:

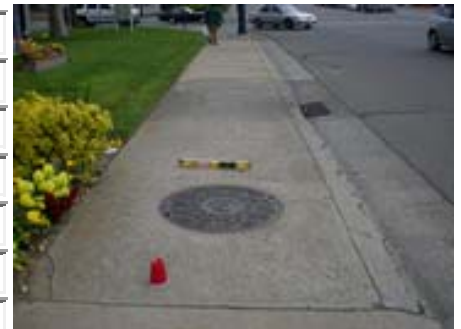
Field Date:	4/20/2011	Report Date:	4/20/2011	Barrier #:	7223
Location:	Greenback Ln - North				
X Coordinate:	-121.26272				
Y Coordinate:	38.67874				
Barrier Area:	Sidewalks				
Barrier Type:	Cross Slope - Existing (4.1% to 4.9%)				
Code Ref:	CBC 1133B.7.1.3 and ADA/ABA 403.3

As Built Meas:	77	Quantity:	LF
Description:	Cross slope exceeds 2.0% (4.1% to 4.9%)		
As Built Desc:	4.3% cross slope		
Solution:	Demolish existing and construct new route		
Bar. Severity:	2 Recommended	Cost Estimate:	\$9,625.00
		Status:	
Implementation Priority:	1	Facility Function:	
Implementation Phase:		Implementation Date:	
Official Responsible:
